Gdańsk University of Technology, Poland

## EXPERIMENTAL INVESTIGATIONS ON CONCRETE BEAMS REINFORCED WITH CFRP LAMELLAS

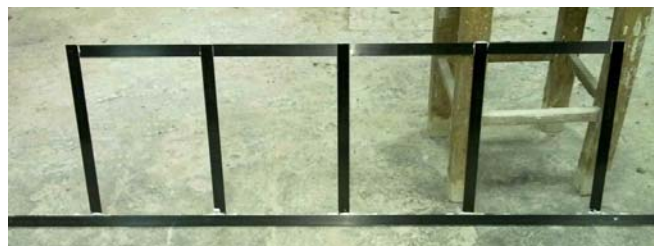
The reinforcement was prepared as a series of frames which were fixed together with the appropriate segments of the lamellas. The mounting material was a two-ingredient epoxy resin glue, also provided by S&P.

Fig. 3. Reinforcing cage before covering with sand

In order to improve the bond between the reinforcement and the concrete, the frames were covered with 1.0-2.0mm grain sand, following the application of the epoxy resin. The same epoxy resin was used for the mounting of the separate reinforcement parts. Gaps were left for strain gauges only.

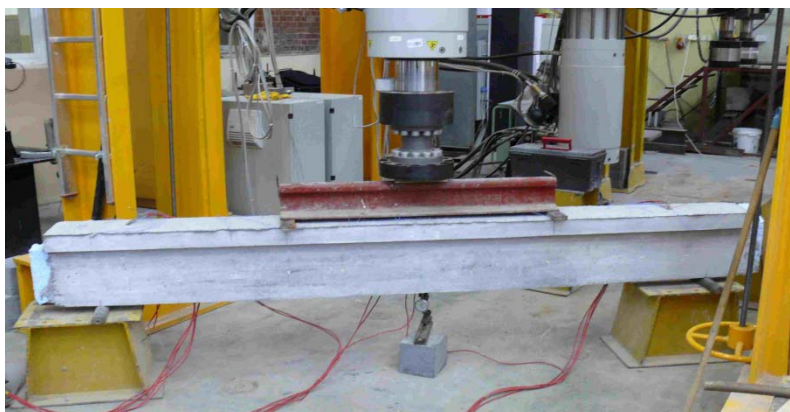
Fig. 5. The beam at the setup

The force from the piston of the tester ( $2P$ ) was transferred to the beam by the travers, which was decomposing it into two concentrated forces. (Fig. 4, Fig. 5). With such parameters of the setup, the slenderness of the shear was  $a/d = 70/30 = 2,33$ .

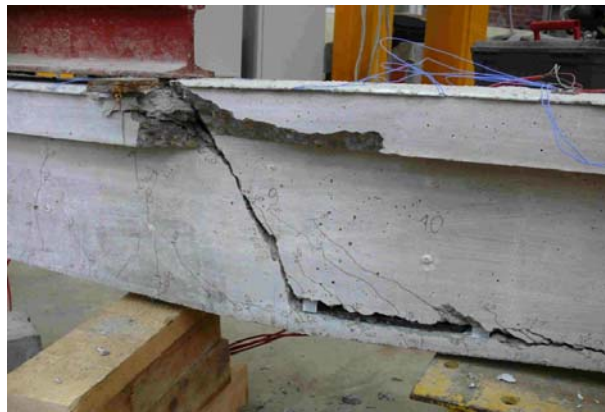
Distinct diagonal crack in beam 1 occurred on the right hand side support. The crack has cut through the base of the extensometer (No 9) The strain of base No 9 was approx. 6%, with the load of  $2P = 100$  kN and it grew to 10,6% with the further increase of the load. This suggests a 1 mm width of the crack. Further increase of the load resulted in the loss of the load-bearing capacity at the force of  $2P = 135$  kN. This was accompanied by a distinct sound of a short, single crack. The load was re-applied to the beam. This resulted in the complete damage of the beam with the crushing of the T- flange concrete. (Fig. 7)

Fig. 7. Cracks in beam 1 on right hand side support

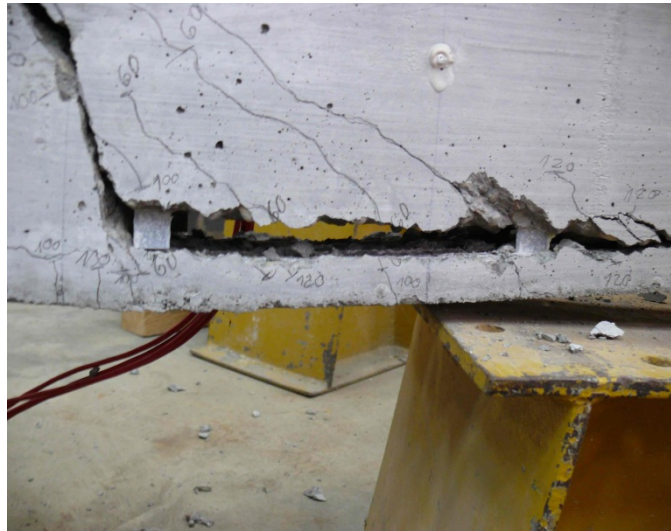
All of the above leads to a conclusion that the reason for the loss of the load bearing capacity for shear was not the loss of the load bearing ability of the stirrups – but the failure of the joint between the stirrups and the main reinforcement. It is apparent in the cracks of both beams that the stirrups were removed from the main reinforcement (Fig. 9). Most probably the failure of the connection was the reason of the distinct cracking sound which was heard during the test of both beams.

Fig. 9. Apparent sliding separation of the neighbouring stirrups from the main reinforcement in beam 1.
