Problem of Clogging in Drainage Systems in the Examples of the Żur and Podgaje Dams

Witold Sterpejkowicz-Wersocki

Abstract

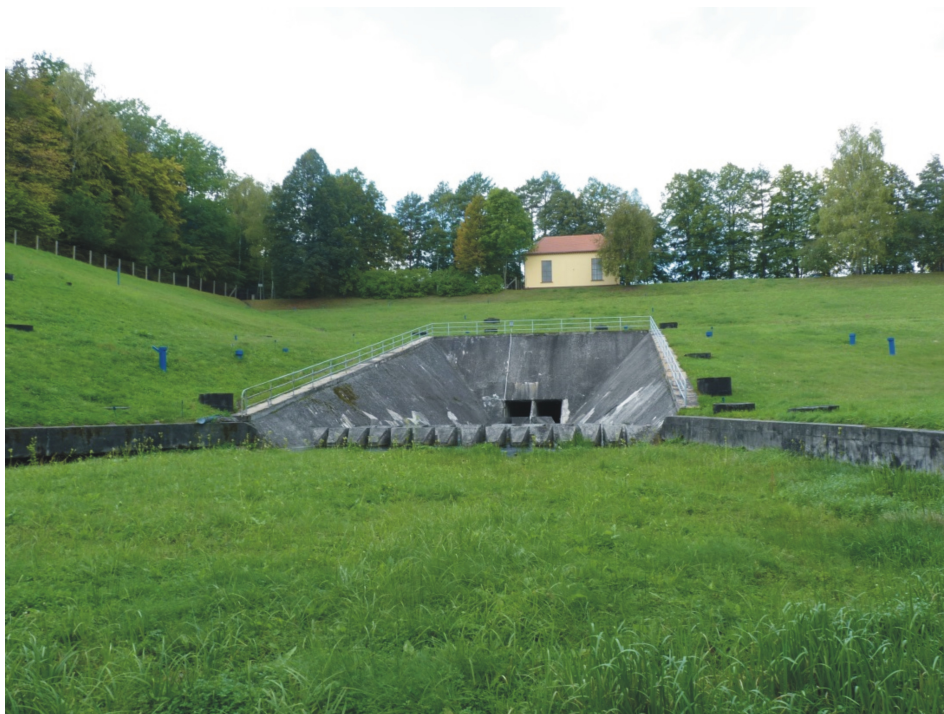
The earth dam in Żur was built in 1928–1930 (Fig. 1). It dams up the Wda (Black Water) river to the elevation of 67.5 m above sea level. The length of the dam at the crown is 175 m, crown elevation 70.0 m a.s.l., base elevation about 52.0 m a.s.l. It is an earth dam sealed with an internal clay core.

Fig. 1. General view of the Zur earth dam and the bottom outlet
