## PROTECTION OF BRIDGES AGAINST STRAY CURRENT CORROSION

**Abstract.** A case study of Siennicki Bridge stray current corrosion hazard is presented. A corrosion risk was caused by incorrectly designed tram line traction which goes over the bridge. No dielectric insulation between running rails and bridge steel construction was used. A variety of protection methods against stray currents are described. Characteristics of the endangered bridge were described. Impressed current cathodic protection system against stray currents was proposed and designed at the Department of Electrochemistry, Corrosion and Materials Engineering, Gdansk University of Technology. Coupon technique measurements and potential measurements were performed to verify the effectiveness of the protection system.

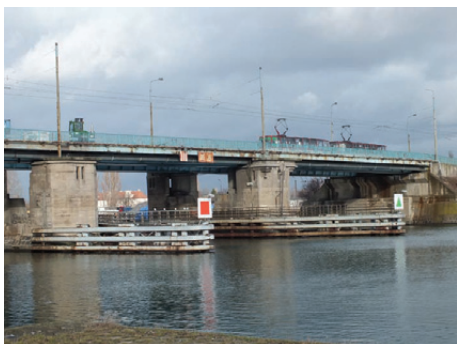
Fig. 1. Siennicki Bridge in Gdansk

The last renovation was carried out in 1990. The bridge is a welded construction made of 18G2A steel. It has one span which is supported by pillars and two bridgeheads. It is approx 96 m long. An image of the bridge is presented in Fig. 1. Old pillars and bridgeheads were adapted to fit the new span. During the general overhaul only the above-water body was rebuilt and consolidated. Pillars and bridgeheads are placed on the old timber pile construction. Their underwater facing is made of stone bonded with cement mortar. During the renovation embrittled parts of the bridge were removed and replaced with reinforced concrete. The bridgeheads were adjusted to fit the span design and there were spherical bearings installed. The bridge pavement is a three layer structure: mastic 1 cm thick, asphaltic concrete 15 cm thick and asphaltic concrete top layer 4 cm thick.

The cathodic protection installation was placed on the left side of the bridge (from Fig. 1 point of view). Parameters of the cathodic protection station were as follows: adjustable current intensity up to 30 A at the maximum output voltage of 40 V. The cathodic protection system was supplied from the bridge electric lighting system. The groundbed was designed as a group of four anodes  $\phi 50 \times 2000$  mm made of high silicon cast iron. Anodes were buried and placed in a graphite-coke backfill in order to lower the current spread resistance. The groundbed was localized approx 50 m away from the bridge. The anode spread resistance equalled 2.15  $\Omega$ . Cable YKOXs 1 $\times$ 16 mm<sup>2</sup> (shipboard power cable with cross-linked polyethylene insulation and PVC sheath) connecting CP station to anodes was buried in soil. The cathode cap was made by connecting the cable (YKOXs 1 $\times$ 16 mm<sup>2</sup>) from CP station to the steel span of the bridge. Pilot electrode – saturated Cu/CuSO<sub>4</sub> electrode of a cylindrical shape (110 mm $\times$ 250 mm) was connected to the CP station with a buried cable (YKOXs 1 $\times$ 4 mm<sup>2</sup>).
