Experimental research on water-lubricated marine stern tube bearings in conditions of improper lubrication and cooling causing rapid bush wear

Gdansk University of Technology, Faculty of Ocean Engineering and Ship Technology, ul. Narutowicza 11/12, 80-233 Gdansk, Poland

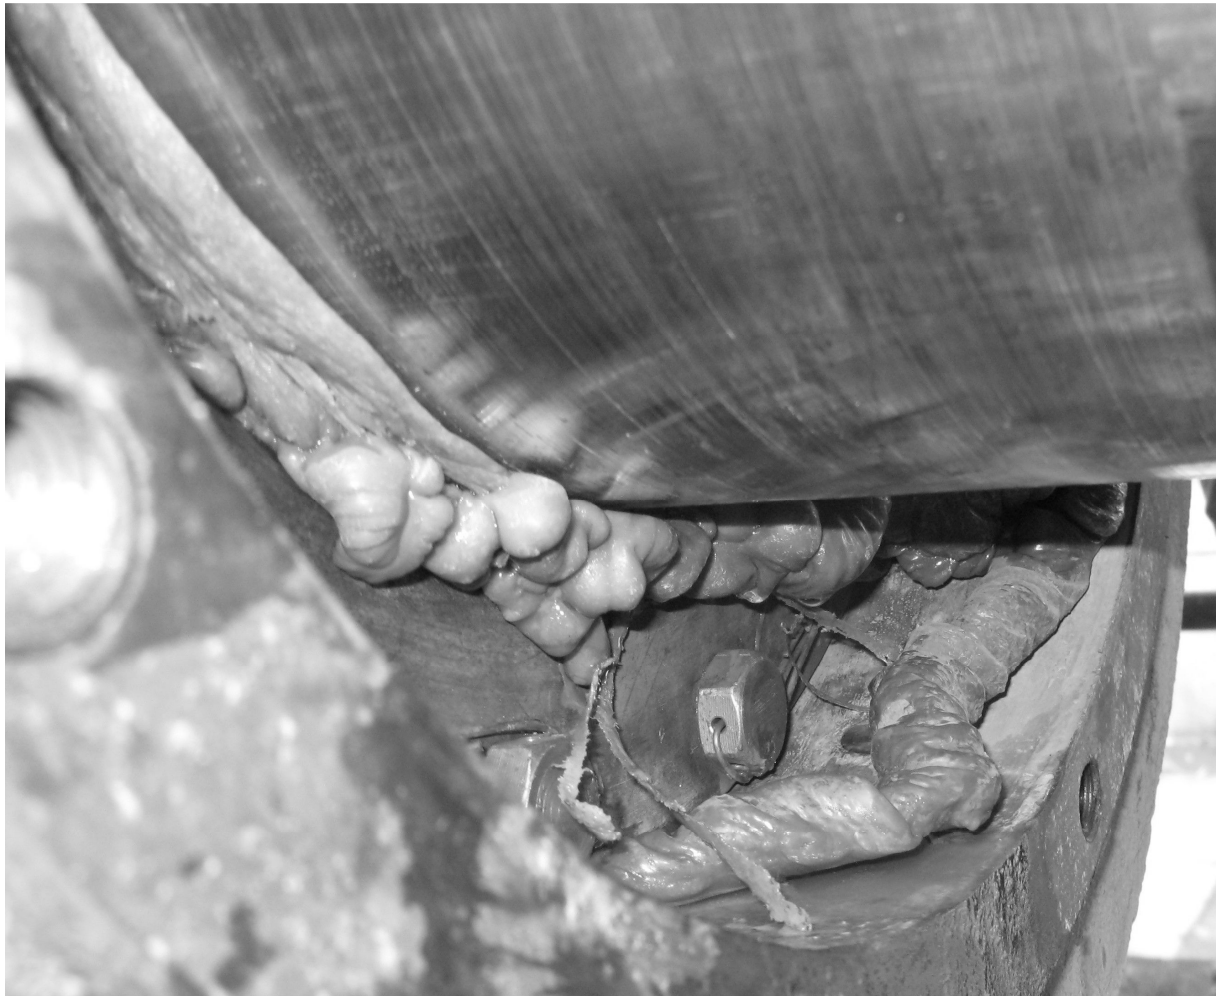
Fig. 1. Melted polymer – the result of an overheated stern tube bearing caused by a cooling system breakdown; shaft diameter 350 mm.

In real-life operations, breakdowns of stern tube bearings in propeller shafts do take place and frequently lead to very serious consequences, resulting in ships being taken out of service. Such breakdowns may be caused by malfunction of the pumping system (Fig. 1). Classification societies

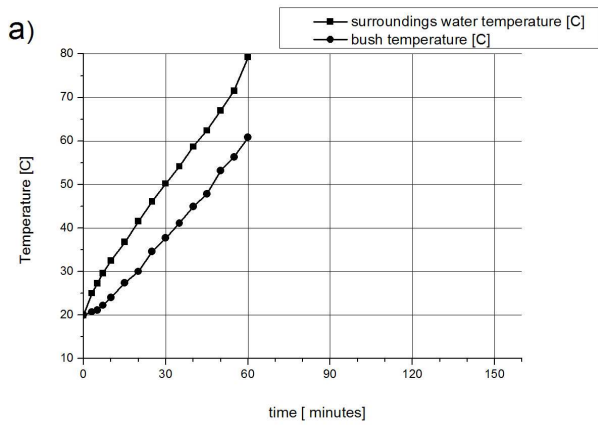
Fig. 6. Temperature increase diagram for bearing C, shaft revolution speed = 11 rev/s,
a) pressure = 0.2 MPa, b) pressure = 0.4 MPa

Earlier comparison-based research into bearing groups of classical geometry with grooves around the entire circumference (A, C) had demonstrated that their hydrodynamic capacity is low (Litwin [26]). The load-carrying capacity may be further limited by sliding surface roughness and there are significant faults in cylindricity (A). As a result of the conducted tests, it was determined that the bearings with classical geometry (A, C) overheated most rapidly. This is because they are working in mixed lubrication conditions, when the power of friction is substantial. In such a scenario, the temperature increases rapidly (Figs. 4, 6).

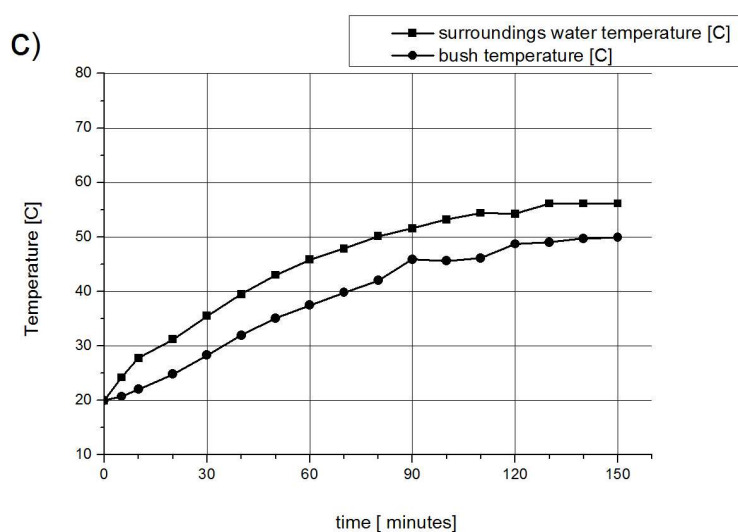
Fig. 10. Temperature increase diagram for bearing D, shaft revolution speed = 11 rev/s,
pressure = 0.6 MPa

also exhibits high hydrodynamic capacity as far as water-lubricated bearings are concerned. The undoubtedly excellent result is not, however, due only to material properties. It is also the result of work in the hydrodynamic lubrication regime, which is supported by the optimum geometry of the bush. This is attested by the fact that a bearing with a bush made of the same material (C) reached a temperature of approximately 80 °C (Fig. 6.) in the zone around the bearing after about 20 minutes of work under a pressure of 0.4 MPa and approximately an hour of work under a pressure of 0.2 MPa.
