CONSTRUCTION SOLUTIONS FOR HISTORICAL OBJECT FOUNDATIONS IN THE CONTEXT OF CHANGING THEIR FUNCTIONAL USE

Kazimierz GWIZDAŁA¹, Sylwia FLORKOWSKA²
Gdańsk University of Technology,
Civil and Environmental Engineering, Gdańsk, Poland

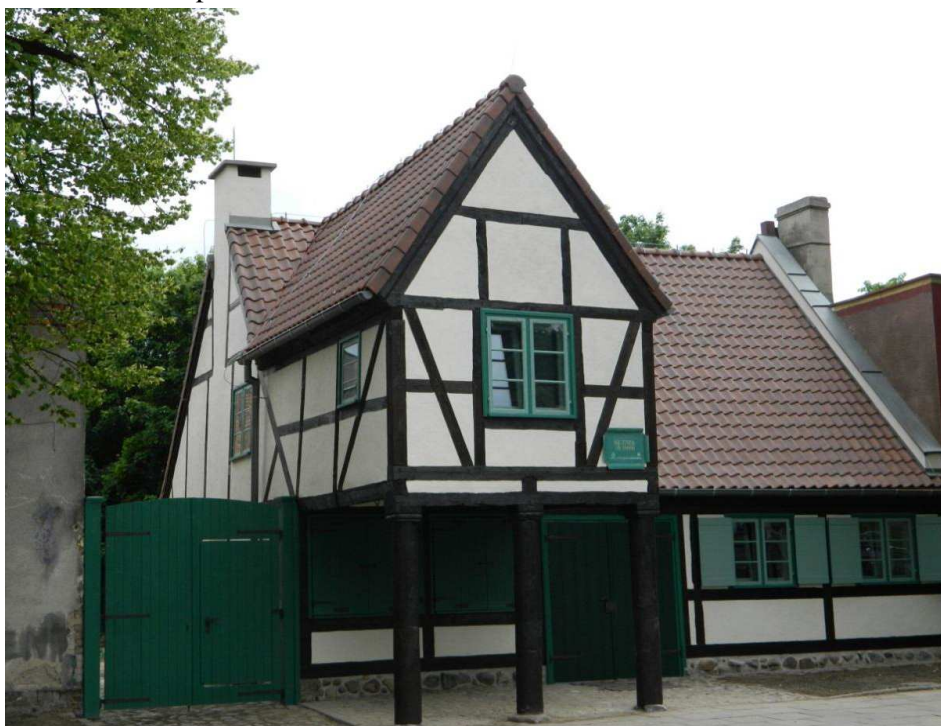
Fig. 1. Forge building after completion of construction-conservation work

An example of a project involving works connected with reinforcing the foundation is the renovation of an arcade house in Gdańsk Orunia. The building was constructed in 1800, and originally served as a workshop and forge; in the XX century, it was converted into a residential dwelling. In 2012, works which aimed to completely renovate the building as well as adapt it to serve a new function were assumed [1]. The existing brick-stone foundations of the building were found to be in a satisfactory technical condition, and required only moisture protection. However, due to the introduction of new construction elements and changes in static and service load, it was necessary to construct new foundations. Favorable subsurface and groundwater conditions made it possible to construct direct foundations in the form of reinforced concrete strips. The works were carried out using the method of reinforcing in segments, after first loading and supporting the construction of the building along the foundations.
