APPLICATION OF ACUSTIC EMISSION FOR DETECTION OF FATIGUE MICRODAMAGE IN MAIN AND CRANK BEARINGS FOR DIESEL ENGINES

Jerzy Girtler

*Gdańsk University of Technology
Faculty of Ocean Engineering and Ship Technology
Department of Ship and Land Power Plants
tel. (+48 58) 347-24-30; fax (+48 58) 347-19-81
e-mail: jgirtl@pg.gda.pl*

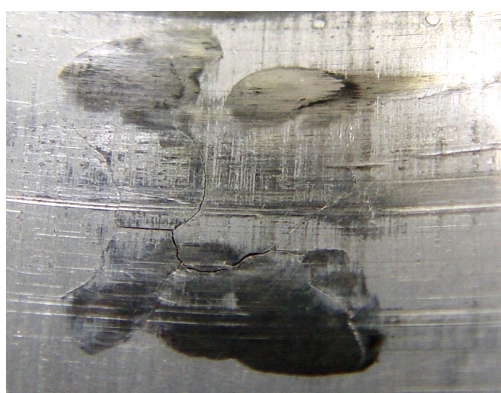
The existence of a standard net of fatigue cracks was recorded on the tested bush of MB58 alloy, as shown in Fig. 7a and b, and Fig. 8.

Fig. 8. Net of cracks on the sliding surface of the MB58 bush (zoom out of the part of the sliding surface shown in Fig. 7b) [9]
