## **APPLICATION OF ACUSTIC EMISSION FOR DETECTION OF FATIGUE MICRODEAMAGE IN MAIN AND CRANK BEARINGS FOR DIESEL ENGINES**

*The article presents reasons for applying the acoustic emission (AE) to detect fatigue microdamage in main bearings and crank bearings of marine main engines. Problem of determination of fatigue life for slide bearing bushes was characterized in general. There were demonstrated properties of the objects of research, which were bushings made of the MB58 alloy, as well as an overall description of the research. It was shown that the frequency bands of AE signals can indicate fatigue damage to the sliding layer of a bearing bush. The fatigue damage in the tested bushes was depicted in figures. General features of the AMSY-6 measuring system, used in the research, were also provided herein.*

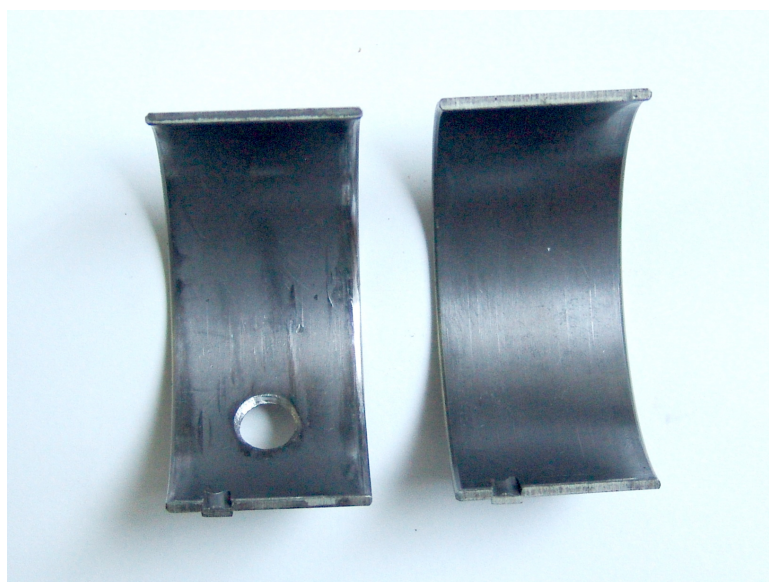
Fig. 2. Surfaces of new half-bushes with sliding layers made of MB58 alloy before testing in the SMOK rig [9]

Fig. 2 shows surfaces of new half-bushes made of MB58 alloy.

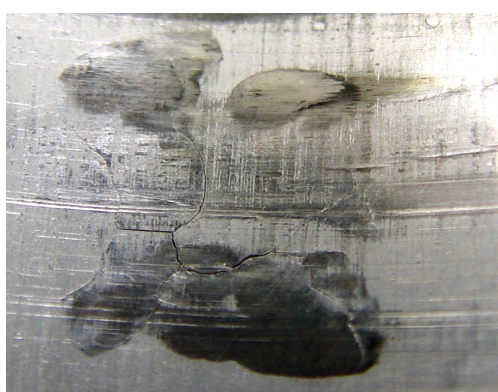
Fig. 8. Net of cracks on the sliding surface of the MB58 bush (zoom out of the part of the sliding surface shown in Fig. 7b) [9]

The existence of a standard net of fatigue cracks was recorded on the tested bush of MB58 alloy, as shown in Fig. 7a and b, and Fig. 8.
