## OVERFLOWING TESTS AT THE POLISH DREDGDIKES RESEARCH DIKE – STABILITY OF THE DIKE SURFACE AGAINST EROSION

**Abstract.** In the project DredgDikes the different research dike embankments were tested with respect to overflowing water induced erosion. Therefore, flumes were installed on the land side embankments in which the effect of overflowing water on the vegetated surface was investigated. On the Polish DredgDikes research dike near Gdansk, Poland, two parallel flumes were installed and the surface of the dike made of different mixtures of ash, silt and sand as well as clay was tested both in vegetated and unvegetated state. The results showed that the grass sods placed on the dike embankment had a comparably low erosion stability, particularly if placed directly on the hardened ash/silt dike cover with better results if placed on a clay cover, while the ash/silt mixture showed a high erosion resistance without vegetation. This results in the recommendation to use a thicker vegetation layer on top of the ash composite dike if the vegetation shall account for the erosion resistance or else, that even if the grass cover is washed away, a very solid cover made of the ash composit

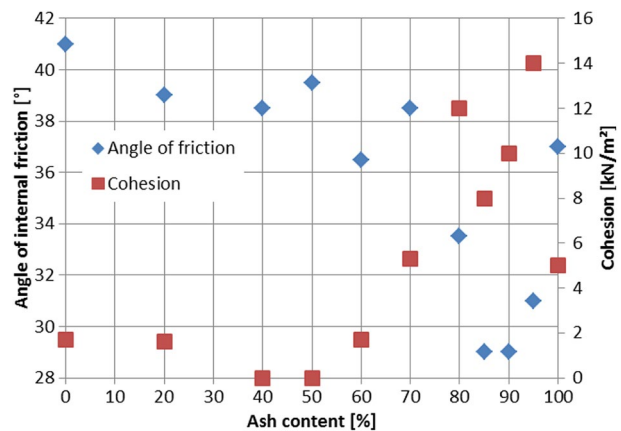
Fig. 2. Angle of internal friction and cohesion of the different sand ash mixtures

The void ratio *e* was determined in the oedometric tests. It increases with increasing ash content. The angle of internal friction and cohesion were derived from direct shear tests. The cohesion increases with an ash content of more than 60% while the angle of friction then decreases, as shown in Figure 2.

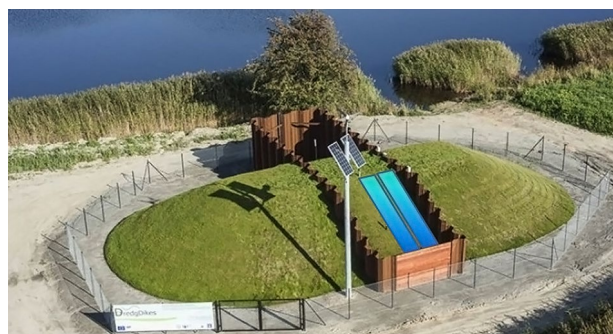
Fig. 3. Gdansk research dike with test section and location of flume 1 (right) and flume 2 (left)

The 3 m high research dike located in Wiślanka/Trzcińsko on the bank of Vistula River ca. 20 km outside the City of Gdańsk was completed in the summer of 2012 (Sikora, Ossowski 2013). It has a slope inclination of 1V:2H and a 3 m wide crest. The 4 m wide test segment of the 24 m long dike is separated by sheet pile walls to obtain two-dimensional plane conditions for seepage and overtopping tests with a controlled water level (Fig. 3).

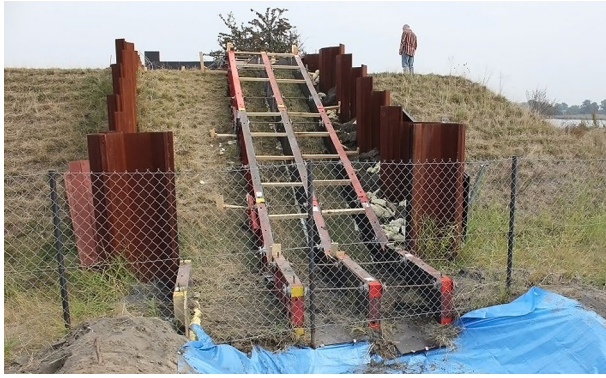
Fig. 5. Basic experimental set-up of the Gdansk flume system

Based on a modified NTPEP (2013) test set-up two parallel flume channels were installed on the downstream embankment of the research dike. Figure 5 shows the basic experimental set-up. Each flume had an inner width of 0.6 m and nine test sections. The flumes were made of construction form elements and each of these was fixed onto the slope and sealed with construction foam. Wooden slats served as markings for the individual test sections (Olschewski *et al.* 2014).

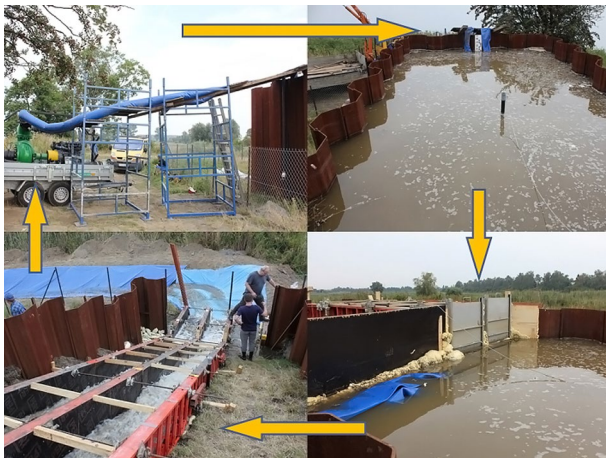
Fig. 6. Water cycle for the overflowing tests: pump, reservoir, shutters and flumes

On the dike crest the water inlets for discharge control were placed. The water delivery system included the Vistula River (as a reservoir), a pump and flexible tubes, the sheet pile basin, steel shutters at the flume inlets and a runoff channel (Fig. 6).

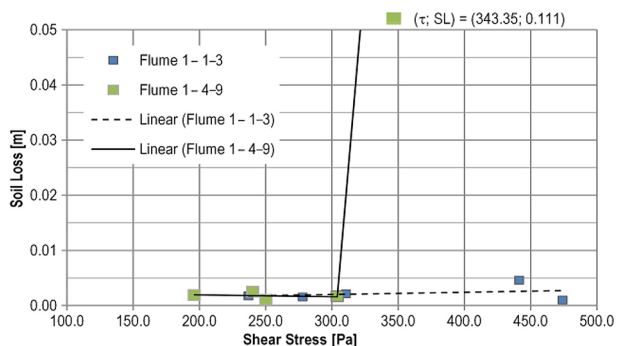
Fig. 10. Erosion rates flume 1 (vegetated); soil loss and shear stress, steep trend line = high erosion rate, focus on the upper (“1-3”) and lower (“4-9”) flume parts, September 2014

Figures 8, 10, 11 and 12 show the results of the vegetated slope while Figures 9, 13, 14 and 15 present the results for the unvegetated conditions, both for the whole flume length and separated into upper and lower section. The shear stress results were chosen to be presented here, since they provide good information regarding the erosion resistance. In addition, Figure 15 shows an example of the image documentation of the slope surface development in flume 1. Due to the scattered measurement results, the definition of a “best fit” trend line through the data points was not reasonable. Instead, a linear trend line was chosen for all charts to define the flume specific soil loss functions. A higher inclination of the trend line stands for a higher erosion rate.

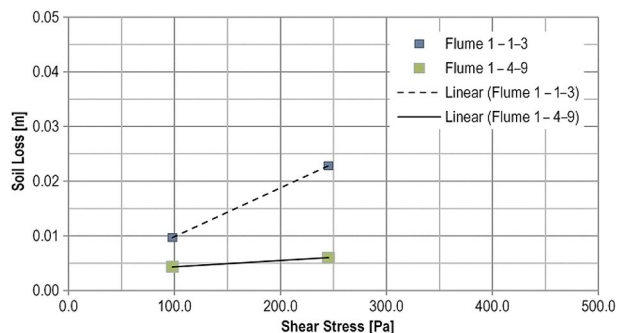
Fig. 13. Erosion rates flume 1 (unvegetated); soil loss and shear stress, steep trend line = high erosion rate, focus on the upper (“1-3”) and lower (“4-9”) flume parts, September 2014

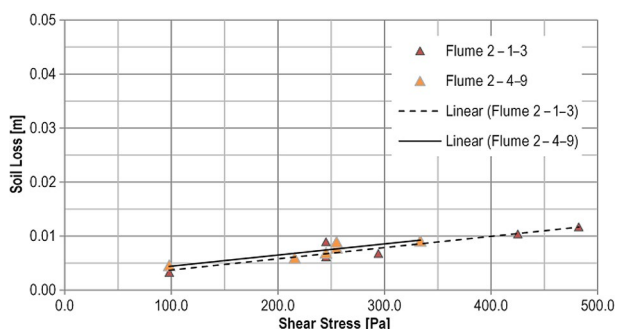
Fig. 14. Erosion rates flume 2 (unvegetated); soil loss and shear stress, steep trend line = high erosion rate, focus on the upper (“1-3”) and lower (“4-9”) flume parts, September 2014

only moderate. This is illustrated by the modest slope of the regression lines in Figures 9 and 14.

charge load. After the removal of the vegetation, the flat surfaces of both materials did not show a measurable difference (Fig. 14).

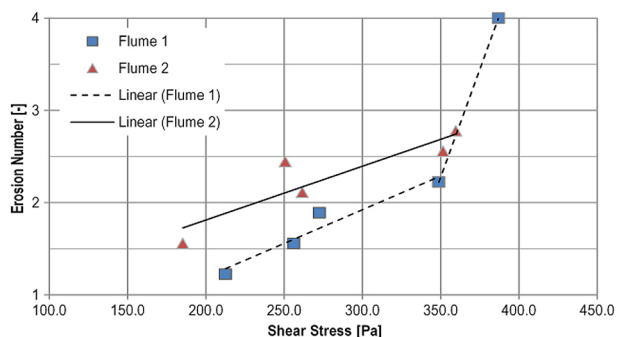
Fig. 12. Erosion numbers flumes 1 & 2 (vegetated); steep trend line = high erosion rate, Sept 2014

An important disadvantage of erosion measurements with a pin profiler is that the erosion is measured only at a few discrete (here: five) points in the upstream part of a test sections used to compute an average value for the whole test section. To overcome this drawback, every test section was additionally rated with the erosion numbers 1 to 4 before and after each flow event. Although there is no quantitative determination of soil loss, this method has the advantage that the condition of the whole surface can be described. The erosion numbers were then compared with the shear stresses for vegetated and unvegetated slope conditions (Figs 12, 15).

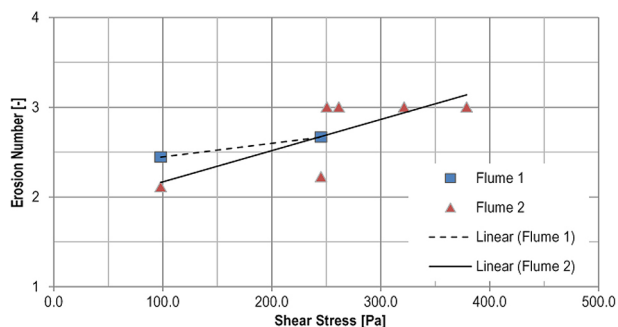
Fig. 15. Erosion numbers flumes 1 & 2 (unvegetated); steep trend line = high erosion rate, September 2014

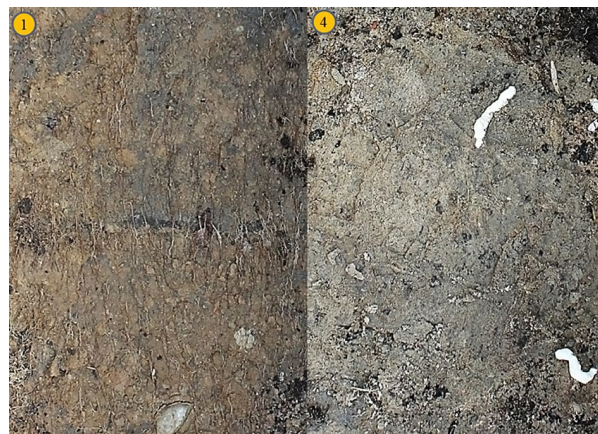
Fig. 16. Root penetration at the unvegetated slope surface. Depending on the subsoil the roots cling into the surface (clay layer, left) or almost not (ash/silt mixture, right). Flume 2, test sections 1 and 4, original unvegetated conditions

Another important issue is the use of rolled turf on the two different cover materials. The connection between the turf and the clay was considerably better (due to roots penetrating the clay and the high adhesion between clay and top soil/turf) than that between turf and ash composite. No roots penetrated the ash composite (Fig. 16). Thus it is not recommended to use rolled turf for dike cover greening if ash composites are used in the dike cover layer. The different cover materials also resulted in a difference in vegetation development due to medium (clay) and no (ash composite) water supply from below. Particularly on the southern embankment the turf failed during the first summer because the thin layer of top soil could not support the turf (not even on top of the clay). Therefore, a top soil layer of 20–40 cm thickness is recommended when installing an ash composite as dike cover material. For this, the benching technique is recommended to stabilise the top soil on the compacted ash composite or else to use a geosynthetic erosion control mat to reinforce the top soil on the embankment.

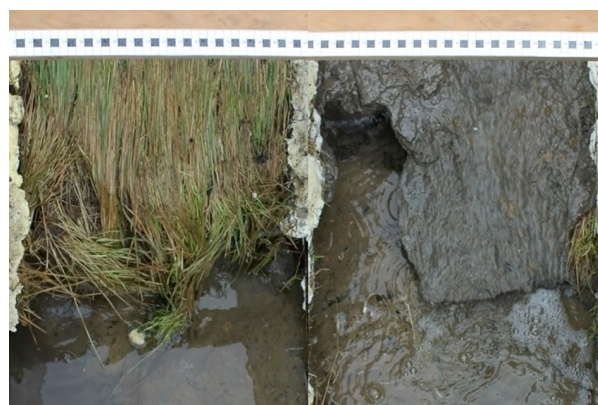
Fig. 17. Dike toe. Clay liner underneath the dike, slip line between the ash/silt dike cover and the clay base. Test section 9 of flume 1 (right) and flume 2 (left) after the 5<sup>th</sup> TD (veg.)

A further important aspect is the underground condition at the dike toe. In case of the research dike the connection between the compacted clay liner that served as an impermeable ground and the ash/silt body/cover material was weak and thus a slip line developed quickly during the overflowing test and the dike toe failed (Fig. 17). This may be mitigated by embedding the dike cross-section including the cover material into the ground or by using technical help such as geosynthetic erosion control mat or reinforcement product.
