## OVERFLOWING TESTS AT THE POLISH DREDGDIKES RESEARCH DIKE – STABILITY OF THE DIKE SURFACE AGAINST EROSION

**Abstract.** In the project DredgDikes the different research dike embankments were tested with respect to overflowing water induced erosion. Therefore, flumes were installed on the land side embankments in which the effect of overflowing water on the vegetated surface was investigated. On the Polish DredgDikes research dike near Gdansk, Poland, two parallel flumes were installed and the surface of the dike made of different mixtures of ash, silt and sand as well as clay was tested both in vegetated and unvegetated state. The results showed that the grass sods placed on the dike embankment had a comparably low erosion stability, particularly if placed directly on the hardened ash/silt dike cover with better results if placed on a clay cover, while the ash/silt mixture showed a high erosion resistance without vegetation. This results in the recommendation to use a thicker vegetation layer on top of the ash composite dike if the vegetation shall account for the erosion resistance or else, that even if the grass cover is washed away, a very solid cover made of the ash composit

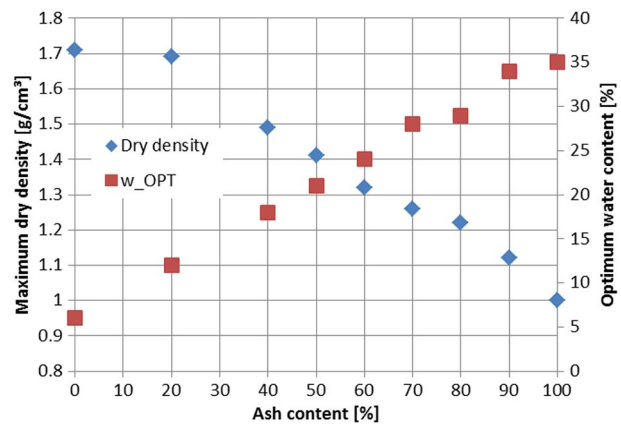
Fig. 1. Maximum dry density and optimum water content of the different sand ash mixtures

The proportion of components in the test dike was chosen based on initial tests on the dredged sand: it was examined, how the properties of the mixture are influenced by the variation of the percentage of ash. For the mixtures, the portion of ash was varied from 0% to 100% in steps of 10%. Figure 1 shows the maximum dry density and optimal water content for

the different mixtures. The optimum water content increases while the density decreases with increasing ash content.

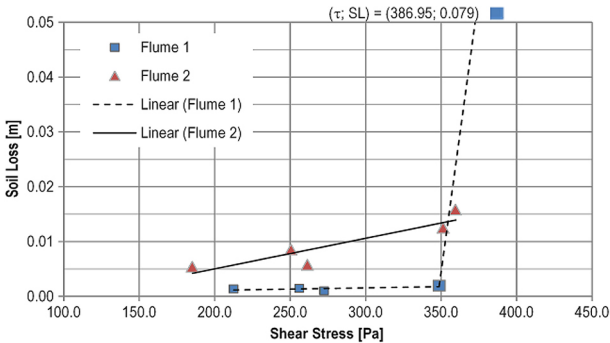
Fig. 8. Erosion rates flumes 1 & 2 (vegetated); soil loss and shear stress, steep trend line = high erosion rate, September 2014

Figures 8, 10, 11 and 12 show the results of the vegetated slope while Figures 9, 13, 14 and 15 present the results for the unvegetated conditions, both for the whole flume length and separated into upper and lower section. The shear stress results were chosen to be presented here, since they provide good information regarding the erosion resistance. In addition, Figure 15 shows an example of the image documentation of the slope surface development in flume 1. Due to the scattered measurement results, the definition of a “best fit” trend line through the data points was not reasonable. Instead, a linear trend line was chosen for all charts to define the flume specific soil loss functions. A higher inclination of the trend line stands for a higher erosion rate.

The results for the vegetated slopes show low values of cumulated soil loss (CSL) during discharge stages 3/4 ( $q_{max} \approx 200 \text{ ls}^{-1}\text{m}^{-1}$ ). The CSL value of  $\approx 2 \text{ mm}$  in flume 1 at a shear stress of  $\tau \approx 350 \text{ Pa}$  is

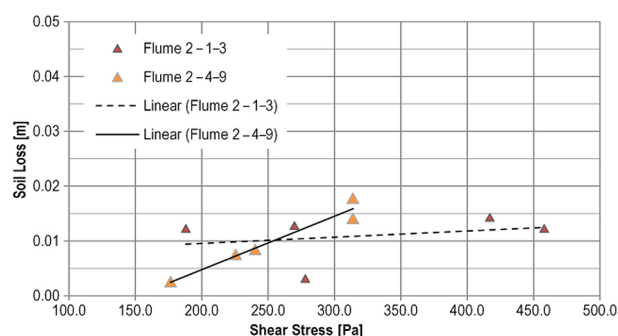
Fig. 11. Erosion rates flume 2 (vegetated); soil loss and shear stress, steep trend line = high erosion rate, focus on the upper (“1-3”) and lower (“4-9”) flume parts, September 2014

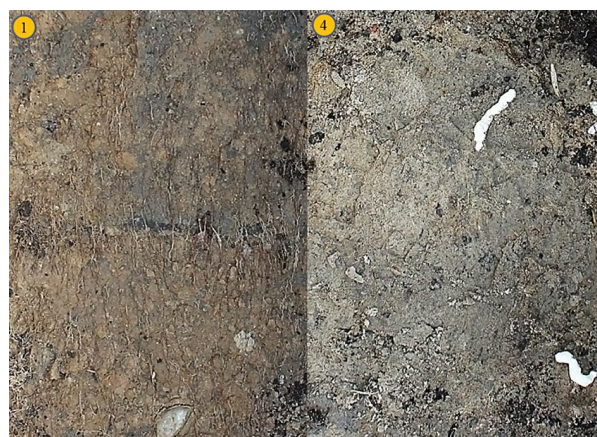
Fig. 16. Root penetration at the unvegetated slope surface. Depending on the subsoil the roots cling into the surface (clay layer, left) or almost not (ash/silt mixture, right). Flume 2, test sections 1 and 4, original unvegetated conditions

Another important issue is the use of rolled turf on the two different cover materials. The connection between the turf and the clay was considerably better (due to roots penetrating the clay and the high adhesion between clay and top soil/turf) than that between turf and ash composite. No roots penetrated the ash composite (Fig. 16). Thus it is not recommended to use rolled turf for dike cover greening if ash composites are used in the dike cover layer. The different cover materials also resulted in a difference in vegetation development due to medium (clay) and no (ash composite) water supply from below. Particularly on the southern embankment the turf failed during the first summer because the thin layer of top soil could not support the turf (not even on top of the clay). Therefore, a top soil layer of 20–40 cm thickness is recommended when installing an ash composite as dike cover material. For this, the benching technique is recommended to stabilise the top soil on the compacted ash composite or else to use a geosynthetic erosion control mat to reinforce the top soil on the embankment.
