## Case study

## Electrolytic corrosion of water pipeline system in the remote distance from stray currents—Case study

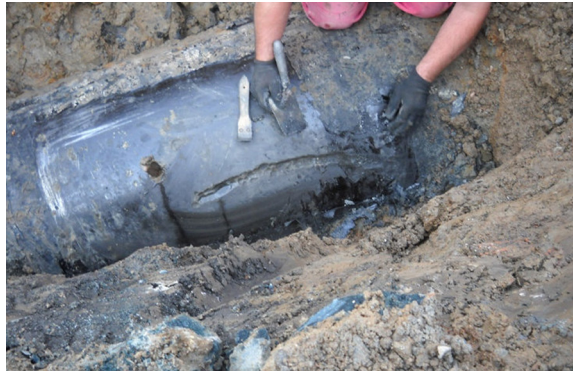
**Fig. 1.** View of pipeline corrosion failure.

Described corrosion damage occurred on the steel water pipe DN 300 in bitumen isolation. The age of this fragment of pipeline is estimated to be about 18 years and actual thickness of the pipe wall in the place of damage is slightly more than half of its normal thickness and it is in the range of 9–11 mm. Pipeline in the place of damage is buried in the sandy type of soil. Uncovered damage after digging out the pipeline, removing the bitumen coating and cleaning the surface is presented in Figs. 1 and 2. The failure occurred at the beginning of branching of the pipeline. The figures show the circular pipe wall perforation having a diameter of about 4 cm, containing the soil with corrosion products. On the right side of the defect, just below it, significant loss of metal within the distance of tens of centimeters and a width of approximately 3–4 cm is visible. This broad defect is probably caused by mechanical damage occurred during the mounting of water pipe system in the ground. In this wide scratch the losses of metal in the shape of circular cavities of different diameters are clearly visible. The shape of these cavities on the surface of a metal pipe wall reminiscent of the effect that would be obtained by destroying surface using drilling tool. Such losses of metal are typical for electrolytic corrosion caused by stray currents flowing from the pipe into the ground through the metal/electrolyte phase boundaries in the protective coating defects [13].

Elimination of the risk of water supply system electrolytic corrosion in the area of the point of failure can be achieved by using magnesium sacrificial anodes. They served also as the earthing electrodes through which stray currents can flow from the water supply system to the ground (instead of through the interface metal/electrolyte), and will be a source of cathodic protection current performed by means of sacrificial anodes.

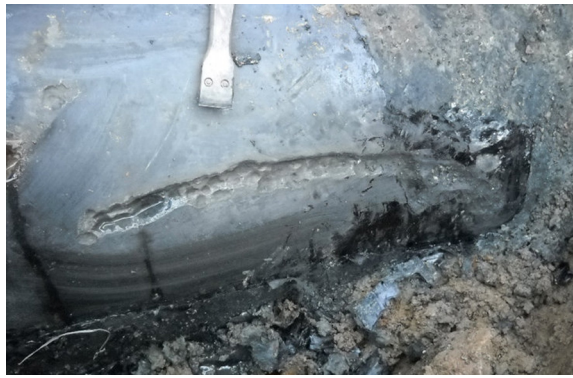
**Fig. 2.** Zoom on the defect site.

The initial diagnosis of the causes of the corrosion of water supply system based on the appearance and shape of corrosion cavities pointed to the effects of stray currents. Suspicion of such impact in this side of water supply network raised certain astonishment, due to the considerable distance from the sources of stray currents. The place of pipeline failure is 800 m away from passes under the tracks of the tram line and after next 200 m it passes under the railroad tracks.
