# Effect of the Magnetisation of Covered Electrodes on the Quality and Properties of Underwater Wet Welded Joints

**Abstract:** The article analyses the effect of the magnetisation of covered electrodes on the geometry and properties of T-joints with fillet welds made of steel S235JR in watery environment. It was established that as regards the conditions and parameters used in the tests, the magnetisation of electrodes affected the stability of arc burning and the formation of shape-related welding imperfections but it did not influence the microstructure and hardness of the test joints.

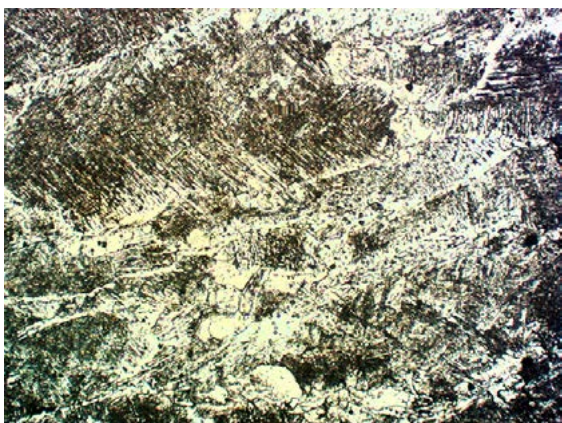
Fig. 7. Microstructure of the weld in joint M01; etchant: Nital; mag. 200x

The microscopic observations did not reveal significant differences in the structures of the

joints made with magnetised electrodes and those made using non-magnetised electrodes. The tested areas did not contain welding micro-imperfections i.e. microcracks, slag inclusions, incomplete microfusions, which were expected particularly in terms of welding performed using magnetised electrodes. The observed structures demonstrated the proper adjustment of welding parameters.

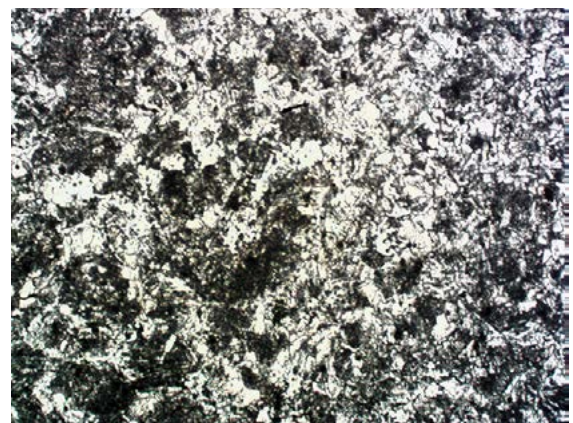
Fig. 9. Microstructure of the HAZ in joint M01; etchant: Nital; mag. 200x

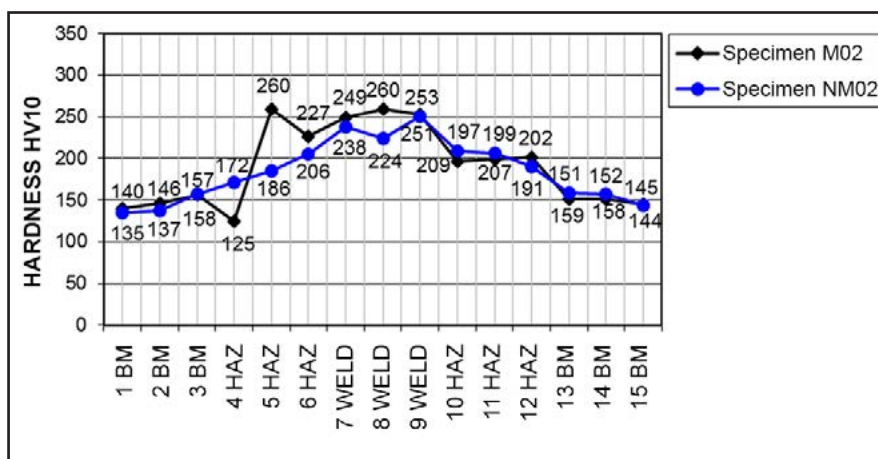
Fig. 12. Hardness distribution in joint W02: NM02 and M02

acceptance criterion adopted for the steel grade used in the tests (material group 1.1 according to TR ISO 15608) was at a level of 350 HV<sub>10</sub>. The Vickers hardness test was performed along a line located 2 mm away from the weld face and sheet surface (Fig. 10). The cross-sectional hardness distribution related to the test joints is presented in Figures 11 and 12. The hardness distribution is typical of joints welded with a filler metal characterised by greater strength than the strength of the base material. The analysis of the minimum (Fig. 12: 125 HV<sub>10</sub>) and the maximum (Fig. 11: 330 HV<sub>10</sub>) HAZ hardness-related individual values justified the assumption that they represented gross errors not subjected to interpretation. The analysis of hardness-related results revealed that the magnetisation of electrodes did not significantly affect the hardness of the joints. For the welding parameters used in the tests (Table V), the obtained results were below the adopted acceptance criterion (350 HV<sub>10</sub>).
