World Multidisciplinary Civil Engineering-Architecture-Urban Planning Symposium 2016,  
WMCAUS 2016

## Analysis of Historic Brick Walls' Strengthening Methods

Calculations were performed in Abaqus software, for the garrison arrest's prison yard at Bohaterów Monte Cassino Street in Olsztyn in Poland. In this object, prison's yard will be covered with the glazed roofing, resting on the perimeter walls. This is the reason why load transmitted to the wall is increased and why strengthening is needed. Survey allows to calculate displacements and the results are used to select the most appropriate methods of strengthening brick wall in this object. A comparison analysis has been performed and possible directions for further research in this field have been indicated.

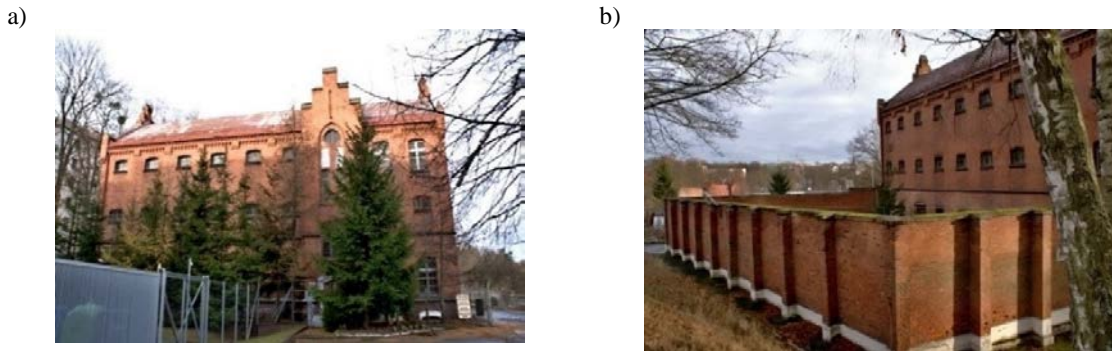
Fig. 1. Building of the garrison arrest: (a) from the south, (b) from the north with the perimeter wall encircling the prison yard.

The northern side of the building was extended on prison yard (Fig. 1a) that was built on the trapezium plan with a shorter base - east wall. Fencing spans with buttresses regularly deployed along the whole length of the walls (the axial distance is 265 cm), were made of face bricks and are 445 cm high. The perimeter walls were built in two stages and their original height may be seen due to considerably stronger soiling and surface coating of the older part of the brick wall by lichens [2]. Fencing encircling the courtyard were put on a 40 cm high foundation made of filed stones, bricks and concrete in depth from 0,90 m to 1,80 m below the ground level [3].
