**Ł. Bolewski, M. Szkodo, M. Kmieć**

*Gdańsk University of Technology, Faculty of Mechanical Engineering, Department of Materials and Welding Engineering, 11/12 Narutowicza, 80-233 Gdańsk, Poland*

## CAVITATION EROSION DEGRADATION OF BELZONA<sup>®</sup> COATINGS

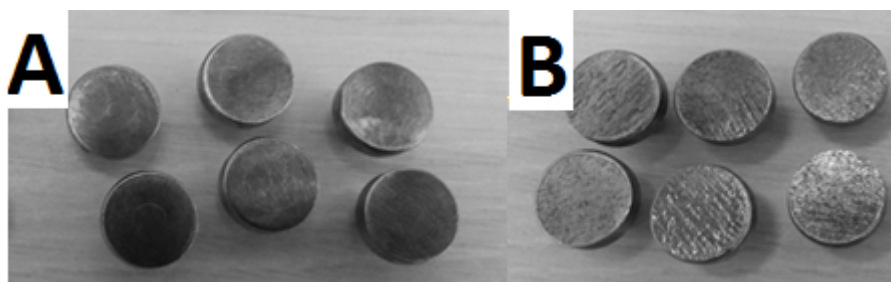
**Fig. 2.** P110 steel probes according to ASTM G32-10. A) Before surface treatment. B) After surface treatment to roughness  $R_z=75 \mu\text{m}$  Belzona® 2141 - ACR-Fluid elastomer

In order to test resistance to cavitation erosion, by courtesy of Belzona the three types of coatings 2141, 1321 and 5831 were obtained. The coatings were prepared and applied according to the instruction on six probes. Probes were prepared with dimensions conforming ASTM G32-10. The front side of probes were prepared with regards to roughness for relevant coating. The suggested roughness of surface stated by the producer was  $R_z = 75 \mu\text{m}$  [8-10]. Samples before and after surface treatment are shown in the Fig. 2. The probes were cleaned in acetone before coating. The instruction for each coating require different time to achieve full mechanical strength of material. The following paper describes applied material in tests and examples of their applications.

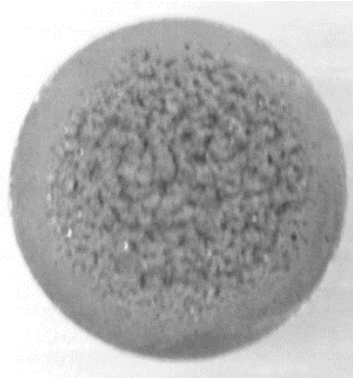
**Fig. 4.** Belzona 1321 applied on P110 probes after cavitation test; Belzona® 5831 - St-barrier

The 2-part ceramic filled epoxy coating designed to provide erosion and corrosion resistance of metal surfaces. This solvent free epoxy coating has high chemical resistance and bonds to any rigid surface. Due to its high compressive strength it can be also used to create a perfect shim. This material is applied without the need for specialist tools in room temperature. The material after cavitation erosion impact is shown in Fig. 4. Examples of applications for Belzona 1321 (Photo 3):

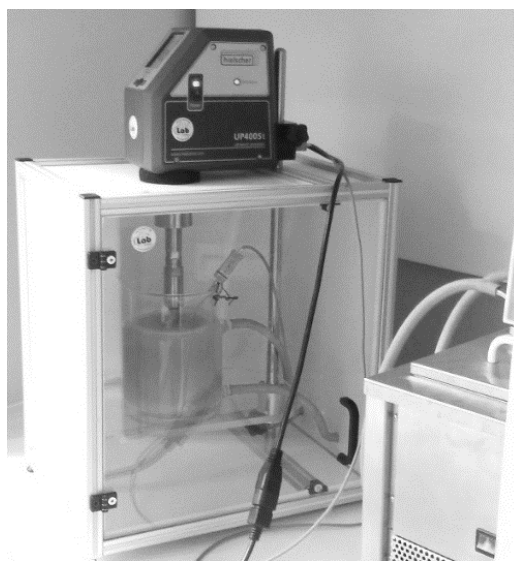
Fig. 6. Cavitation test stand

Cavitation erosion tests were performed on the ultrasonic cavitation test rig to explore the coatings' cavitation erosion resistance according to most of ASTM G32-10 tests method recommendations. The vibratory cavitation apparatus Hielscher UP400s is shown in Fig. 6. This equipment with ultrasonic processor generates longitudinal mechanical vibrations. The medium is subjected to compression and decompression subsequently, which causes it to tear in weakest

points, form cavitation bubbles, and then collapse. The power output of the processor can be steplessly adjusted between 20% and 100% of the maximum output. The vibrations are amplified by the sonotrode fitted to the horn and formed as a  $\lambda/2$  vibrator and transferred via its end face to the medium to be sonically irradiated. The UP400s device can be used to irradiate liquids and granulates. The sonotrode H14 has 14 mm diameter tip and provides maximum of 110  $\mu\text{m}$  peak to peak amplitude in water. The acoustic power density on its tip is about 106  $\text{W}/\text{cm}^2$ . An integrated PC interface with special control enables the PC aided monitoring and control of all the important parameters of the ultrasonic processor and the connection of additional sets (e.g. temperature probes) [6]. The vessel used for the tests has a cooling bath, through which an ultra-thermostat circulates cooling agent. The temperature can be set between  $-10$  to  $100^\circ\text{C}$  [18].

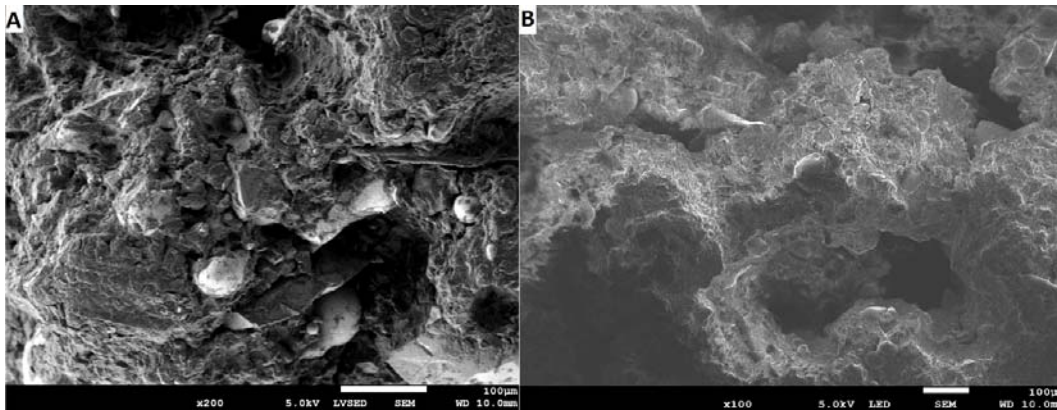
Fig. 11. SEM photos of coating 1321 sample after end of cavitation tests in distilled water

The microscopic observation from Scanning Electron Microscopy (SEM) shown results of effect of cavitation erosion on coatings 1321 (Fig. 11), and 2141 (Fig. 12). For the sample coated 5831 SEM images not been made, because the coatings was detached in 80% from steel probe in all two studied cases: water (30 min) and drilling mud (90 min) (Fig. 8-9, Table 3-4). The so high adhesion failure may be caused by the thermal mismatch between the coating and substrate or by local thermal softening of coating. Adhesion plays an important role in the incubation period and ensures the protection of the substrate material against mass lose. Coating 1321 revealed a significant degradation during the test, but not detached out from the surface of probe (Fig. 4). In the pictures (Fig. 11) see visible surfaces after cavitation treated, the material has been deformed and expose the internal structure of protective two-component epoxy structure with ceramic strengthening grains. The 1321 material is eroding by initiating cracks at interface of matrix/ceramic particles that following propagation in an epoxy matrix. The cracks combine and cause chip off epoxy matrix. This results in exposure of ceramic particles and pluck them out from matrix support. Authors conclude that cavitation phenomena of high pressure micro-jet impacts that act on surface when bubbles collapse. Under influence of this phenomenon coating 1321 may undergo local thermal softening, which has essential impact on the coatings deformation. The soft epoxy resin first to erode away, leaving behind the exposed ceramic particles Fig.11.

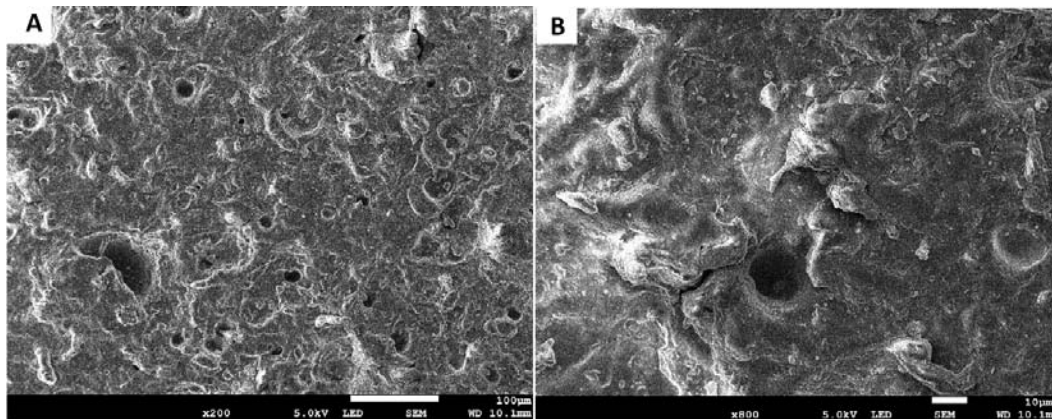
Fig. 12. SEM photos of coating 2141 samples after end of cavitation in distilled water

Material 2141 coating of two-component polyurethane is characterized by high plasticity behaviour reminiscent of elastomer. SEM results shown in Fig. 12 the essence of the impact of cavitation erosion on the material. Fig. 12 A) shown a cavities of spherical shapes, which have causes of micro-jet impact generated during implosion of cavitation bubbles. Fig. 12 B) shows one of such voids and cavitation impacts in the traces formed on the sample surface. Also visible cracks formed in the area near cavitation craters, cavitation load initiate fracture that develop on surface of the eroded material and leading to loose of thin flakes of material (delamination). However, the weight loss was unnoticeable, the accuracy of scales not captured changes in the mass of the coated sample. The outstanding observed results can be attribute of the strong adhesive connection of coating.
