**Ł. Bolewski, M. Szkodo, M. Kmieć**

*Gdańsk University of Technology, Faculty of Mechanical Engineering, Department of Materials and Welding Engineering, 11/12 Narutowicza, 80-233 Gdańsk, Poland*

## CAVITATION EROSION DEGRADATION OF BELZONA<sup>®</sup> COATINGS

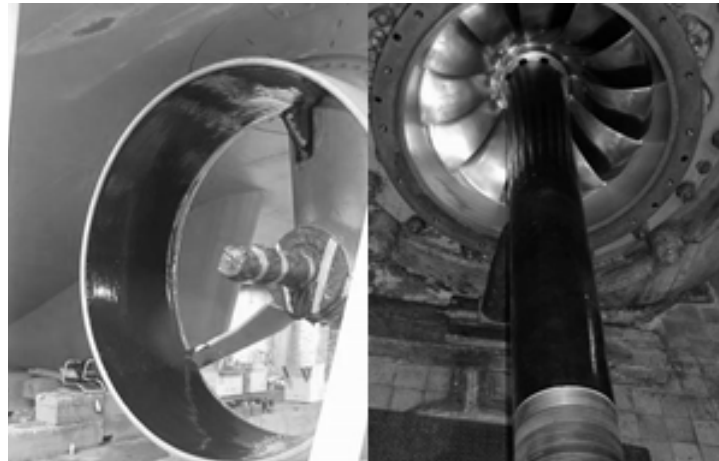
Fig. 1. Examples of use Belzona products in Maritime [1]

The paper presents the study on cavitation erosion resistance of three composite materials. The tested materials were Belzona<sup>®</sup> 2141 (acr-fluid elastomer), 1321 (ceramic s-metal) and 5831 (st-barrier). All of those materials were commonly used in hydrocarbon exploration systems and maritime to protect equipment surface from harmful effects of environment. Below in Fig. 1 presents examples of protection marine propulsion and pump elements on effects of cavitation erosion.

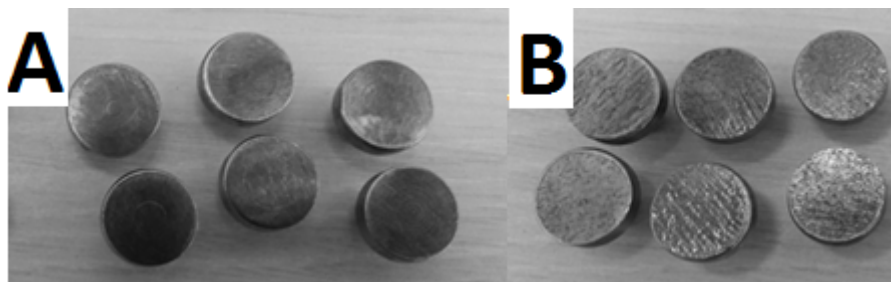
**Fig. 2.** P110 steel probes according to ASTM G32-10. A) Before surface treatment. B) After surface treatment to roughness  $R_z=75 \mu\text{m}$  Belzona® 2141 - ACR-Fluid elastomer

In order to test resistance to cavitation erosion, by courtesy of Belzona the three types of coatings 2141, 1321 and 5831 were obtained. The coatings were prepared and applied according to the instruction on six probes. Probes were prepared with dimensions conforming ASTM G32-10. The front side of probes were prepared with regards to roughness for relevant coating. The suggested roughness of surface stated by the producer was  $R_z = 75 \mu\text{m}$  [8-10]. Samples before and after surface treatment are shown in the Fig. 2. The probes were cleaned in acetone before coating. The instruction for each coating require different time to achieve full mechanical strength of material. The following paper describes applied material in tests and examples of their applications.

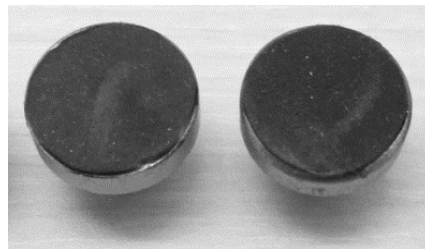
**Fig. 3.** Belzona 2141 applied on P110 probes; Belzona® 1321 - Ceramic s-metal

The material with marketing mark 2141 is elastomer coating used to preform anti-cavitation security. The 2-part polyurethane resin was designed for the coating of metal and rubber components. This material is appropriate for coating localized in high pressure areas where abrasion, cavitation, erosion and corrosion resistance are required. This fluid material is applied without the need for specialist tools and it cures at room temperature eliminating the need for hot work. The probes with applied 2141 coating are shown in Fig. 3. The example of applications for Belzona 2141:

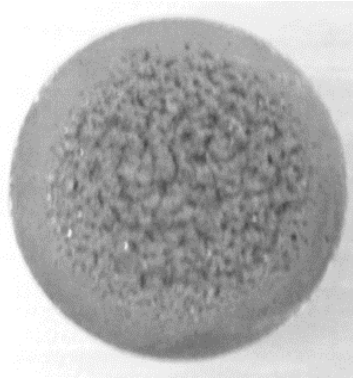
**Fig. 4.** Belzona 1321 applied on P110 probes after cavitation test; Belzona® 5831 - St-barrier

The 2-part ceramic filled epoxy coating designed to provide erosion and corrosion resistance of metal surfaces. This solvent free epoxy coating has high chemical resistance and bonds to any rigid surface. Due to its high compressive strength it can be also used to create a perfect shim. This material is applied without the need for specialist tools in room temperature. The material after cavitation erosion impact is shown in Fig. 4. Examples of applications for Belzona 1321 (Photo 3):

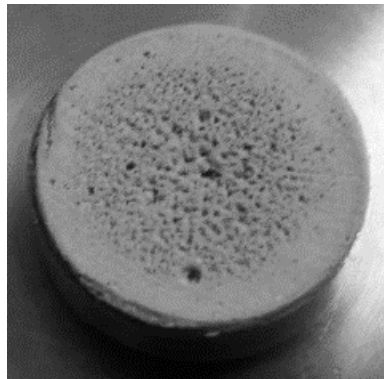
**Fig. 5.** Belzona 5831 applied on P110 probes at counter probe stand

The 2-part epoxy coating which once cured forms a barrier coating for the protection of equipment operating under immersed conditions or in contact with aqueous solutions. This solvent free epoxy coating bonds strongly to steel and other metallic and non-metallic surfaces such as concrete or brick. Belzona 5831 (ST-Barrier) is formulated for application to wet and oil contaminated surfaces that cannot be dry for application, as well as for underwater applications. The coating displaces water from the surface ensuring maximum adhesion to damp or wet surfaces, even underwater. Examples of applications for Belzona 5831 (Fig. 5.):

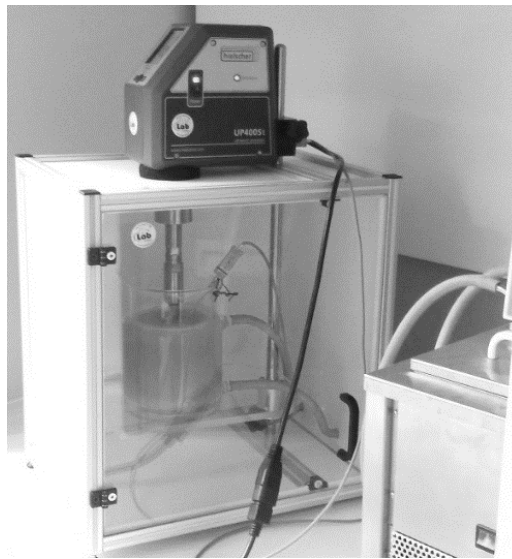
Cavitation erosion tests were performed on the ultrasonic cavitation test rig to explore the coatings' cavitation erosion resistance according to most of ASTM G32-10 tests method recommendations. The vibratory cavitation apparatus Hielscher UP400s is shown in Fig. 6. This equipment with ultrasonic processor generates longitudinal mechanical vibrations. The medium is subjected to compression and decompression subsequently, which causes it to tear in weakest

points, form cavitation bubbles, and then collapse. The power output of the processor can be steplessly adjusted between 20% and 100% of the maximum output. The vibrations are amplified by the sonotrode fitted to the horn and formed as a  $\lambda/2$  vibrator and transferred via its end face to the medium to be sonically irradiated. The UP400s device can be used to irradiate liquids and granulates. The sonotrode H14 has 14 mm diameter tip and provides maximum of 110  $\mu\text{m}$  peak to peak amplitude in water. The acoustic power density on its tip is about 106  $\text{W}/\text{cm}^2$ . An integrated PC interface with special control enables the PC aided monitoring and control of all the important parameters of the ultrasonic processor and the connection of additional sets (e.g. temperature probes) [6]. The vessel used for the tests has a cooling bath, through which an ultra-thermostat circulates cooling agent. The temperature can be set between  $-10$  to  $100^\circ\text{C}$  [18].

Fig. 6. Cavitation test stand

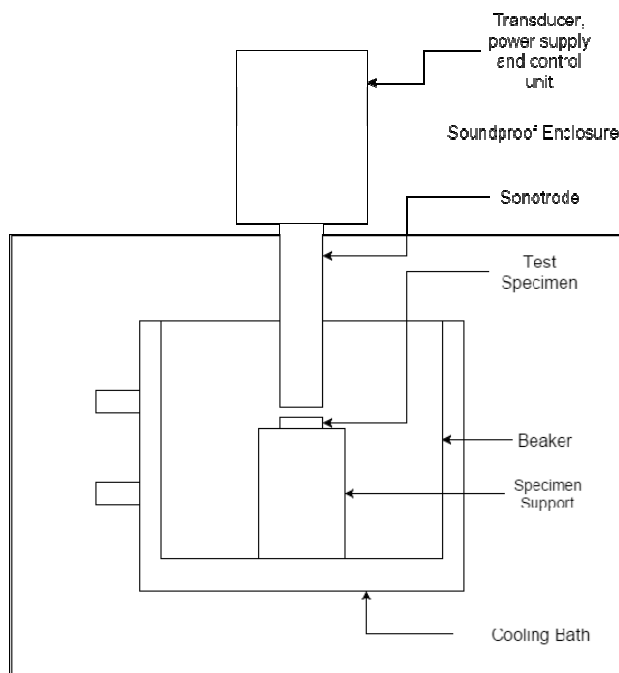
**Fig. 7.** Test configuration schematic

The three kinds of coatings were investigated in distilled water and drill mud under the same cavitation intensity. Epoxy coatings with thicknesses between 200-300  $\mu\text{m}$  were brushed on alloy steel P110. The coatings were prepared and applied according to the instruction on six probes with suggested roughness by producer. Tested samples were treated with cavitation in counter stand with ultrasonic apparatus. The liquids were irradiated with a 24 kHz frequency and amplitude of 0.05 mm. The vibratory apparatus for all tests was set to maintain amplitude of 50% which for this configuration stands for 0.05 mm peak to peak. The device maintained this amplitude in both mediums by regulating output power. The average power needed was 45 Watts. The probes were inserted into the counter stand in 0.5 mm distance from ultrasonic horn. The counterpart test configuration is shown on Fig. 7. The test was prepared in an environment of distilled water and drilling mud at constant temperature of  $22^\circ\text{C}$ . The composition of used drilling fluid are shown in Table 2. After a fixed period of time samples were removed, dried and

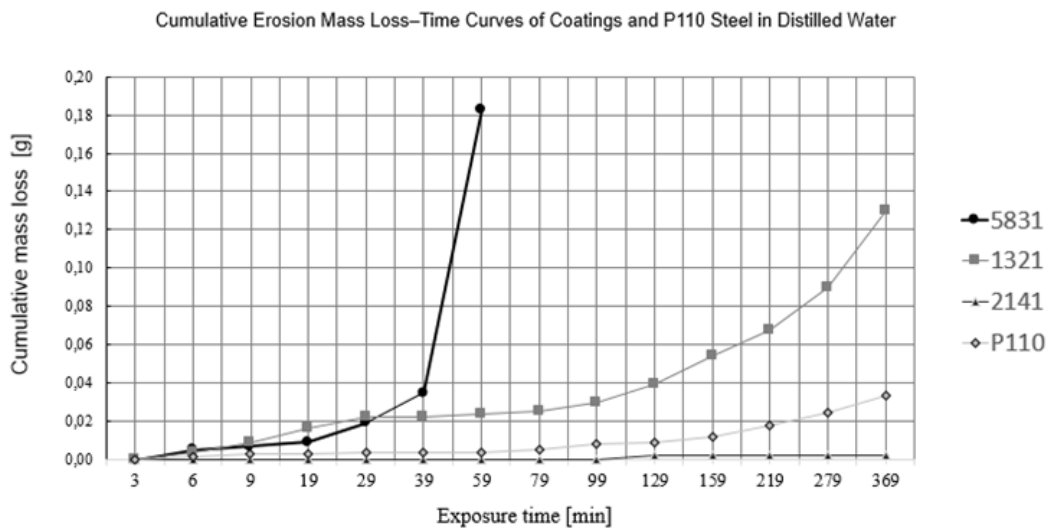
The relationship between materials coatings and steel P110 cumulative mass loss versus time established in Fig. 8 distilled water and Fig. 9 drilling mud. For purpose of comparison, results were listed in Table 3 and 4.

Fig. 8. Results of cavitation tests (erosion curves) in environments of distilled water

weighed. The evaluation parameter of cavitation erosion resistance is the cumulative mass loss versus exposure time determined for each sample and showed in the Fig. 8.

The above tests results indicate cavitation erosion resistance of three different coatings. The all tests was performed on the stand with counterprobe. The cumulative mass losses of the coatings deposited on P110 stainless steel during cavitation test in two environments of water and drilling mud are shown in Fig. 8-9. The conducted studies shows that tests in environmental of drilling mud decreases cavitation erosion rate [18]. The deposition of coating 5831 (St-barrier) has decreased the mass loss middling 90% (Table 3,4) in comparison of coating mass before tests on probes in two different environments. The 2-part polyurethane 2141 coating has the best cavitation erosion protection properties due to its longest incubation period and smallest mass lost among all tested coatings Fig.8-9. The cumulative mass loss of other coatings were higher than reference steel P110 Fig.8-9. The deposition of 5831 coating increase in 1/3 of test time and end 80% detachment of coated layer from probe. This results preventing examination of this sample. The 1321 coating also have good cavitation resistance, which was confirmed by the low cumulative mass loss, but still higher than stainless steel P110. Coating 2141 has received the smallest cumulative mass losses during performed tests. As the further work, number of research of coatings properties used in industry can be investigated and compared with conducted tests.

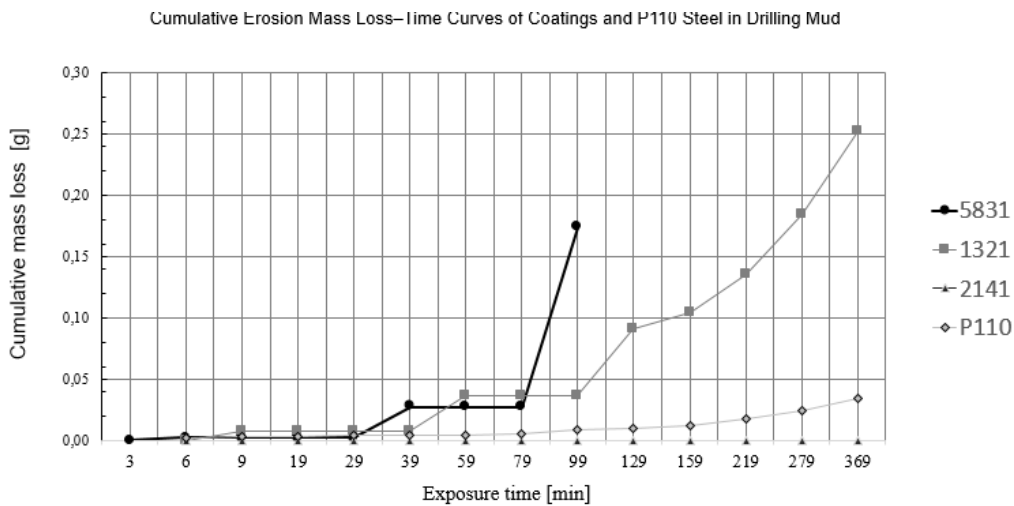
Fig. 9. Results of cavitation tests (erosion curves) in environments of drilling mud

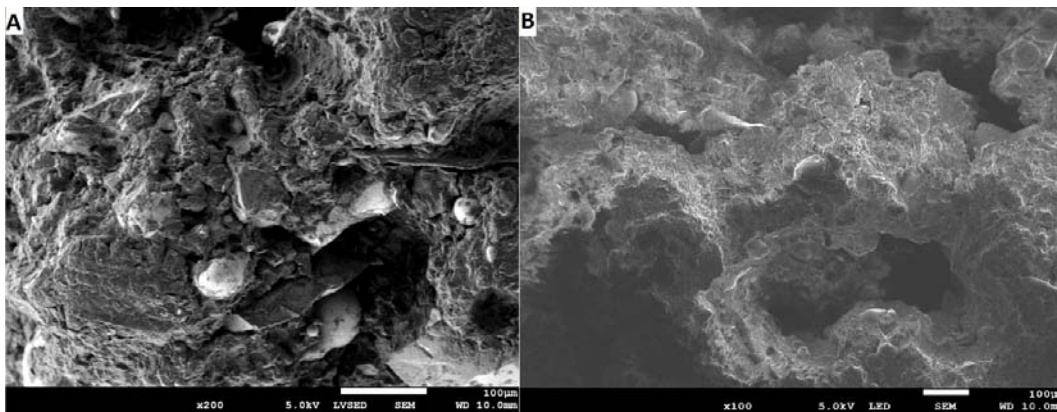
The microscopic observation from Scanning Electron Microscopy (SEM) shown results of effect of cavitation erosion on coatings 1321 (Fig. 11), and 2141 (Fig. 12). For the sample coated 5831 SEM images not been made, because the coatings was detached in 80% from steel probe in all two studied cases: water (30 min) and drilling mud (90 min) (Fig. 8-9, Table 3-4). The so high adhesion failure may be caused by the thermal mismatch between the coating and substrate or by local thermal softening of coating. Adhesion plays an important role in the incubation period and ensures the protection of the substrate material against mass lose. Coating 1321 revealed a significant degradation during the test, but not detached out from the surface of probe (Fig. 4). In the pictures (Fig. 11) see visible surfaces after cavitation treated, the material has been deformed and expose the internal structure of protective two-component epoxy structure with ceramic strengthening grains. The 1321 material is eroding by initiating cracks at interface of matrix/ceramic particles that following propagation in an epoxy matrix. The cracks combine and cause chip off epoxy matrix. This results in exposure of ceramic particles and pluck them out from matrix support. Authors conclude that cavitation phenomena of high pressure micro-jet impacts that act on surface when bubbles collapse. Under influence of this phenomenon coating 1321 may undergo local thermal softening, which has essential impact on the coatings deformation. The soft epoxy resin first to erode away, leaving behind the exposed ceramic particles Fig.11.

Fig. 11. SEM photos of coating 1321 sample after end of cavitation tests in distilled water

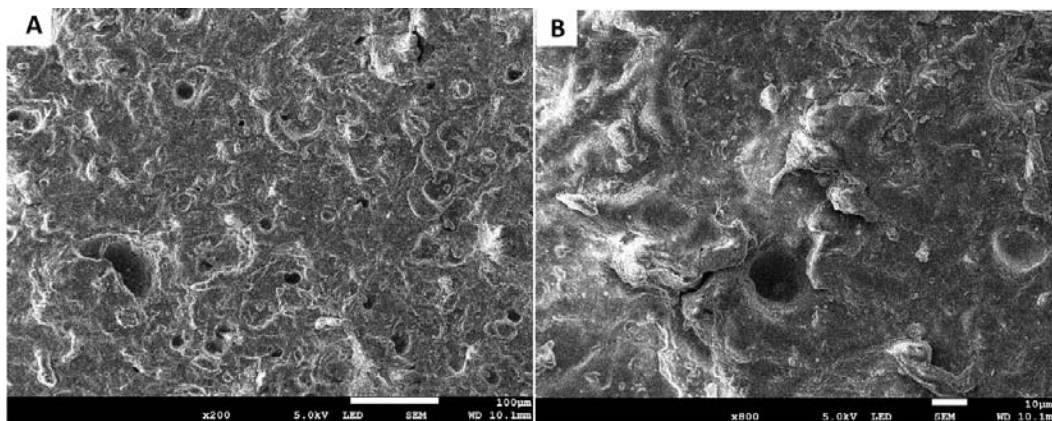
Material 2141 coating of two-component polyurethane is characterized by high plasticity behaviour reminiscent of elastomer. SEM results shown in Fig. 12 the essence of the impact of cavitation erosion on the material. Fig. 12 A) shown a cavities of spherical shapes, which have causes of micro-jet impact generated during implosion of cavitation bubbles. Fig. 12 B) shows one of such voids and cavitation impacts in the traces formed on the sample surface. Also visible cracks formed in the area near cavitation craters, cavitation load initiate fracture that develop on surface of the eroded material and leading to loose of thin flakes of material (delamination). However, the weight loss was unnoticeable, the accuracy of scales not captured changes in the mass of the coated sample. The outstanding observed results can be attribute of the strong adhesive connection of coating.

Fig. 12. SEM photos of coating 2141 samples after end of cavitation in distilled water

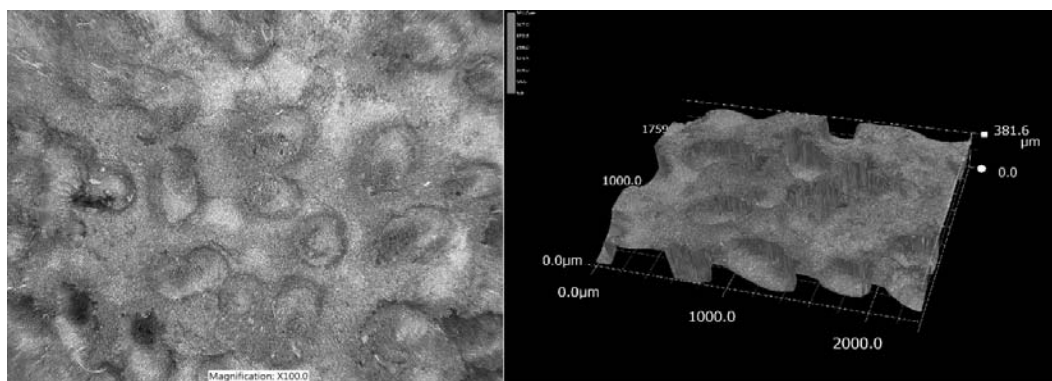
Fig. 13 shows micrographs of tested surface steel P110 sample. Two mechanisms of mass removal were observed. Formation of deep micro-cavities due to micro-jet action and cracking of the material from slip line or grain boundaries.

Fig. 13. Optical microscope photos of eroded surface of P110 sample tests in distilled water
