Ł. Bolewski, M. Szkodo, M. Kmieć

Gdańsk University of Technology, Faculty of Mechanical Engineering, Department of Materials and Welding Engineering, 11/12 Narutowicza, 80-233 Gdańsk, Poland

CAVITATION EROSION DEGRADATION OF BELZONA[®] COATINGS

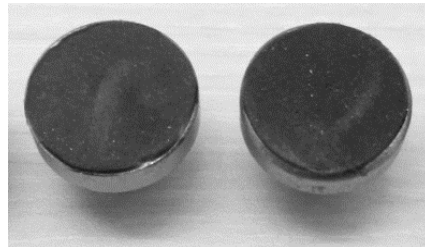
Fig. 3. Belzona 2141 applied on P110 probes; Belzona® 1321 - Ceramic s-metal

The material with marketing mark 2141 is elastomer coating used to preform anti-cavitation security. The 2-part polyurethane resin was designed for the coating of metal and rubber components. This material is appropriate for coating localized in high pressure areas where abrasion, cavitation, erosion and corrosion resistance are required. This fluid material is applied without the need for specialist tools and it cures at room temperature eliminating the need for hot work. The probes with applied 2141 coating are shown in Fig. 3. The example of applications for Belzona 2141:

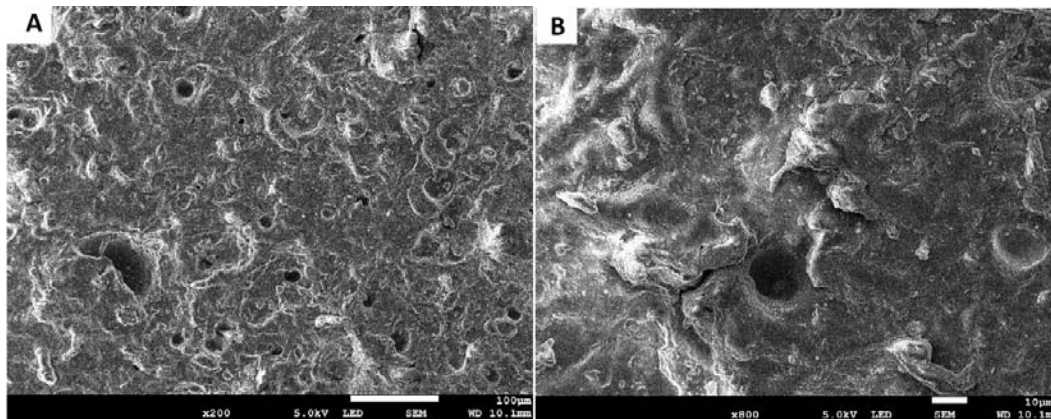
Fig. 12. SEM photos of coating 2141 samples after end of cavitation in distilled water

Material 2141 coating of two-component polyurethane is characterized by high plasticity behaviour reminiscent of elastomer. SEM results shown in Fig. 12 the essence of the impact of cavitation erosion on the material. Fig. 12 A) shown a cavities of spherical shapes, which have causes of micro-jet impact generated during implosion of cavitation bubbles. Fig. 12 B) shows one of such voids and cavitation impacts in the traces formed on the sample surface. Also visible cracks formed in the area near cavitation craters, cavitation load initiate fracture that develop on surface of the eroded material and leading to loose of thin flakes of material (delamination). However, the weight loss was unnoticeable, the accuracy of scales not captured changes in the mass of the coated sample. The outstanding observed results can be attribute of the strong adhesive connection of coating.

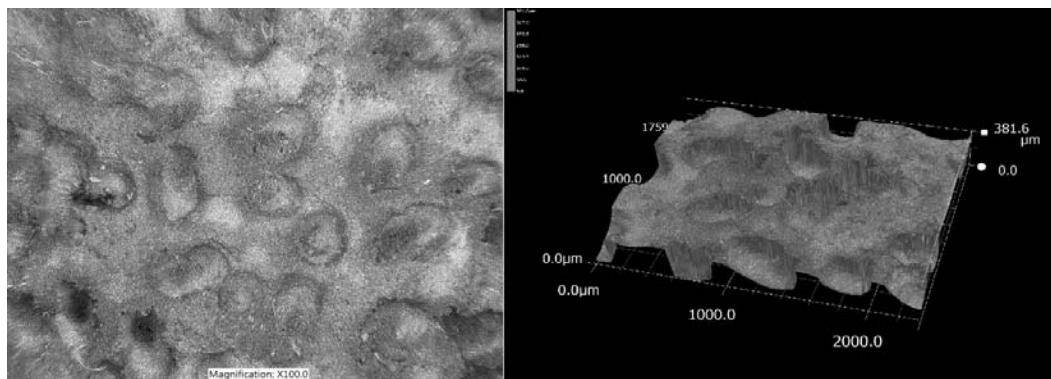
Fig. 13. Optical microscope photos of eroded surface of P110 sample tests in distilled water

Fig. 13 shows micrographs of tested surface steel P110 sample. Two mechanisms of mass removal were observed. Formation of deep micro-cavities due to micro-jet action and cracking of the material from slip line or grain boundaries.
