# THE EFFECT OF FISHING BASIN CONSTRUCTION ON THE BEHAVIOUR OF A FOOTBRIDGE OVER THE PORT CHANNEL

Gdansk University of Technology, Faculty of Civil and Environmental Engineering

*The paper analyses possible causes of failure of the rotating footbridge over the Ustka port channel. In July, 2015, strange behaviour of this object was observed in the form of excessive vibrations of bridge platform suspension rods, with the accompanying acoustic effects. A preliminary geotechnical analysis has revealed that this destructive effect was caused by the nearby construction works, namely construction of a fishing basin and communication routes in the area close to the bridge, which affected the bridge lashing rod foundation settings. Ground vibrations generated by certain construction activities were likely to have direct impact on decreasing the bearing capacity of these rods and increasing the susceptibility of the piles to extraction. After detecting the above problems in bridge operation, its geodetic monitoring was started. The data recorded during this monitoring, along with the results of force measurements in the rods, have made the basis for a series of numerical simulations, perfo

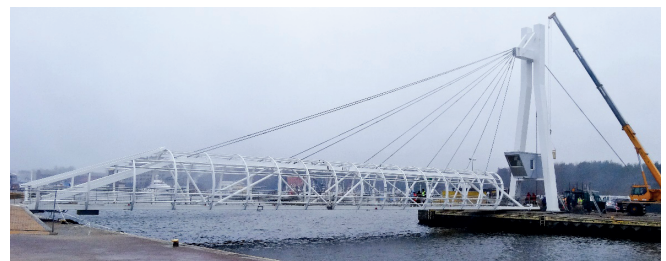
The analysed footbridge (Fig. 1.) is situated in the area of Port Morski w Ustce Sp. z o.o., Pomorskie voivodeship. Its function is to pass the pedestrian and cycle traffic over the port channel being the mouth of the Słupia river. The rotating structure of the bridge makes it possible to close the passage temporarily to allow the watercraft to enter or leave the port [19-22].

Fig. 1. Rotating footbridge for pedestrians over the Ustka port channel (configuration W1a)

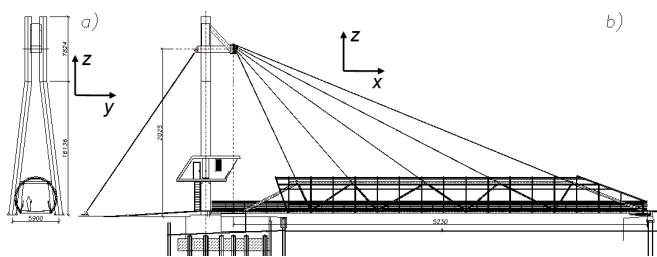
The object of analysis is a steel rotating suspended footbridge structure with the span in the form of truss (Fig. 2). The pylon is fixed in the base and stabilised by two lashing rods anchored by their foundations in the ground. From the pylon side, the support for the suspended span is provided by the rotating mechanism, while from the other side it is supported by a system of hydraulic cylinders taking the form of sliding articulated supports. The bridge platform is a steel orthotropic plate. Beside the truss girders, steel elliptic clamps welded to the truss chords are used as lateral stiffeners of the span. Span suspension and lashing rods are made of a system of structural bars.

Fig. 2. General view of the footbridge in configuration (W1) - locked, open for pedestrian traffic: a) cross section, b) south-side view; XYZ - the reference coordinate system used in the analysis

At the top of the pylon, pull rod anchors are fixed to the rotating head, which protrudes with respect to the bridge opening axis in such a way as to ensure passive movement of suspension rods to follow the motion of the span. The pylon lashing rods are fixed in anchor blocks embedded in the ground. The bridge is set on steel pipe piles 508/10 mm

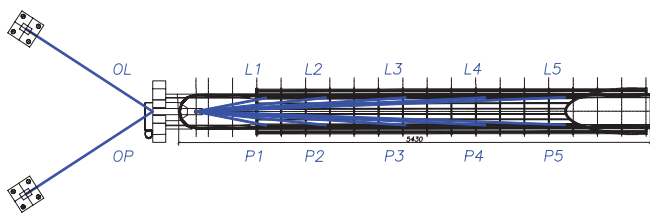
In order to evaluate current effort states of individual footbridge elements, forces were measured in the pull rods composing the bridge suspension and in the lashing rods. The measurements were made using the vibration method [23] and the 15-channel set for vibration monitoring in building structures WE 3001a, cooperating with three-axis accelerometers MEMS. The forces in the rod elements were evaluated by measuring their free vibrations. Along with local vibration frequencies, the measurements performed on selected rods made it possible to work out the characteristics corresponding to global movements of the entire structure. The adopted rod labelling in the footbridge structure is given in Fig. 3.

Fig. 3. Top view of the footbridge structure – rod labelling

The identified absolute values of normal forces  $N$  in the lashing rods and the longest suspension rods are given in Tab. 2, along with the reference to their design values.

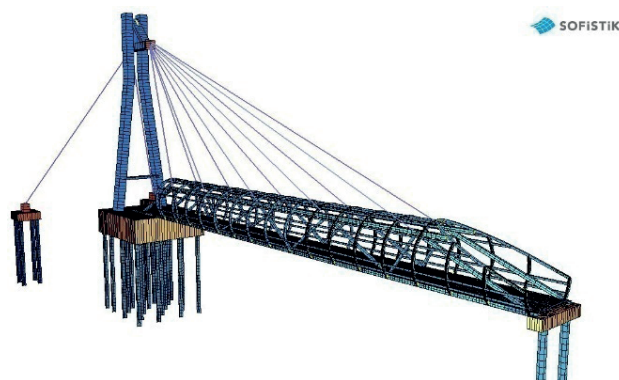
Computer simulations of the state of the structure were performed in the FEM environment within the linear-elastic range of material and the geometrically nonlinear range of the structure with imperfections [1,3,4,7,8,10,17,18]. In the adopted FEM models (Fig. 4) the following finite elements were used:

- 1-dimensional, 2-node spatial rod (beam) finite elements of Timoszenko type with eccentricity - used to model: pylon, grate, elliptic clamps, ribs and traverses of orthotropic platform plate, piles (8632 elements in the model);
- 2-dimensional, 4-node sheet elements of Timoszenko-Reissner type – used to model: the orthotropic platform plate (7627 elements in the model);
- 1-dimensional, 2-node spatial elements of rod-grate type – used to model: the footbridge structure suspension system (360 elements in the model).

The boundary conditions for the support took into account the foundation/ground cooperation and the conditions resulting from locking/unlocking of the bridge span structure on the river bank opposite to the pylon.

Fig. 4. Visualisation of the FEM model used in the analysis

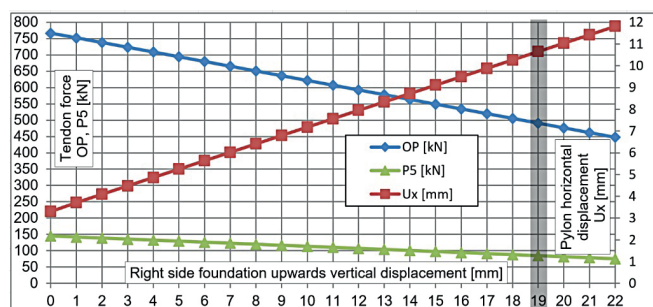
Mistuning of the system of tension forces in the suspension and lashing rods, along with the measured slipping of the lashing rod foundation block out of the ground, suggest the need for performing a numerical simulation of parametric analysis type to assess the effect of possible further foundation displacement on the redistribution of internal forces in the structure. This simulation was made for the bridge position variant W1 and the so-called useless state of the structure as the initial phase. The controlled variable in the analysis was the displacement parameter which represented vertical upward movement of the right lashing rod foundation. The control parameters which were considered as representative for problem illustration were the following: force in the right lashing rod, force in the longest span suspension rod, and pylon displacement.

The vertical displacement of the foundation which was recorded during geodetic monitoring increased by 6 mm. However, the results of the performed simulation suggest that the real displacement which possibly took place from the beginning of footbridge operation is of the order of 19 mm, as only for this value the calculated control parameters reach the levels corresponding to the in-situ measurements (see Fig. 5). It is also noteworthy that in the real situation, the analysed foundation was likely to move in an uncontrolled

manner also in the horizontal direction, which could affect the obtained results.

Fig. 5. Changes of control parameters: force in the right lashing rod (OP), force in the longest right suspension rod (P5), and horizontal pylon displacement (Ux) as functions of vertical upward displacement of the right lashing rod foundation

Restoring correct operation and safe use of the footbridge over the Ustka port channel requires corrective actions, which should aim at eliminating damages caused by the construction of the fishing basin and communication routes in the area close to the bridge. These corrective actions should consist, first, in stabilising the most vulnerable lashing rod foundations and then, in adjusting tension forces in the rods to bring them to the target state with the vertical axis of the rotating head at the top of the pylon. After force adjustment in the rods, the internal resonance phenomenon, being the effect of coupling of global and local frequencies at the level of about 1 Hz, should disappear. However, due to the theoretical nature of the performed analysis, the process of force adjustment in the rods should be followed by relevant examination, making a basis for formulating final conclusions relating to the dynamic response of the object. Additionally, due to incorrect operation of the system, being the result of changes in ground conditions in the footbridge foundation area, during the first year of further bridge operation after its release to service, permanent Structural Health Monitoring System (SHT) is to be installed, according to [16], along with the numerical simulation module which will monitor safe operation of the footbridge [12,24].
