## Monitoring System of the Road Embankment

**Abstract.** The paper presents the monitoring system of the embankment supported on concrete columns and overlaid by a load transfer platform (LTP) with the embedded steel grid. This field investigation was to study the complex interaction between the columns, the LTP layer, and steel reinforcement via full-scale in situ measurements during erection of the embankment. The study was focused on the behaviour of steel reinforcement and the behaviour of the outer rows of columns since there are limited reference data available for this problem. The system was designed to provide information to engineers about the condition of the embankment at every stage of construction and during standard exploitation of road. The measurements provided information about the changes of strains of steel grid and concrete columns and settlement of the structure.

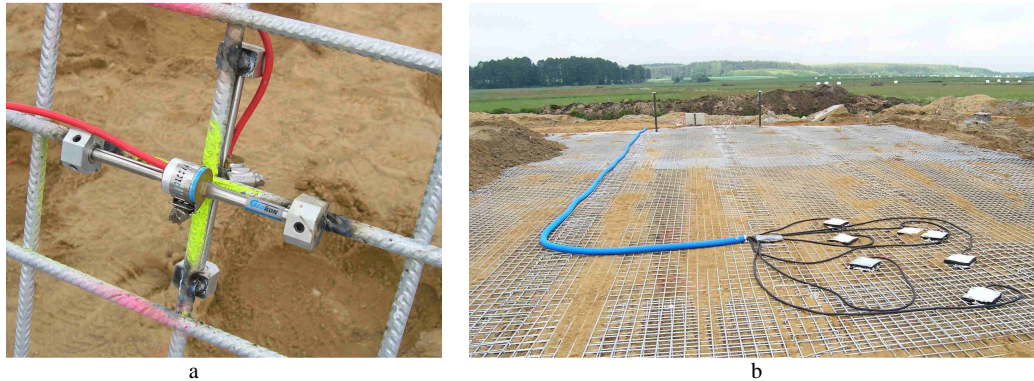
Fig. 6. a. Strain gages on the steel grid; b. Location of the protected sensors before backfilling

Short base vibrating wire sensors were attached to the steel grid by welding (Fig. 6a). The works were conducted after backfilling of the first part of the LTP layer (Fig. 6b). The instrumented steel grid was laid down on the compacted fill. Afterward, the vibrating wire sensors were covered with waterproof boxes to protect them from external influences. The sensor shields were constructed using plastic boxes, sealed with micro-rubber and silicone sealant. The control measurements after installation of all sensors showed that each of them was operational and the readings were within the desired range.

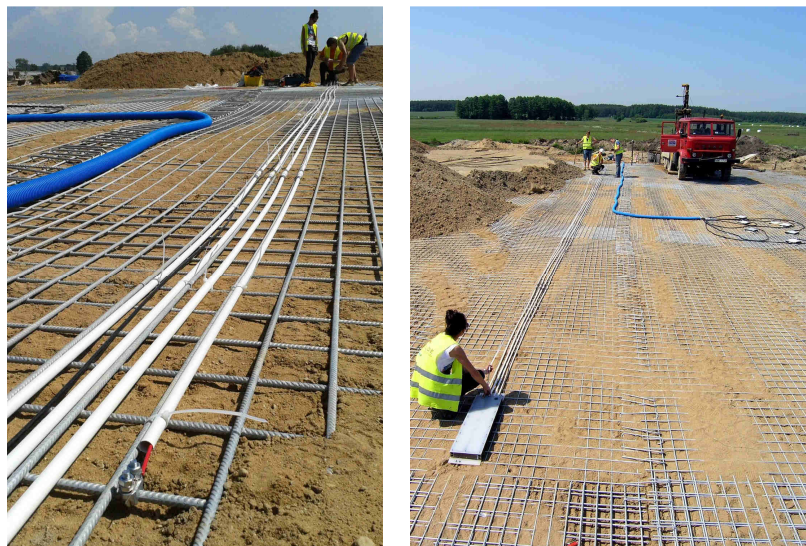
Fig. 7. Long base extensometers for measuring elongation of the steel grid

Long base extensometers measured “elongation” of steel grid sheets laid down on the ground with an overlapping. The device consisted of four steel wires with different lengths (from 14.465 m to 23.743 m) connected to steel grid sheets in selected locations, and the measuring “box” with four extensometers screwed to the steel grid at the centre of the embankment (Fig. 7). All wires were covered with PVC protection tubes. Extensometers were installed across two or three separate steel grid sheets.
