Monitoring System of the Road Embankment

Abstract. The paper presents the monitoring system of the embankment supported on concrete columns and overlaid by a load transfer platform (LTP) with the embedded steel grid. This field investigation was to study the complex interaction between the columns, the LTP layer, and steel reinforcement via full-scale in situ measurements during erection of the embankment. The study was focused on the behaviour of steel reinforcement and the behaviour of the outer rows of columns since there are limited reference data available for this problem. The system was designed to provide information to engineers about the condition of the embankment at every stage of construction and during standard exploitation of road. The measurements provided information about the changes of strains of steel grid and concrete columns and settlement of the structure.

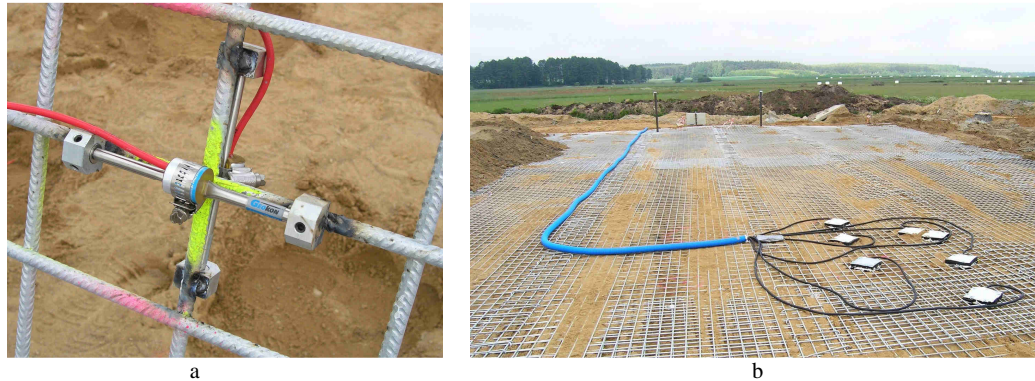
Fig. 6. a. Strain gages on the steel grid; b. Location of the protected sensors before backfilling

Short base vibrating wire sensors were attached to the steel grid by welding (Fig. 6a). The works were conducted after backfilling of the first part of the LTP layer (Fig. 6b). The instrumented steel grid was laid down on the compacted fill. Afterward, the vibrating wire sensors were covered with waterproof boxes to protect them from external influences. The sensor shields were constructed using plastic boxes, sealed with micro-rubber and silicone sealant. The control measurements after installation of all sensors showed that each of them was operational and the readings were within the desired range.

Unfortunately, during fill compaction by the GC using the smallest vibrator equipment available on site, 7 of 14 strain sensors experienced excessive deformations. The vibro-compaction caused seven sensors to reach the readings above the allowable range. It was assumed that some of the sensors have been damaged and have changed their measurement parameters. Most likely they were damaged due to excessive bending occurring during compaction and localized plastic deformations of the transmission layer and the soil underneath. Consequently, the possible readings of the remaining and still “operating” grid sensors had to be interpreted with caution and cross-checked with other measurements.
