UNDERWATER WET REPAIR WELDING OF API 5L X65M PIPELINE STEEL

Gdansk University of Technology, Poland

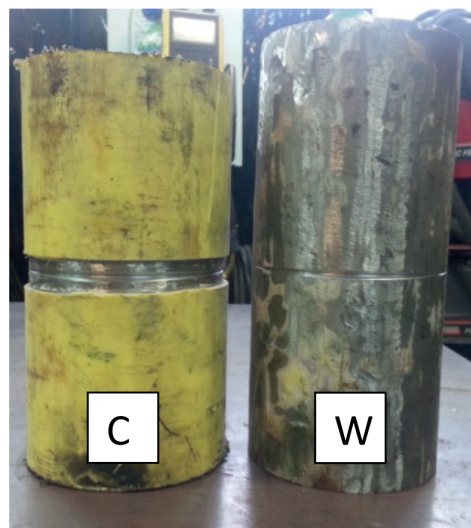
Fig. 1. Specimens prepared to welding. C – specimen covered with anticorrosive polymer coating; W – specimen without the coating.

For the experiments two pipe segments of the dimensions: $\phi=102,9 \times 5,7 \times 250$ mm were taken from the water pressing pipeline installed at the underwater crude-oil field (Fig. 1). The specimen C was covered with an anticorrosive polymer coating of 2.5 mm in thickness. The specimen W had metallic surface after mechanical removal of the anticorrosive coating. Over 75% circumference of the pipes 1.5 mm-deep grooves simulating the repair - demanding defects (cracks, corrosive wear) on pipeline surface, were cut.

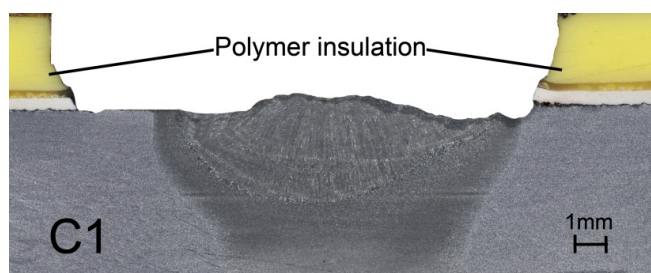
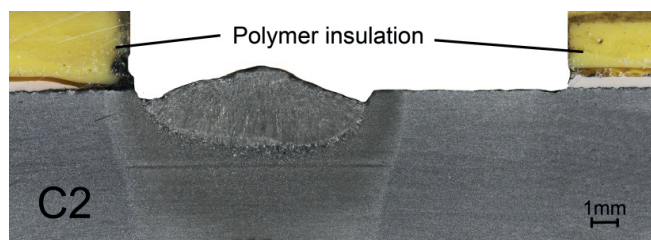
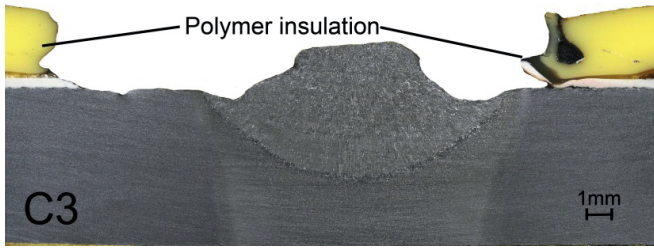
Fig. 2. Macro cross-section of the welded specimens C1, C2, C3 (insulated specimen C). Etch. Nital

The visual and penetrating tests were carried out in compliance with the recommendations of PN-EN ISO 17637 and PN-EN ISO 3452-1 standards, 72 h after completion of welding. As assumed, the welded joints have to meet acceptance criteria for B - quality level according to the requirements of PN-EN ISO 5817 standard, excluding defects of 5th group acc. PN-EN ISO 6520-1, e.g. an excessive weld - back reinforcement. No welding defects characteristic for such joints and welding conditions, e.g. weld or HAZ cracks as well as craters or pores, were observed. Local spots of incompletely filled groove were found on the insulated specimen C2 (Fig. 2).

The macroscopic examinations were conducted according to the requirements of PN-EN ISO 17639 standard. Fig. 2 and 3 present macro cross-sections of the surface layer welds.

The specimens presented in Fig. 2 and 3 show full depth of fusion and fully filled groove, only the specimen C2 exhibited undercuts in face of the weld. In case of underwater welding such defects are caused by an improper angular position of electrode against welded element. The remaining joints have a correct, symmetrical structure. On all specimens the wide heat affected zone caused by influence of the water present inside and outside the pipe, can be observed. In the insulated specimens (C1, C2, C3), the HAZ covers a smaller area than in the specimens without insulation (W1, W2, W3). It can be explained by a lower cooling rate of the joint due to presence of polymer coating on pipe surface. The largest fusion penetration was observed in the specimen without

polymer coating (W1) where the largest heat input, equal to 1,52 kJ/mm, was applied.

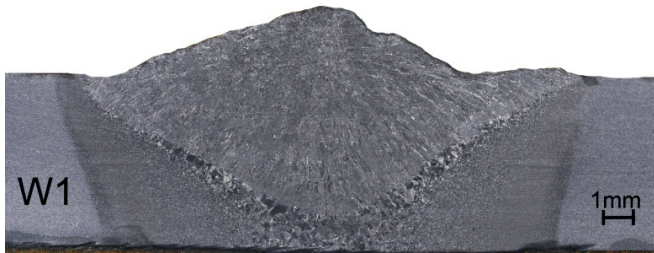
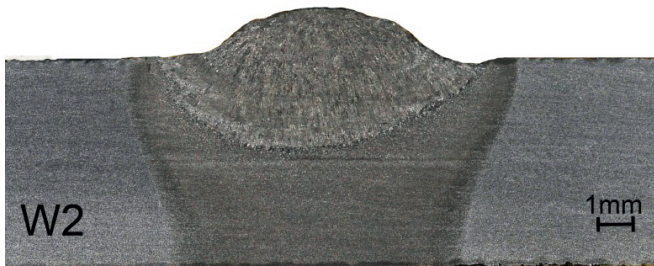
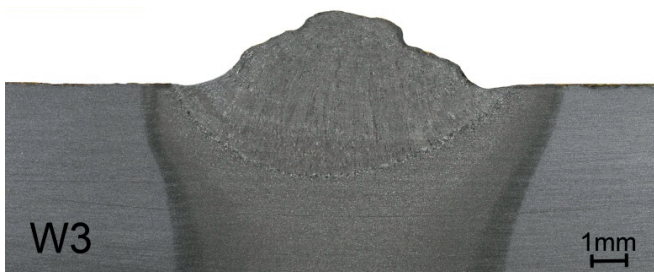
Fig. 3. Macro cross-section of the welded specimens W1, W2 i W3 (specimen without insulation W). Etch. Nital

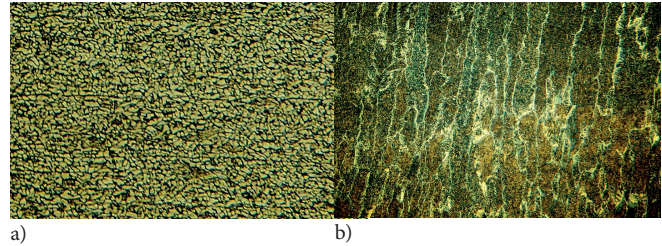
Fig. 4. Microstructures: a) base material of API 5L X65M steel, b) weld area. Magn. 100x

The microscopic examinations were performed to reveal structures in characteristic areas of the joints as well as possible microscopic welding defects. Fig. 4 presents of base and weld materials structures. In the base material fine-grain ferrite structure with a low share of pearlite, characteristic for this grade of steel, is observed, whereas the weld has a dendritic structure with column arrangement of ferrite and quasi-pearlite.

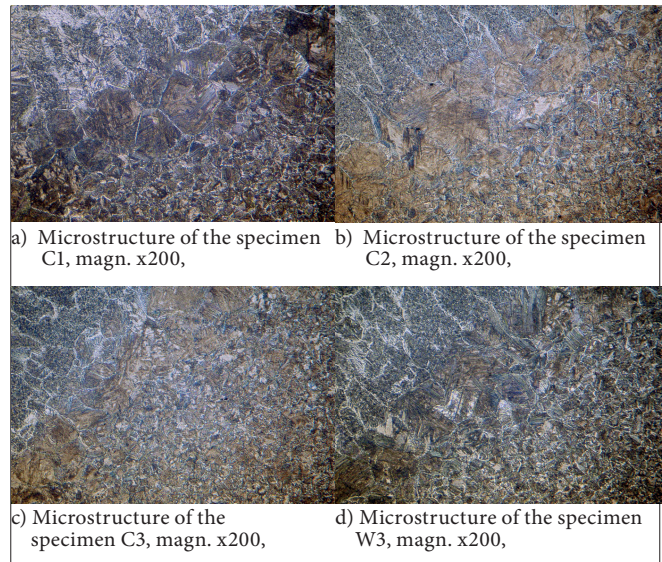
Fig. 5. Microstructure of HAZ in the joints where no cracks were found; a) the specimen C1, b) the specimen C2, c) the specimen C3; d) the specimen W3, magn. x 200

In the welded joints in insulated pipes no cracks were found. Fig. 5 shows microstructures along fusion line of the joints. There are visible characteristic areas: the dendritic structure of the weld, coarse-grain structure of the HAZ, normalized area of the HAZ, as well as the structure of the base material. As can be observed, in HAZ microstructure of the C1 specimen made with the highest value of heat input the biggest grains were formed close to the fusion line, Fig. 5a. In the remaining joints (C2 and C3) size of the grains in the HAZ is significantly smaller, Fig. 5b,c.

The tests revealed presence of trans-crystalline cracks in the HAZ microstructure of the specimens without insulation (W1 and W2), Fig. 6. They are characteristic cold cracks which are formed at high cooling rate of the joint in the conditions of stress and diffusible hydrogen occurrence. In both the specimens the cracks propagated along the fusion line: in the specimen W1 – across the area of bainitic structure (Fig. 6a), and in the specimen W2 (Fig. 6b) the crack occurred in the coarse-grain area of the HAZ. In the specimen W3 welded with the lowest value of heat input no cracks were found (Fig. 5d).

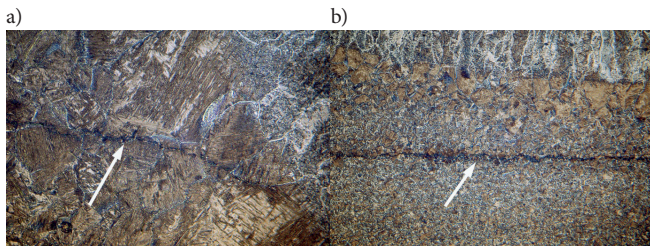
Fig. 6. Cracks occurred in the HAZ of the specimens : a) W1, magn. x 200; b) W2, magn. x 100

During microscopic examinations, a growth of grain size in the HAZ of the joints, proportional to the heat input, was observed. In the HAZ of two specimens without insulation (W1 and W2) cold cracks were found. The cold cracks run across crystals through brittle areas of the HAZ. It was caused due to the following factors: the relatively high value of carbon equivalent of the steel (0,41%), high cooling rate of the joint as well as high level of diffusible hydrogen in the welded joint. On the basis of the earlier conducted tests [16,21] it may be assessed that the diffusible hydrogen content in the deposited metal exceeded 35 ml/100g. Presence of polymer insulation was conducive to the lowering of width of the HAZ. Any distinct effect of heat input during welding (within the range

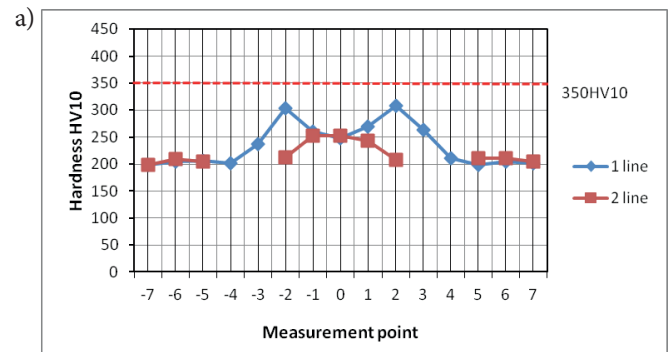
Fig. 8. Distribution of HV10 hardness values along the measurement lines 1 and 2 for the welded joints of the pipes with insulation coating : a) C1, b) C2, c) C3

The hardness acceptance criterion for the tested joints was taken equal to 350 HV10 on the basis of the DNV-OS-C401 Offshore Standard (Fabrication and testing of offshore structures). Maximum hardness values of the HAZ in the insulated pipe specimens amounted from 300 to 318 HV10, hence the values were distinctly lower than the acceptance one equal to 350 HV10. In the specimen W1 (without insulation)

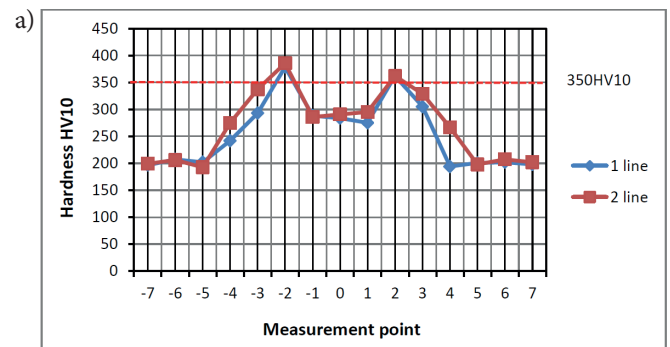
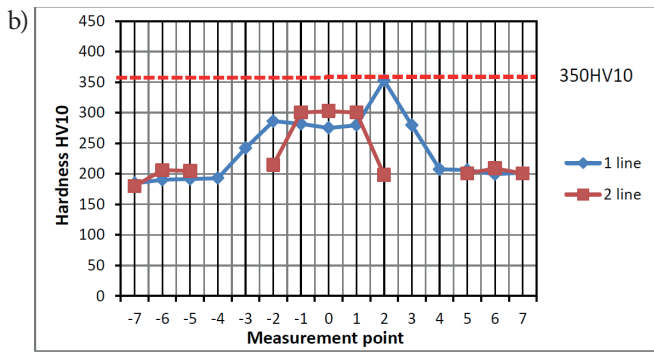
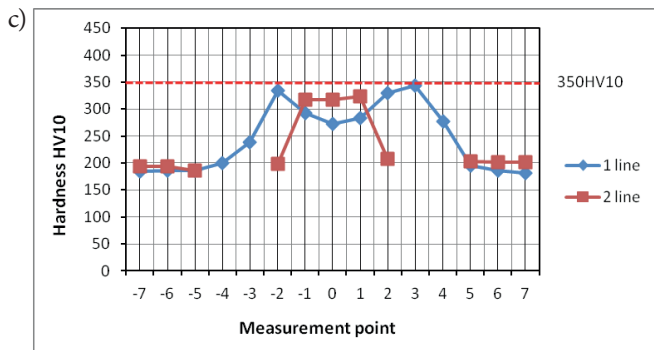
Fig. 9. Distribution of HV10 hardness values along the measurement lines 1 and 2 for the welded joints of the pipes without insulation coating: a) W1, b) W2, c) W3

an excessive increasing of the maximum hardness in the HAZ, up to the level of 386 HV10 and 385 HV10 for the upper and lower measurement line, respectively, was observed. In HAZ of the subsequent specimens without insulation coating (W2 and W3) the maximum hardness values equal to 343 and 353 HV10, respectively, i.e. close to that of the selected criterion, were measured.
