## MONITORING SYSTEM OF THE ROAD EMBANKMENT

**Abstract.** The paper presents the analysis of the monitoring system of the embankment supported on concrete columns and overlaid by a load transfer platform with the embedded steel grid. This field investigation was to study the complex interaction between the columns, the load transfer platform layer, and steel grid via in situ measurements during erection and live loading of the embankment. The study was focused on the behaviour of steel grid and the behaviour of the outer rows of columns since there are limited reference data available for this problem. The system was designed to inform the engineers about the condition of the embankment at every stage of construction and during standard operation of the road. The measurements brought the information on strain variations of steel grid, concrete columns, and structural settlement and provided necessary evidence for the embankment numerical model validation.

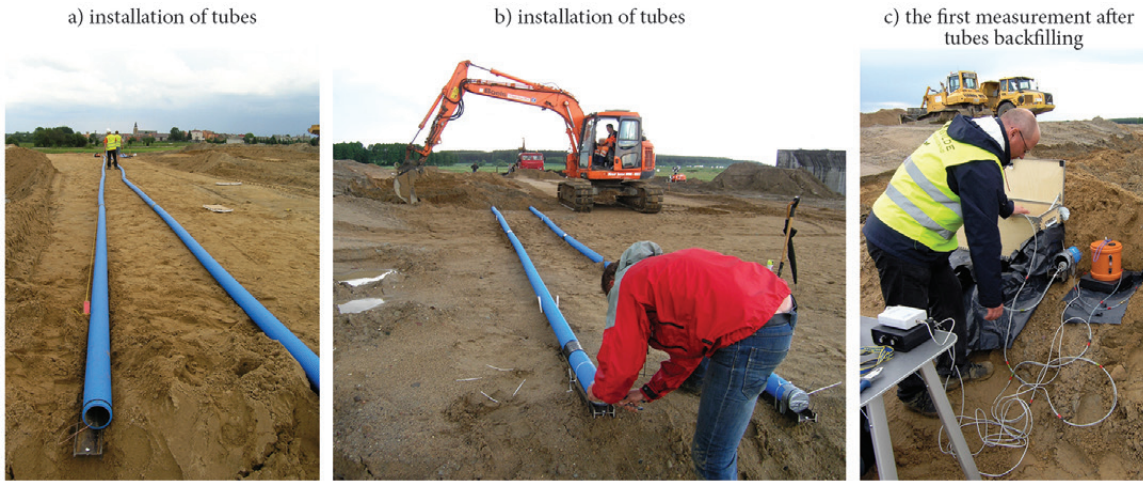
Fig. 8. Embankment settlement measurement by hydrostatic levelling

Two horizontal tubes were initially installed (Fig. 8a–b). First, it was planned to install one tube beneath the transmission layer and the second one above this layer. However, because the monitoring system was a prototype, it was decided to double the measurements conducted at the top of the transmission layer. Both tubes of 10 cm diameter were made of PVC, corrugated outside and smooth

inside. At both ends of each tube, steel H-beams of 1 m length were attached (Fig. 8a). The steel beams allowed to stabilize the tubes and were used for installation of the reference pins required to make geodetic measurements.

The settlement at the LPT level was measured using a high-precision differential pressure transducer (Fig. 8c). The device consists of a probe, inserted into the tube and pulling the tube using a rope. Inside the probe, there is a sensor with a membrane recording small pressure changes
