MONITORING SYSTEM OF THE ROAD EMBANKMENT

Abstract. The paper presents the analysis of the monitoring system of the embankment supported on concrete columns and overlaid by a load transfer platform with the embedded steel grid. This field investigation was to study the complex interaction between the columns, the load transfer platform layer, and steel grid via in situ measurements during erection and live loading of the embankment. The study was focused on the behaviour of steel grid and the behaviour of the outer rows of columns since there are limited reference data available for this problem. The system was designed to inform the engineers about the condition of the embankment at every stage of construction and during standard operation of the road. The measurements brought the information on strain variations of steel grid, concrete columns, and structural settlement and provided necessary evidence for the embankment numerical model validation.

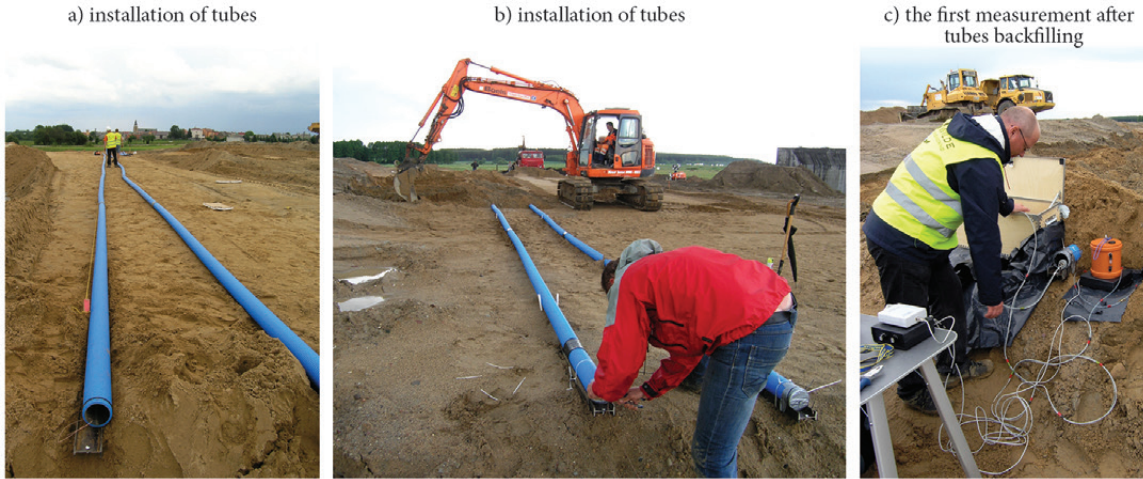
Two horizontal tubes were initially installed (Fig. 8a–b). First, it was planned to install one tube beneath the transmission layer and the second one above this layer. However, because the monitoring system was a prototype, it was decided to double the measurements conducted at the top of the transmission layer. Both tubes of 10 cm diameter were made of PVC, corrugated outside and smooth

Fig. 8. Embankment settlement measurement by hydrostatic levelling

inside. At both ends of each tube, steel H-beams of 1 m length were attached (Fig. 8a). The steel beams allowed to stabilize the tubes and were used for installation of the reference pins required to make geodetic measurements.

The settlement at the LPT level was measured using a high-precision differential pressure transducer (Fig. 8c). The device consists of a probe, inserted into the tube and pulling the tube using a rope. Inside the probe, there is a sensor with a membrane recording small pressure changes
