MONITORING SYSTEM OF THE ROAD EMBANKMENT

Abstract. The paper presents the analysis of the monitoring system of the embankment supported on concrete columns and overlaid by a load transfer platform with the embedded steel grid. This field investigation was to study the complex interaction between the columns, the load transfer platform layer, and steel grid via in situ measurements during erection and live loading of the embankment. The study was focused on the behaviour of steel grid and the behaviour of the outer rows of columns since there are limited reference data available for this problem. The system was designed to inform the engineers about the condition of the embankment at every stage of construction and during standard operation of the road. The measurements brought the information on strain variations of steel grid, concrete columns, and structural settlement and provided necessary evidence for the embankment numerical model validation.

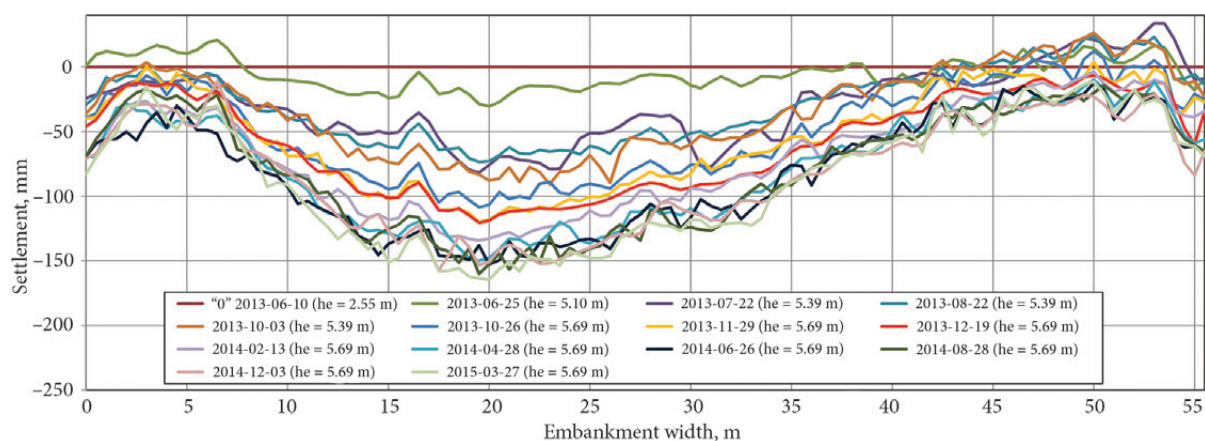
Fig. 10. Embankment settlement during construction (he – height of embankment)

Structural displacements obtained by the observational method are shown in Fig. 10. The measurements corresponding to the above numerical results are plotted by the red line, corresponding to the day of launching the road S-61 to public transport (December 19, 2013). At that time, the maximum displacement reached 12 cm, more than the displacement obtained by numerical analysis. The measured displacement profile (Fig. 10) is unsymmetrical along the road cross-section indicating that the soil parameters are irregular. The settlement process finally stabilized around one year after completion of the embankment construction. The maximum value of settlement during the observation period is about 150 mm.
