## The effectiveness of fault detection in common rail injectors examination methods

The article presents the effectiveness tests of fault detection in common rail injectors. 40 injectors with different wear levels were tested. Testing was made on two test benches of a completely different design. Research includes comparison of accuracy, reproducibility and testability to detect specific defects. A device was created for visualization of the fuel injector spraying steam.

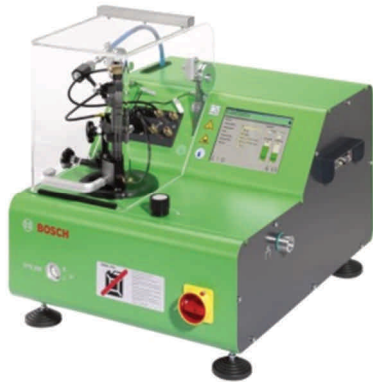
Fig. 1. Bosch EPS 200

The Bosch EPS 200 (Fig. 1) is an automatic injector tester. It has a compact design but allows to test only one injector at a time. It consists of a high pressure pump Bosch CP3, which pumps the test oil to a rail. The rail is equipped with a piezoelectric pressure sensor and a pressure control valve.

The built-in two-chamber calibration fluid reservoir has a capacity of approximately 7 litres. The fluid used in the test is drained into the first chamber where larger impurities

are deposited. In the second chamber, the test oil is brought to the correct test temperature and then fed to the high pressure pump. The most important element of the device is the turbine flowmeter, because it directly reflects on the accuracy of measurements.

The flowmeter measures the injected fuel quantity or the return quantity, depending on the setting of the valves directing the streams flowing out of a tested injector.

Measurements are possible only in an automatic mode, which is controlled according to the test procedure specified for each kind of injector. This makes the workshop test, comfortable and fast, and greatly limits the possibility of human error. On the other hand, in laboratory conditions, it also limits testing capabilities. [2]

In the case of piezo injectors, to ensure their proper operation, it is important to determine the threshold voltage for the piezo actuator. During exploitation, the nature of the piezo stack and the components directly associated with it may be changed and the ISA code designated at the factory may become wrong. The Bosch EPS can check the adequacy of this code and take it into account when the impulses are generated during the test. Furthermore, the construction of the piezo injectors requires increased return back pressure (approximately 10 bar) which EPS provides.

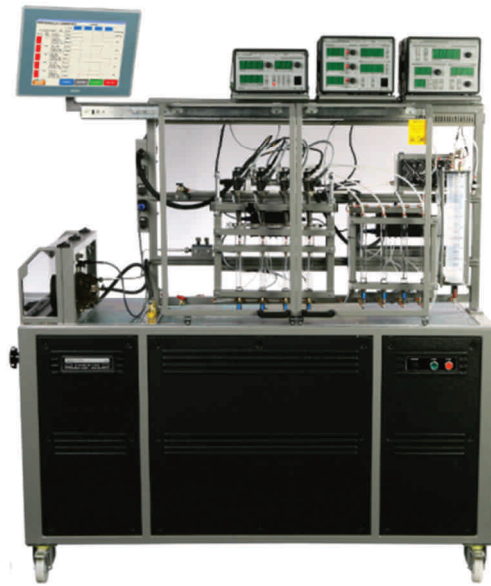
Fig. 2. STPiW 3

STPiW 3 is designed for testing pumps, injectors, pressure sensors and control valves which occur in common rail systems and systems with distributor pump. Construction of the test bench allows simultaneous testing of four injectors. Figure 3 shows the layout of the device. The fuel system has all the elements that can be found in a system of a car. The electric feed pump (1) supplies calibration fluid through the filter (2) to the high pressure pump (PO1). This is the 3-plunger radial-piston pump Bosch CP1H. It is driven through toothed belt by the induction motor (SIL). The motor is powered by the inverter (FAL) that provides smooth and precise speed control. The pump is controlled by the cut-off valve (ZAW2) and the pressure regulator valve (ZAW3). The rail (K) is equipped with the pressure sensor (CC1) and the pressure control valve (ZAW1). Pressure value in a high pressure system is controlled by the electronic module (D2) which controls all valves on the basis of a sensor reading. Tested injectors connected by flexible cables are placed in

the injected fuel quantity measuring cylinders (H). On the right side, there are cylinders that measure the return quantity (I). All return pipes are connected to the return collector (9) from which the liquid flows into the main tank (4). Injectors control the pulse generator (D1), which is set by the software on the computer connected to the device. In order to maintain accuracy of the tests and comparability of the results, it is necessary to keep the fluid temperature constant. This is done by the system, marked by dotted line, consisting of the heater (6), the electric pump (7) and the cooler with the fan (WEN1).

Quantity measurement begins with the measurement of hydrostatic pressure of the liquid in the measuring cylinders (H). Subsequently, the motor driving the pump is started. When the pump speed is stabilized, the pressure is adjusted to the setpoint. In the next stage, the injectors start injecting the calibration fluid into the measuring cylinders. The standard measuring cycle is set to 1000 injections. At the end of the series of injections, the hydrostatic pressure is measured again. Based on the pressure difference, before and after a test, the software calculates the amount of liquid that has increased during the test. Afterwards the volume is divided by the amount of injections which determines the injected fuel quantity.

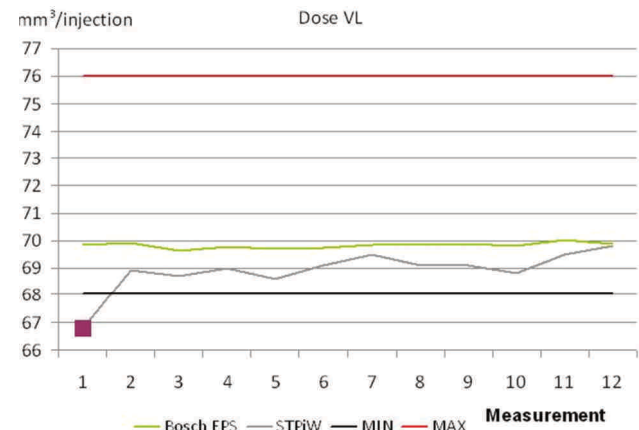
Fig. 6. VL test (actuation time 1300 μs, pressure 130 MPa)

In order to compare the accuracy and reproducibility of the measurements, a series of 12 measurements was carried out on both devices. The solenoid injector with a catalogue number 0 445 110 021 was used to carry out the tests. The following graphs (Figs 6–9) presents the results of the tests. Green lines indicate results obtained on the Bosch EPS and grey lines stand for the STPiW device. The minimum

permissible quantity is marked with a black line, while the red is the maximum. If injector test results are within the range between these lines, the injector retain its correct work parameters.

The first VL result is vitiated by a gross error, which is marked with a red point (Fig. 6). It will not be considered in calculations.

Table 3 shows the juxtaposition of standard deviations of the measurement series depending on the device and the type of test. The arithmetic mean of the standard deviations, which is a measure of the precision, is in the last row of the table. It is very clear that the tests performed with Bosch EPS are more precise and more reproducible. It is also noticed that the standard deviations for the VL tests performed on both devices is much higher than the standard deviations for the other tests. The difference is not due to lower precision of testers in these conditions, but rather to lower precision in the injector dosage at such high pressures and injection times, as the flow process inside the injector is more turbulent.

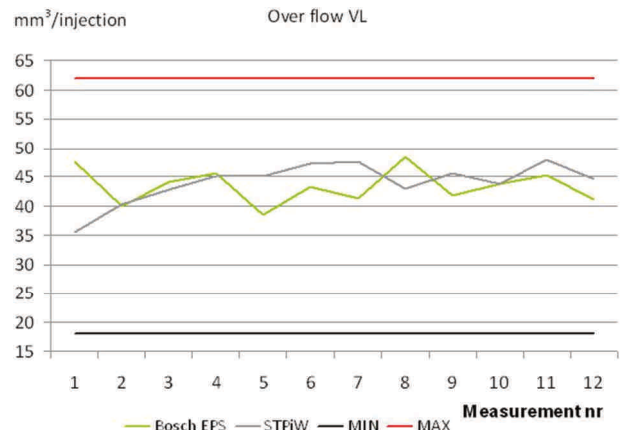
Fig. 10. Return quantity in VL test (actuation time 1300  $\mu$ s, pressure 130 MPa)

Return quantity was considered in the case of mentioned comparison. This quantity has no direct influence on the

engine's operation, so there is no requirement for the injector dosage to be precise. For this reason, the discrepancies in the measurement results do not reflect the precision of the measuring equipment because they are caused by the nature of the injector work. Therefore, the measurement accuracy of the devices cannot be compared. Fig. 10 presents the distribution of the return quantity measurement results during the VL test.

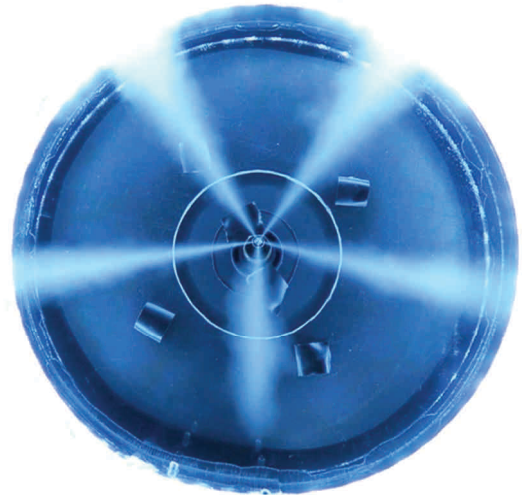
Fig. 20. Fuel spray pattern of a damaged injector

In addition, the spray pattern of the injector number 1 was documented (Fig. 20). The streams formed by the two upper holes are characterized by a larger cone angle than the others. Considering the amount of reflected light from these streams it can be inferred that they contained a higher injected fuel quantity. The spraying from the lower hole is

severely opened from the beginning, while the sprayed droplets have not yet reached the wall of the visualization chamber. This means that spreading speed of the droplets flowing from the lower hole is smaller than those from the remaining holes. The reason for such phenomenon is because the flow through this channel is disturbed by the unevenness of its geometry, which may be due to internal sediments.
