The effectiveness of fault detection in common rail injectors examination methods

The article presents the effectiveness tests of fault detection in common rail injectors. 40 injectors with different wear levels were tested. Testing was made on two test benches of a completely different design. Research includes comparison of accuracy, reproducibility and testability to detect specific defects. A device was created for visualization of the fuel injector spraying steam.

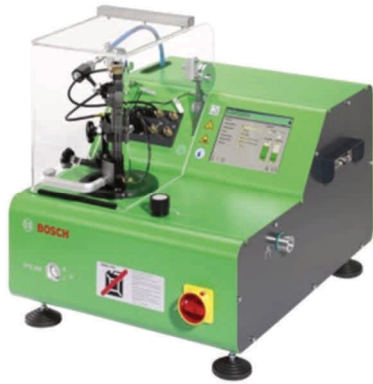
Fig. 1. Bosch EPS 200

The Bosch EPS 200 (Fig. 1) is an automatic injector tester. It has a compact design but allows to test only one injector at a time. It consists of a high pressure pump Bosch CP3, which pumps the test oil to a rail. The rail is equipped with a piezoelectric pressure sensor and a pressure control valve.

The built-in two-chamber calibration fluid reservoir has a capacity of approximately 7 litres. The fluid used in the test is drained into the first chamber where larger impurities

are deposited. In the second chamber, the test oil is brought to the correct test temperature and then fed to the high pressure pump. The most important element of the device is the turbine flowmeter, because it directly reflects on the accuracy of measurements.

The flowmeter measures the injected fuel quantity or the return quantity, depending on the setting of the valves directing the streams flowing out of a tested injector.

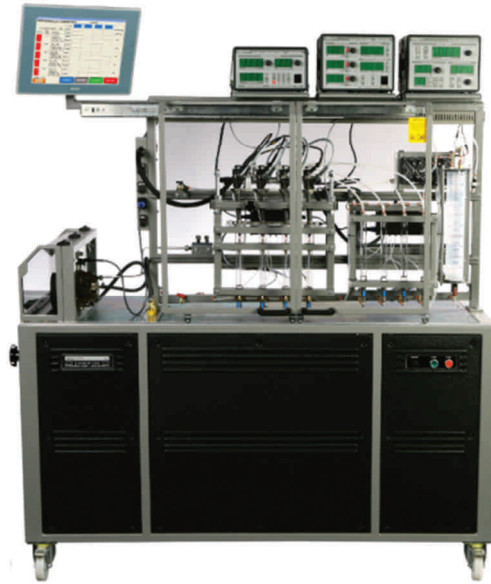
Fig. 2. STPiW 3

STPiW 3 is designed for testing pumps, injectors, pressure sensors and control valves which occur in common rail systems and systems with distributor pump. Construction of the test bench allows simultaneous testing of four injectors. Figure 3 shows the layout of the device. The fuel system has all the elements that can be found in a system of a car. The electric feed pump (1) supplies calibration fluid through the filter (2) to the high pressure pump (PO1). This is the 3-plunger radial-piston pump Bosch CP1H. It is driven through toothed belt by the induction motor (SIL). The motor is powered by the inverter (FAL) that provides smooth and precise speed control. The pump is controlled by the cut-off valve (ZAW2) and the pressure regulator valve (ZAW3). The rail (K) is equipped with the pressure sensor (CC1) and the pressure control valve (ZAW1). Pressure value in a high pressure system is controlled by the electronic module (D2) which controls all valves on the basis of a sensor reading. Tested injectors connected by flexible cables are placed in

the injected fuel quantity measuring cylinders (H). On the right side, there are cylinders that measure the return quantity (I). All return pipes are connected to the return collector (9) from which the liquid flows into the main tank (4). Injectors control the pulse generator (D1), which is set by the software on the computer connected to the device. In order to maintain accuracy of the tests and comparability of the results, it is necessary to keep the fluid temperature constant. This is done by the system, marked by dotted line, consisting of the heater (6), the electric pump (7) and the cooler with the fan (WEN1).

Quantity measurement begins with the measurement of hydrostatic pressure of the liquid in the measuring cylinders (H). Subsequently, the motor driving the pump is started. When the pump speed is stabilized, the pressure is adjusted to the setpoint. In the next stage, the injectors start injecting the calibration fluid into the measuring cylinders. The standard measuring cycle is set to 1000 injections. At the end of the series of injections, the hydrostatic pressure is measured again. Based on the pressure difference, before and after a test, the software calculates the amount of liquid that has increased during the test. Afterwards the volume is divided by the amount of injections which determines the injected fuel quantity.
