# Application of Soil Nailing Technique for Protection and Preservation Historical Buildings

Marek Kulczykowski<sup>1</sup>, Jarosław Przewłócki<sup>2</sup>, Bogusława Konarzewska<sup>1</sup>

**Abstract.** Soil nailing is one of the recent *in situ* techniques used for soil improvement and in stabilizing slopes. The process of soil nailing consists of reinforcing the natural ground with relatively small steel bars or metal rods, grouted in the pre-drilled holes. This method has a wide range of applications for stabilizing deep excavations and steep slopes. Soil nailing has recently become a very common method of slope stabilisation especially where situated beneath or adjacent to historical buildings. Stabilisation by nails drilled into existing masonry structures such as failing retaining walls abutments, provide long term stability without demolition and rebuilding costs. Two cases of soil nailing technology aimed at stabilising slopes beneath old buildings in Poland are presented in this paper. The first concerns application of this technology to repair a retaining wall supporting the base of the dam at the historic hydroelectric power plant in Rutki. The second regards a conc

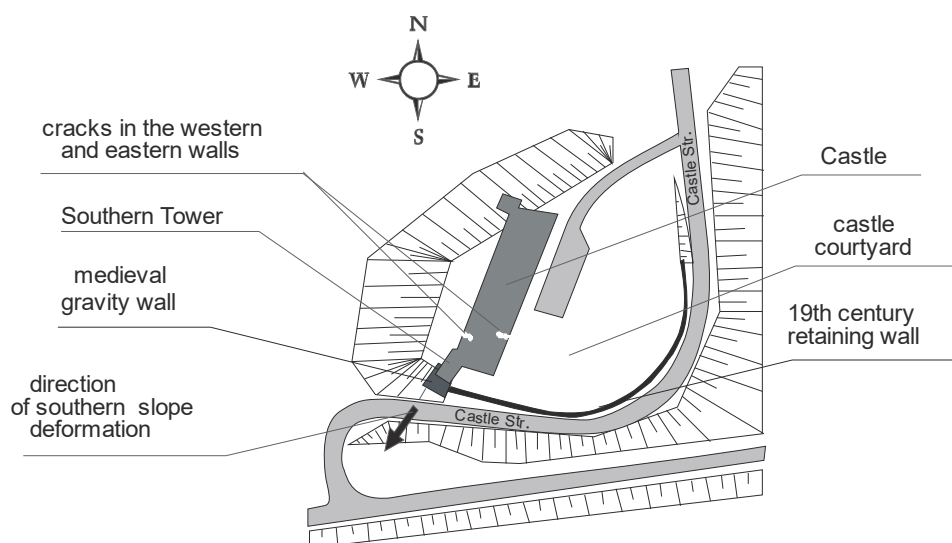
Figure 4 Site plan of Castle Hill

At present the castle is a rectangular building having a dimension of 63 meters in long and 15 meters wide with a courtyard on the eastern side. Two of the castle's exterior towers are located on the north-west and southwest corners of the main building (figure 4).

The Southern Tower is situated on the edge of a very steep slope, in the immediate vicinity supported by an 11-meter-high medieval masonry gravity wall. The courtyard's area is also surrounded on the east and south sides by a curved 19<sup>th</sup> century retaining wall (figures 4, 5).
