As- built inventory of the office building with the use of terrestrial laser scanning

Abstract. Terrestrial Laser Scanning (TLS) is an efficient tool for building inventories. Based on the red-laser beam technology it is possible to provide the high accuracy data with complete spatial information about a scanned object. In this article, authors present the solution of use a TLS in as-built inventory of the office building. Based on the provided data, it is possible to evaluate the correctness of built details of a building and provide information for further construction works, for example an area needed for Styrofoam installation. The biggest problem in this research is that an error which equals over 1cm could generate costs, which could be a problem to cover by a constructor. Based on a complicated place of the construction works (centre of a city) it was a challenge to maintain the accuracy.

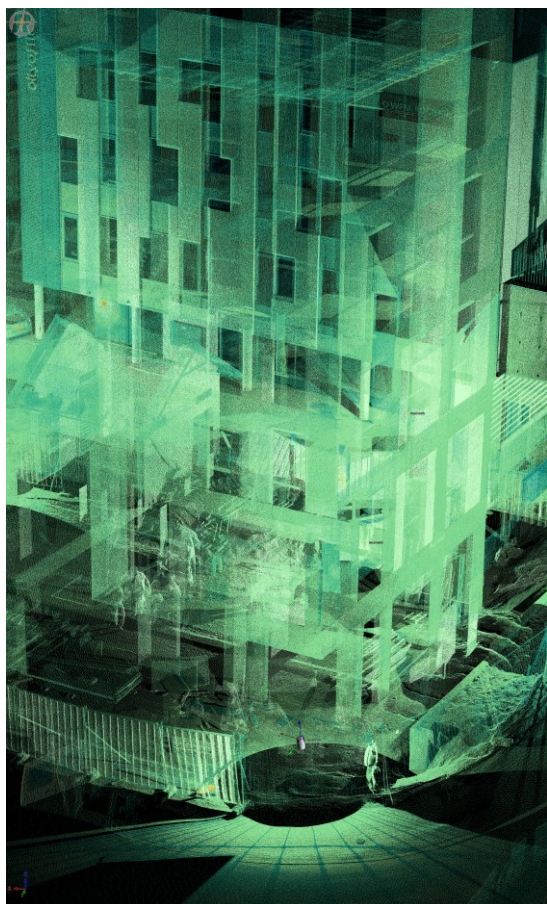
Unfortunately, the situation was different from presumed. The whole object was enclosed by metal plates, preventing from enter into the construction site. Also, a close neighbourhood of road and other buildings was a problem for data acquisition. It was not possible to cover assumptions. It was a need to create a lot more scan stations. Authors placed 15 scan positions. The alignment of that positions and estimate the perfect, according to the project place of walls for deviations calculations was crucial. The Fig. 2 is presenting the scanned object.

Fig. 2. The view of a scanned object.
