Influence of Property Division on the Technical Condition of a Building

To cite this article: Emilia Miszewska-Urbaska *et al* 2017 *IOP Conf. Ser.: Mater. Sci. Eng.* **245** 062051

Emilia Miszewska-Urbańska ¹, Beata Grzyl ¹, Adam Kristowski ¹

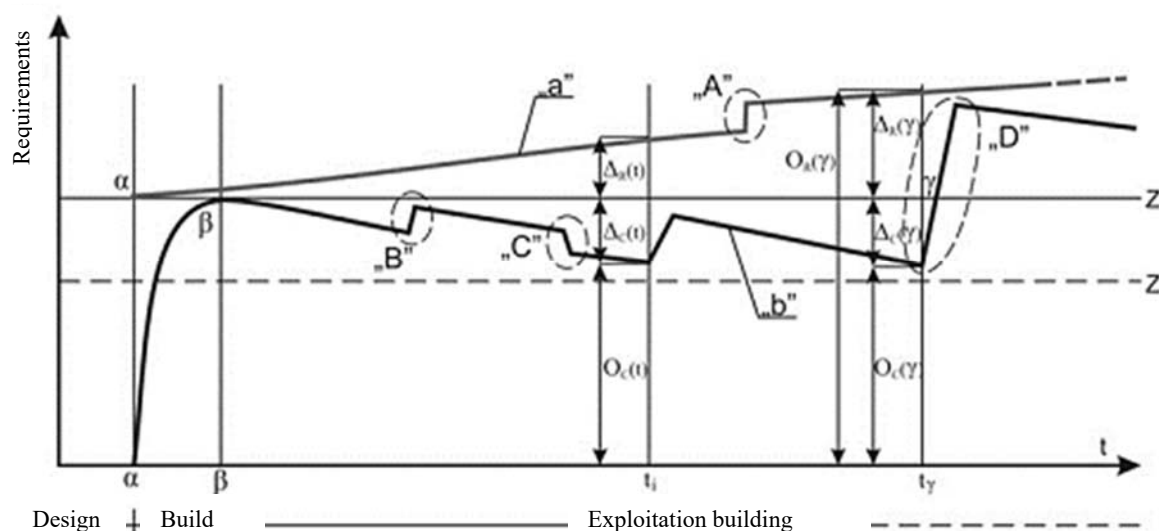
Figure 1. The phenomena relating to the assessment of the performance of the building as a function of time; and - an increase in user requirements of the object, b - changes in the performance of building [4]

In the paper entitled “The analysis of the usage value of a building in the time function” [4], the authors indicate that there are two types of opposing processes taking place during the usage of buildings. These are firstly, the constant decreasing of usage characteristics of a building and secondly, the increase of requirements of the building’s users. The course of these phenomena on the time line has been presented on figure 1. [4].

- z - assessment of the building when put to use (it is assumed that the building was designed and manufactured in accordance with applicable regulations and standards)
- z' - the minimum acceptable requirements of the utility building
- OR (t) - the value in use of the building reference time t
- OC (t) – usable value of the analysed building at the time t
- ΔC (t) - loss (loss) value in use of the building at the time t
- ΔR (t) - the difference between the value in use of the reference building and the actual use value of the analyzed object at time t [4].

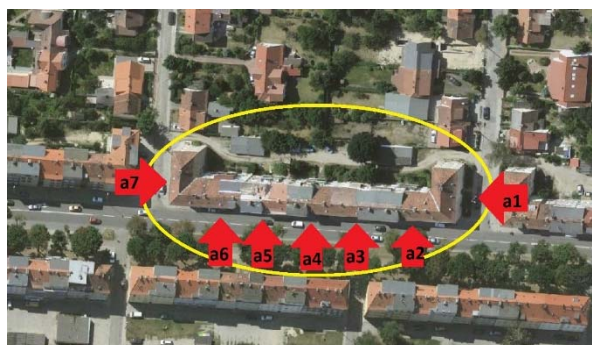
Figure 2. Fragment of the city plan with the selected segments [10] based on [9]

The object of study is a four-storey, multi-family residential building consisting of seven segments, with a basement and functional loft, positioned in the shape of letter "C". The location of the building and indication of particular segments is shown on figure 2, whereas the front and the backyard view of the building has been presented on figures 3,4,5 and 6. The building was constructed according to the traditional technology, with a gable roof covered with plain tiles. The residents of each segment established a separate housing cooperative. Five independent management companies undertook the

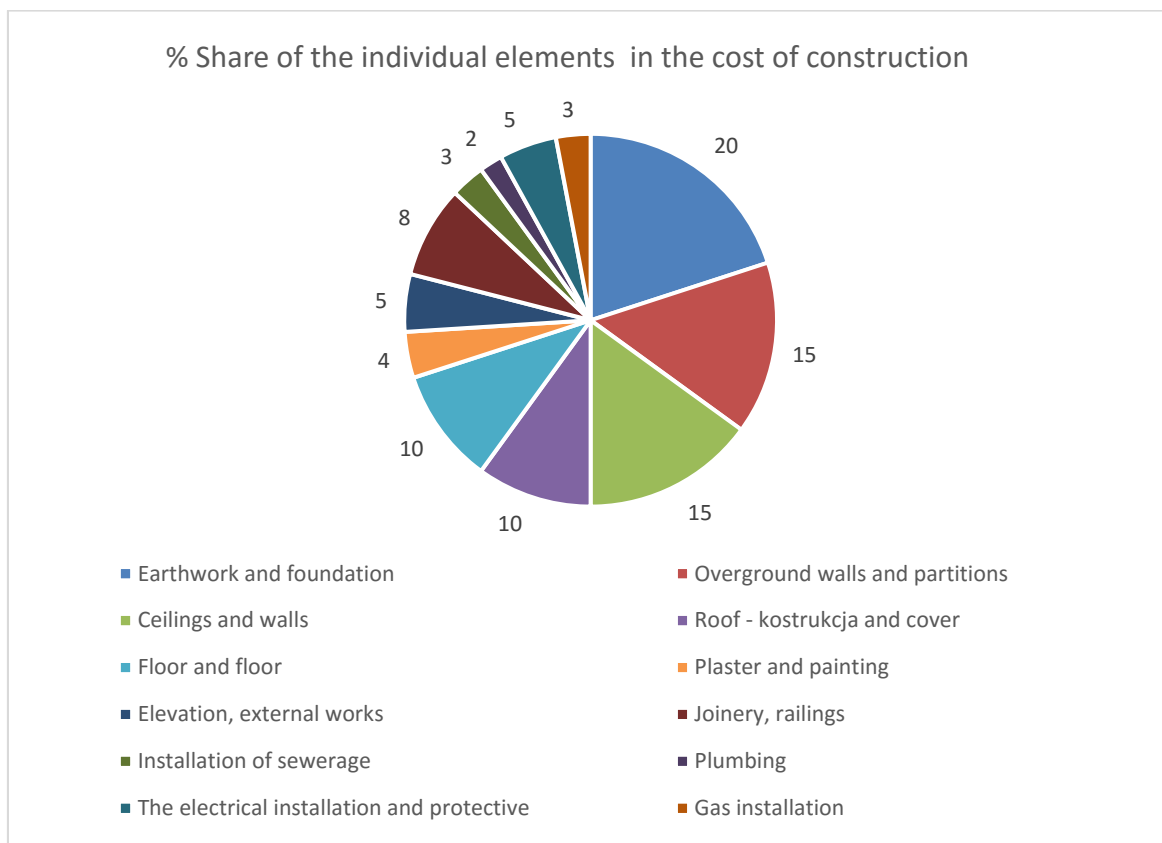
Figure 7. % Share of the individual elements in the cost of construction [10].

- 1) determining the percentage share of particular elements (for example, flooring and floor- 10%) in the reconstruction cost of the residential building as a whole (figure 7)- U_i ,
- 2) determining the percentage share of particular segments (seven sections) in the cost of construction of residential building as a whole - from u_{i1} to u_{i7} ,
- 3) determining the share of particular element in the construction cost of a particular segment
- 4) a list of results of the above-mentioned operations has been presented in table 1,
- 5) determining in % the extent of wear and tear of a particular element - a component of a certain segment- s_{e1} to s_{e7} ,
- 6) a list of results has been presented in table 2,
- 7) calculating the extent of technical wear and tear of a particular segment - s_{z1} to s_{z7} ,

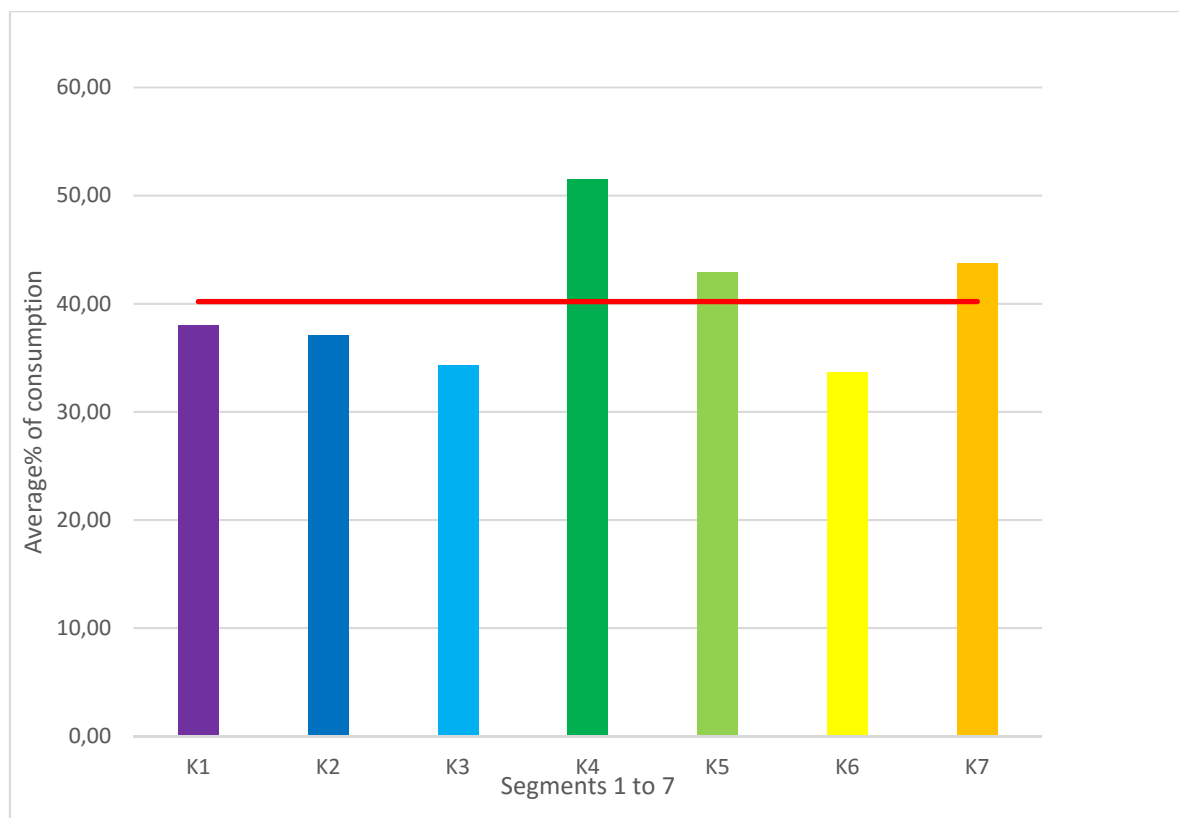
Figure 8. The weighted average degree of technical wear of the segments and the whole building% [10].

The results shown in figure 8 present significant differences in weighted-average extent of technical wear and tear of individual segments contributing to the extent of technical wear and tear of the whole building.

The greatest difference, which amounted to 17,80% can be observed between segment a3 and a6. The average extent of technical wear and tear has been calculated and amounted to 40,20%. It must be stressed that it is a theoretical average (computational), because it is very difficult to determine their actual technical state by dividing the construction elements.
