Article

Failure Monitoring and Condition Assessment of Steel-Concrete Adhesive Connection Using Ultrasonic Waves

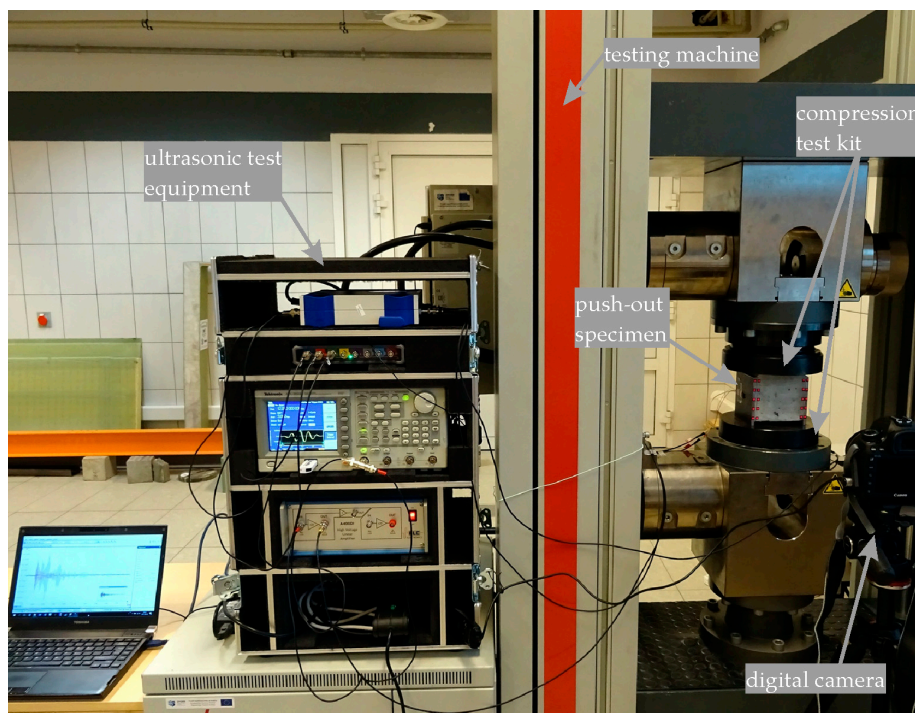
Figure 3. Experimental setup for push-out and ultrasonic tests.

During the mechanical degradation in the testing machine, ultrasonic waves were induced and acquired every 2 s, until the specimen failure. Figure 3 shows the experimental setup. Three multilayer

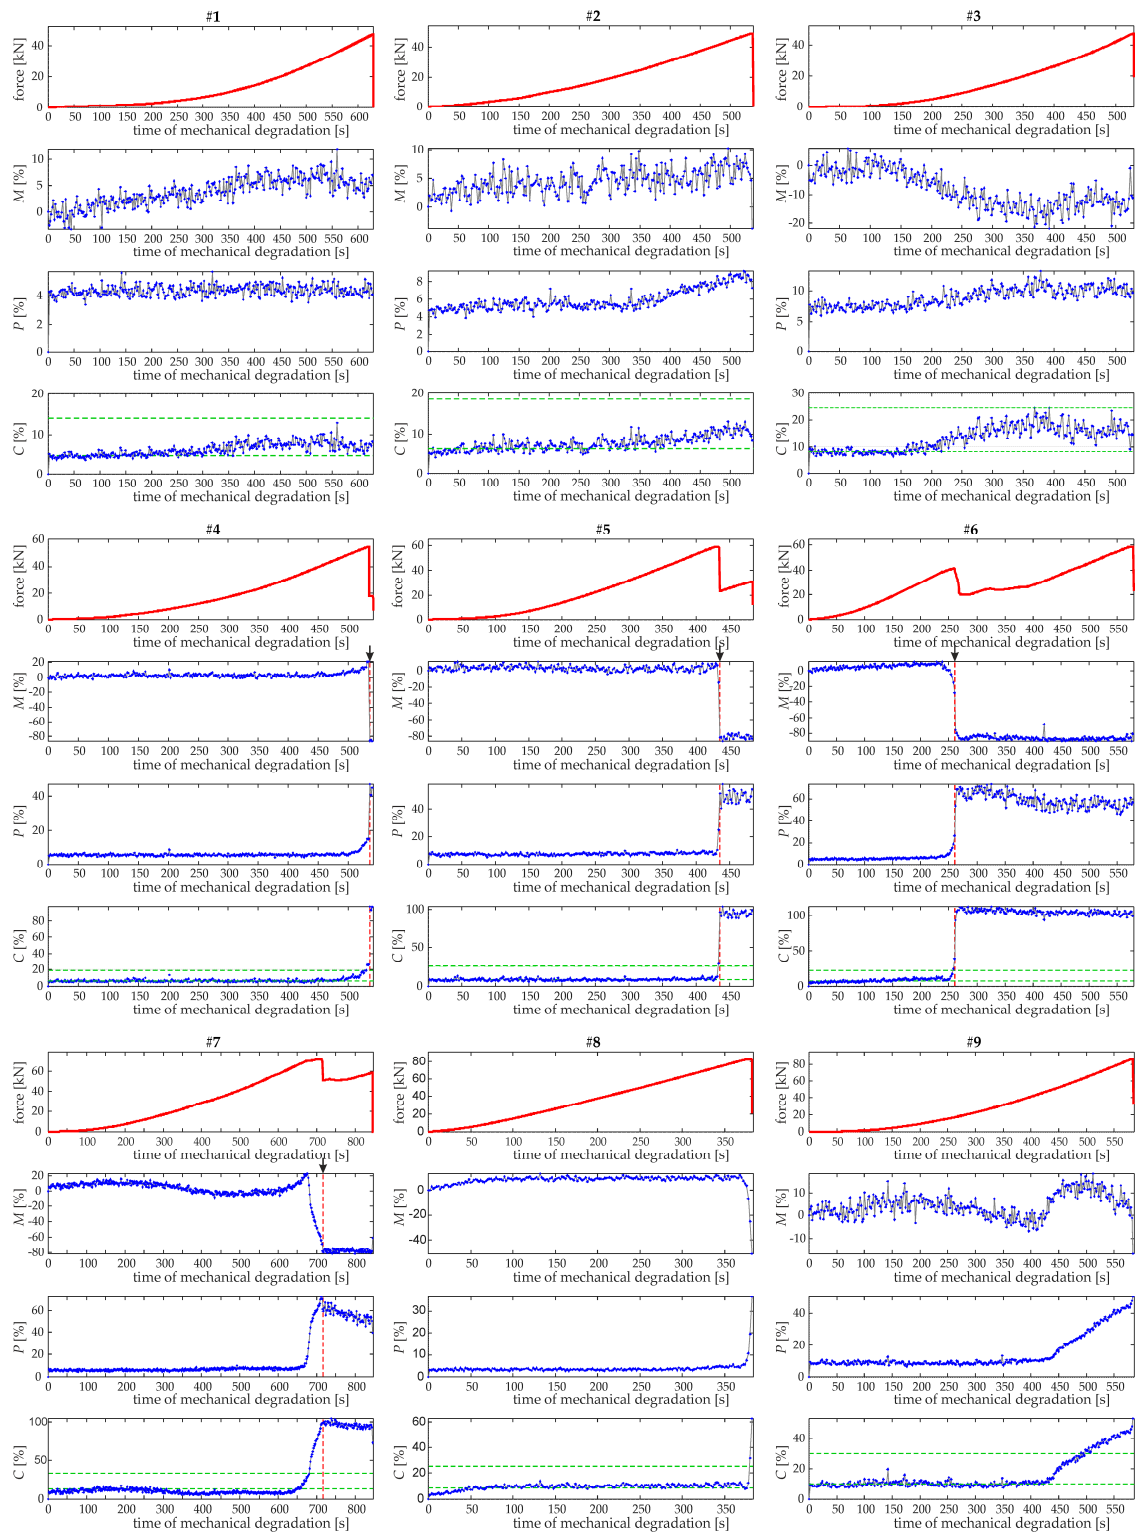
Figure 11. S&G metric errors (magnitude error M , phase error P , comprehensive error C) during subsequent phases of degradation of push-out specimens (#1–#9).

The results of applying the Sprague and Geers metric to all signals registered during the monitoring of the push-out test are presented in Figure 11. For clarity of observation, the load-time curves were provided for each specimen. Additionally, for specimens #4–#7, red dashed lines were drawn at the moment of initiation of the crack in the concrete cube. The S&G metric expresses the difference between the reference signal and the other signals registered during the push-out test. The error measures can range from 0 to 1 or more. The perfect agreement of time histories results in a zero value of the error measures, while the value of unity indicates a difference of 100%. The value of the P -error is always positive while the value of the M -error can be positive or negative, depending on whether the monitored signal has higher or lower amplitude than the reference signal. At the beginning of the process, the P -error fluctuated around the value of about 5% and the M -error around the value of about 0%. These values resulted from the presence of measuring noise in the subsequently triggered measuring signals.

Considering the specimens with the adhesive-type damage (the first row in Figure 11), all error measures are rather constant during the entire push-out test. A slight increase in the P -error value was observed for specimen #6; however, based on these errors it was not possible to detect incoming damage before the failure.

The second group are specimens belonging to failure modes IIa and IIb, for which the separation between the steel plate and concrete was preceded by the cracking of concrete. For specimens #4, #5 and #6, the increase in the P -error can be observed before the initiation of the diagonal cracks. This increase was quite sudden for specimen #5, but for specimens #4 and #6 it was gradual signaling incoming damage. Moreover, for specimen #6, the M -error gradually decreased before the initiation of the diagonal cracks. In the case of specimen #7, for which the crack appeared in the middle of the concrete cube, the gradual increase of the P -error and the decrease in the M -error can be seen, enabling detection of the micro-crack zones in the concrete long before the appearance of the macro-crack.

The last two specimens represented the failure of mode IIc. For the specimen #8, the detection of the cohesive failure was possible based on both the M and P -errors. In the case of specimen #9, the gradual increase of the P -error was observed (similarly as for specimen #2) indicating the increase in the load but not the appearance of the failure. This was because, the failure of specimen #9 was mainly adhesive, with a small area at which the cohesive failure occurred.

As a damage indicator, the C -error is proposed because it contains both the magnitude and phase errors. For each specimen, two horizontal lines were drawn in the plots of the comprehensive error (Figure 11). The first line is a mean of the 100 first values of the C -error and it determines a baseline. The second line is the baseline multiplied by a coefficient and it represents the state of possible damage. In this study, the value of the coefficient was set a priori as 3, however, in potential applications of structural monitoring, it should be verified based on comprehensive experimental data. Based on the indicator, it was not possible to recognize the upcoming separation between steel and concrete in any specimen with the adhesive failure (specimens #1–#3). In the case of specimens exhibiting the cohesive

or mixed adhesive-cohesive failure, the gradual increase of the C-error enabled earlier detection of potential damage.
