Article

Failure Monitoring and Condition Assessment of Steel-Concrete Adhesive Connection Using Ultrasonic Waves

Magdalena Rucka

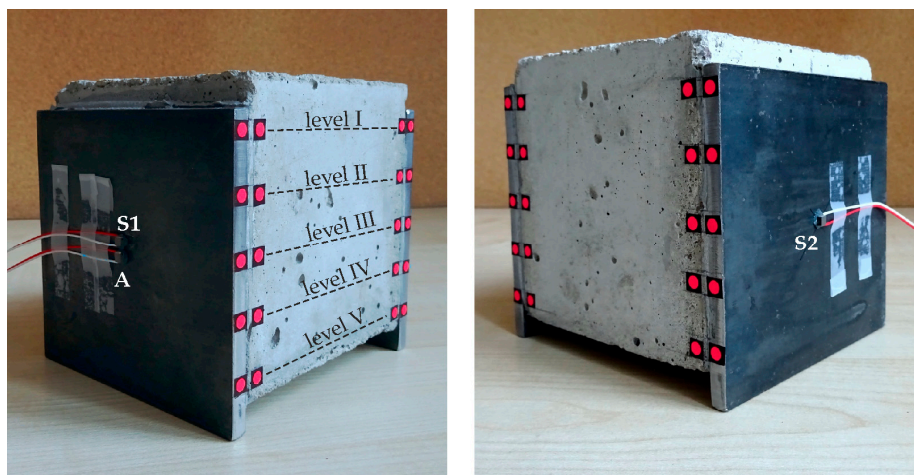
Figure 2. Steel-concrete specimen with attached piezoelectric actuator (A) and sensors (S1, S2).

Experimental procedure included simultaneous push-out and wave propagation testing. Push-out tests were performed in the testing machine Zwick Z400 equipped with a compression test kit. The force and the displacement of the cross-head were recorded. The preload applied to the specimen was equal to 100 N. Then, each steel-concrete specimen was loaded with the speed of the crosshead of 0.1 mm/min up to the failure. Additionally, photographs were taken every 2 s on the front side of the specimen by the Canon EOS 5D III digital camera to observe the damage evolution and to determine the slip between steel and concrete. At each specimen, 10 pairs of magenta points with a diameter of 4 mm were attached at five levels (levels I to V, as indicated in Figure 2).

piezoelectric actuators NAC2024 manufactured by Noliac were used for both excitation and registration of wave propagation signals. They were adhesively bonded to the steel plates using petro wax (PCB 080A109). The configuration of piezoelectric transducers is given in Figure 2. The actuator (A) was bonded at the center of the left steel plate. The first sensor (S1) was attached next to the actuator, while the second one (S2) was attached at the center of the right steel plate. An arbitrary waveform generator (Tektronix AFG3022C) created an excitation signal in the form of a wave packet composed of a 5-cycle sine with a central frequency of 60 kHz modulated by the Hanning window (Figure 4). Then the signal was amplified 20 times by a high voltage amplifier (FLC Electronics AB A400DI). A digital oscilloscope (PicoScope 4824) was used to collect time signals of propagating waves with a sampling frequency of 20 MHz.

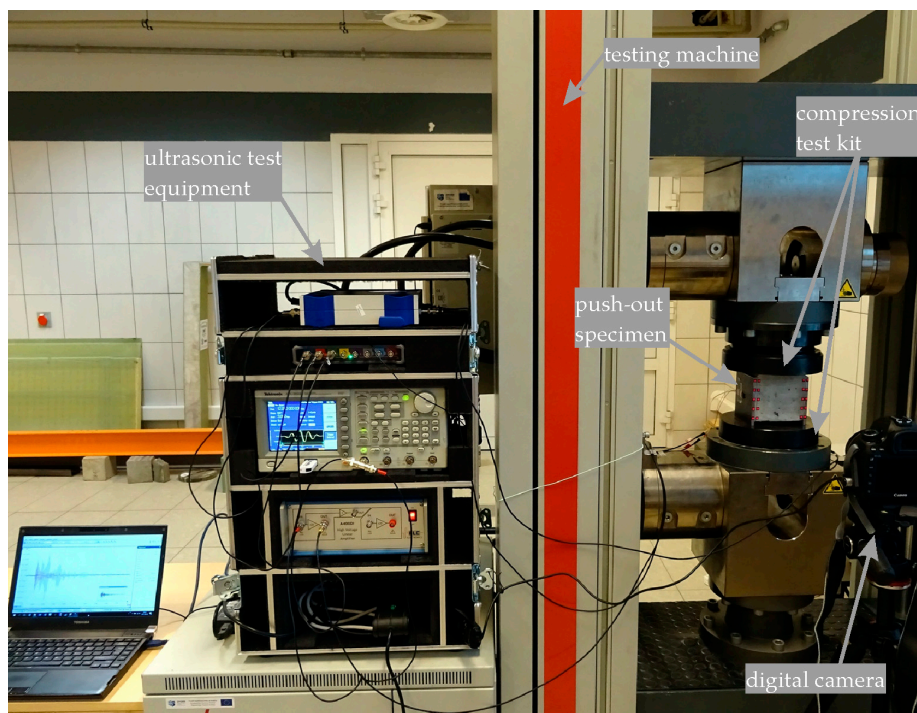
Figure 3. Experimental setup for push-out and ultrasonic tests.

During the mechanical degradation in the testing machine, ultrasonic waves were induced and acquired every 2 s, until the specimen failure. Figure 3 shows the experimental setup. Three multilayer
