A NEW APPROACH OF COASTAL CLIFF MONITORING USING MOBILE LASER SCANNING

Gdańsk University of Technology, Poland

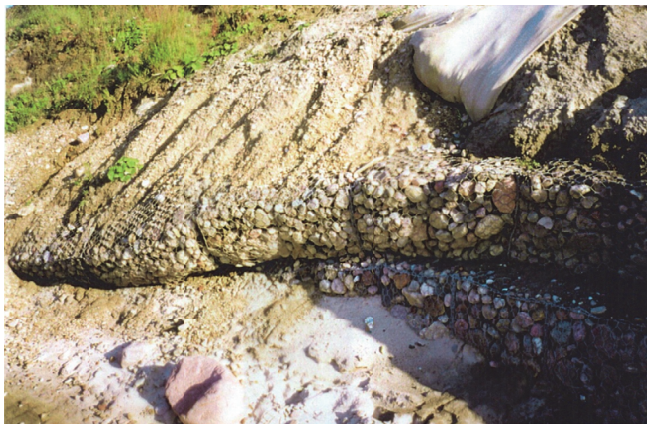
Fig. 3. Gabions composing the seawall in the region of "Bałtyk", damaged in 1998
(photo courtesy of W. Subotowicz)

abovementioned cliff segment at Jastrzebia Gora. It had the form of a seawall consisting of gabions. At first, it was built along the eastern cliff part, of 200 m in length, where the partially damaged leisure centre "Horyzont" was situated. Unfortunately, first damages of this seawall were already observed as early as in 1998 (Fig. 3).

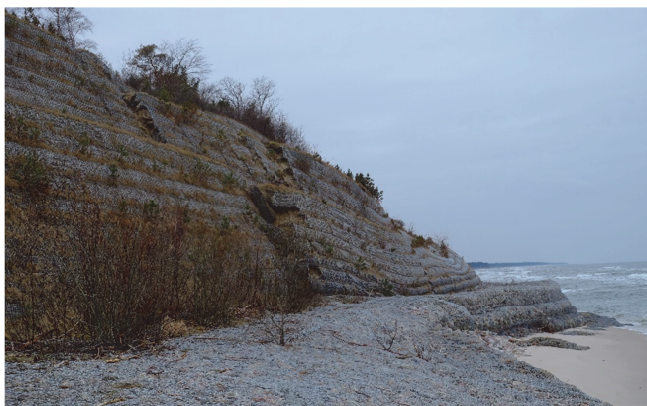
Fig.4. Degradation of reinforced cliff part at Jastrzebia Gora – situation of January 2017.

A general conclusion from the above situation is that all past protection measures revealed low durability (see Fig. 4). Consequently, permanent monitoring of the cliff is indispensable for the safety of tourists and residents.

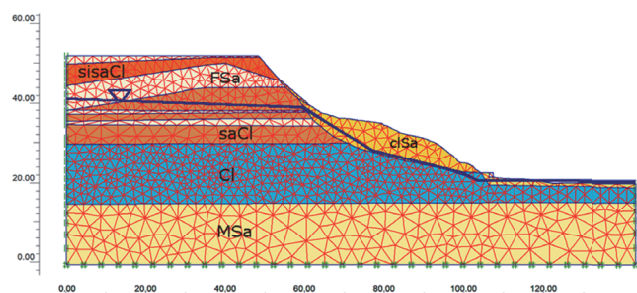
Fig. 9. Geotechnical cross section of km 134.1 and its discretisation

on the results of laser scanning from the sea, complemented with terrestrial scans. The geometry of these sections is shown in Figs. 8-9.
