A NEW APPROACH OF COASTAL CLIFF MONITORING USING MOBILE LASER SCANNING

Gdańsk University of Technology, Poland

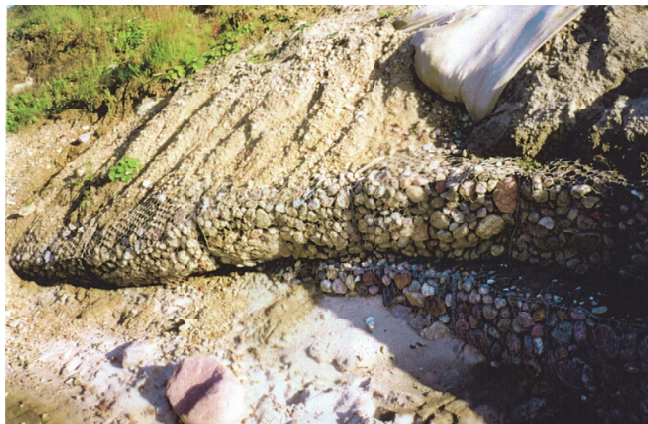
Fig. 3. Gabions composing the seawall in the region of "Bałtyk", damaged in 1998
(photo courtesy of W. Subotowicz)

abovementioned cliff segment at Jastrzebia Gora. It had the form of a seawall consisting of gabions. At first, it was built along the eastern cliff part, of 200 m in length, where the partially damaged leisure centre "Horyzont" was situated. Unfortunately, first damages of this seawall were already observed as early as in 1998 (Fig. 3).
