Chinese Journal of Aeronautics

Effect of selective laser treatment on initiation of fatigue crack in the main part of an undercarriage drag strut

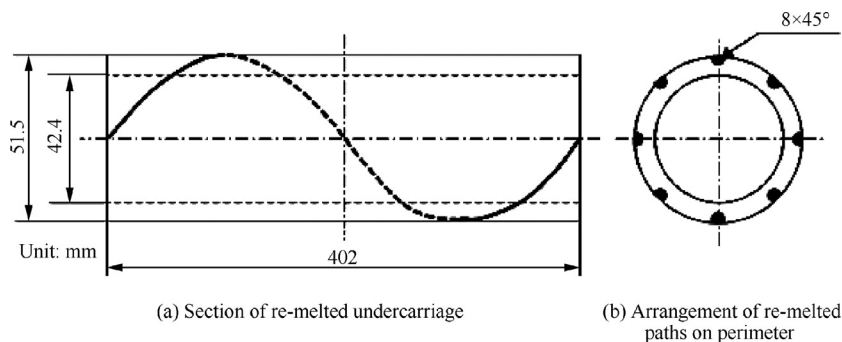
**Fig. 2** Eight melted paths were made as spiral lines along the axis of the drag strut.

spiral with a pitch equal to the sleeve length of the drag strut was that cracks formed in the area of the sleeve of the drag strut were disposed perpendicularly to the axis of the sleeve. In order to reduce torsional stresses in the sleeve of the processed drag strut, an alternating direction of performed pathways was used. With this technique, eight melted paths were made as spiral lines along the axis of the drag strut (see Fig. 2). The laser processing parameters for treatment of the drag strut are presented in Table 3. Fig. 2 shows a schematic drawing of the section of the re-melted undercarriage drag strut with a single re-melted path marked in Fig. 2(a), and the arrangement of re-melted paths on the perimeter in Fig. 2(b). The amount of energy delivered by the laser beam to the workpiece was selected on the basis of earlier experiments by optimizing the thickness of the re-melted layer.

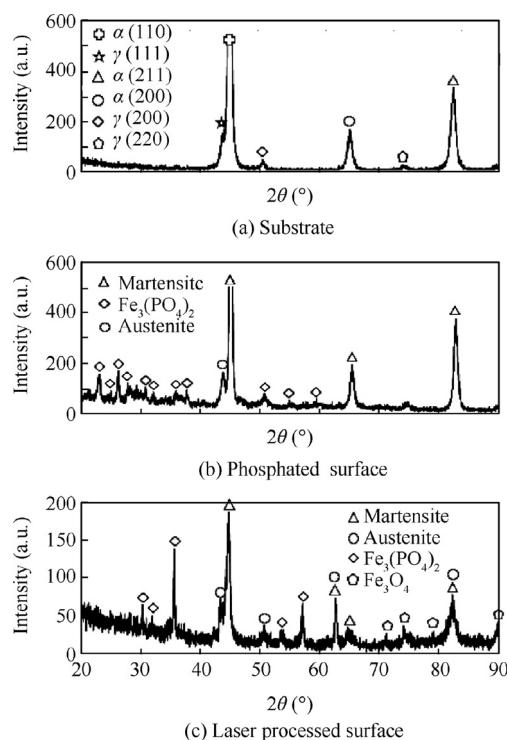
Fig. 9 X-ray diffraction patterns of the substrate, phosphated surface, and laser-processed surface.

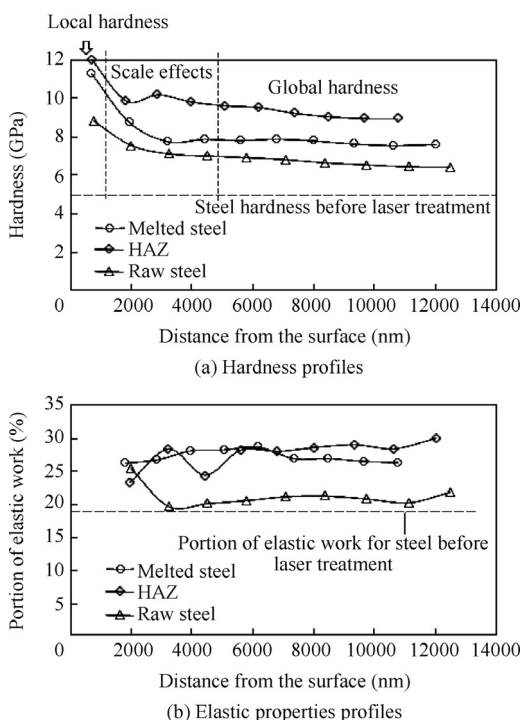
Fig. 16 Mechanical properties of the laser-processed undercarriage drag strut.

microstructure of the melted material resulting in an increase in the density of defects in the crystalline lattice and thus an increase in the strength properties of the alloy. The second reason that contributed to increased hardness was the scale effect. Hardness profiles were determined in a multiple-load cycle. The minimum load was 100 mN, and the maximum load was 20 times higher and amounted to 20 N. For small loads, local hardness was measured, while for higher loads, global hardness was obtained (see Fig. 16(a)). Hardness tests also allowed the determination of the elastic properties of the processed material. During the hardness tests, plastic and elastic works of deformation of the tested material were measured. The portion of elastic work, W_{el} , was defined as the area under the unload curve in the diagram of load vs. indenter displacement. Fig. 16(b) shows changes of portion of elastic work (related to the total work of deformation during indentation) for three analyzed areas. As can be seen in Fig. 16(b), the elastic properties of both the melted area and the HAZ have increased as a result of laser treatment.

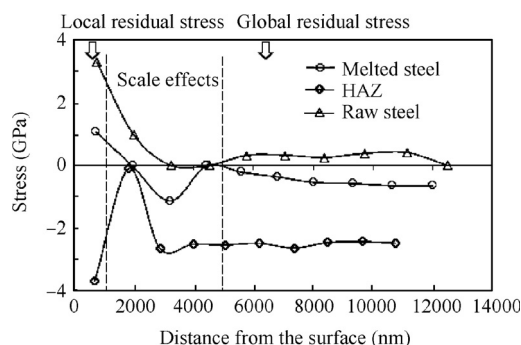
Fig. 18 Residual stress profiles for analyzed areas.

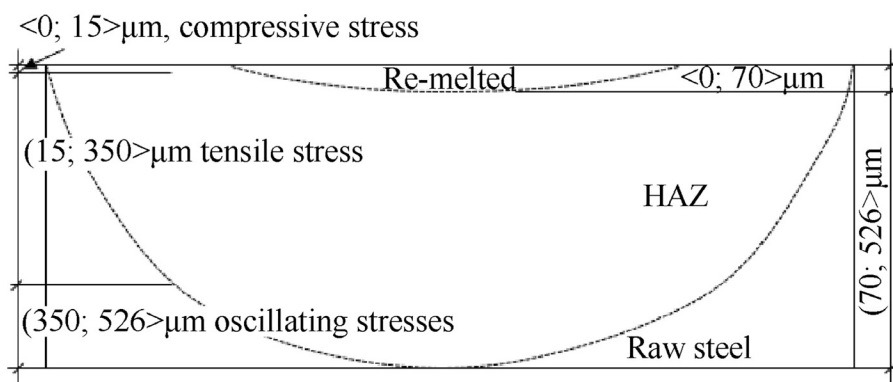
Fig. 20 Sample for CT testing.

(a) CT scan of the sample with marked areas for detection of fatigue crack initiation sites

(b) A sample scheme with marked areas of different nature of residual stresses and microstructure

(c) Place of sample cutout for testing-depicted by arrow the sample size 0.526 mm×2 mm×14.64 m

In order to determine the effects of the microstructure of steel and the residual stress on the rate of initiation of fatigue cracks, a sample was scanned using a computer microtomograph. Fig. 20 presents the sample used for the study with the marked areas for detection of fatigue cracking initiation sites. To determine the content of defects in alloy subjected to laser treatment, four volumes of metal were extracted in
