Article

Non-Destructive Assessment of Masonry Pillars using Ultrasonic Tomography

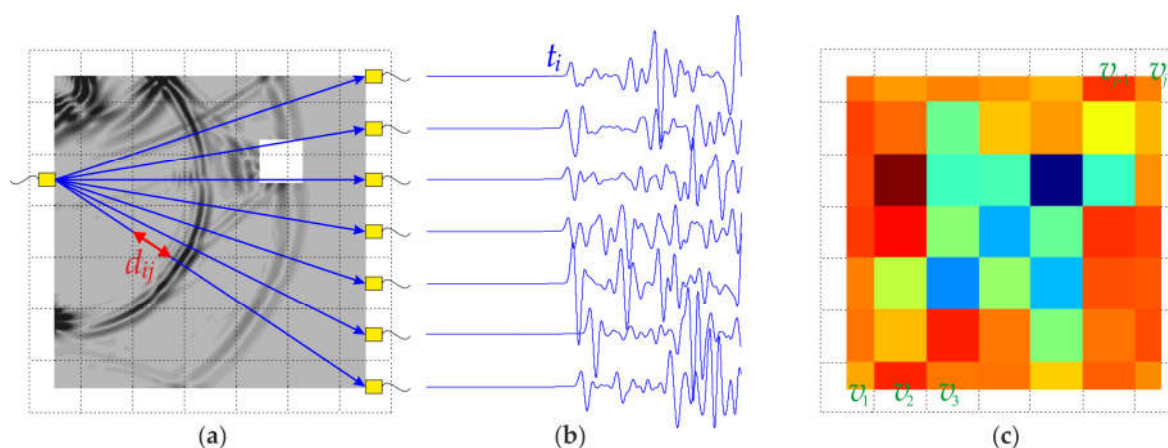
Figure 1. Schematic diagram of ultrasound tomography: (a) cross-section divided into pixels, with an indicated transmission point, receivers and a simulated wave field; (b) wave propagation signals; (c) tomographic image.

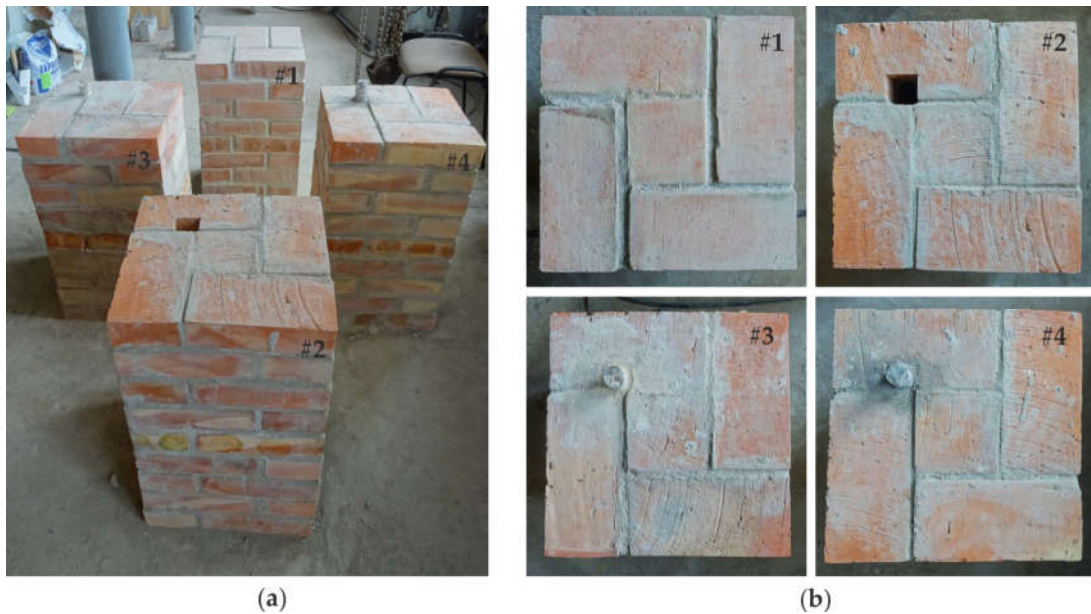
Figure 3. Photographs of laboratory models of the brick pillars: (a) overall view; (b) plane views of specimens #1 to #4.

The test specimens included one pristine pillar and three pillars with inclusions (Figure 3). The first pillar (#1) was prepared as a reference model. Pillars #2, #3 and #4 had a square hole through the entire height of the specimen. The hole, with dimensions of 5.3 cm × 5.3 cm, was situated at a distance of 7.7 cm from the pillar edges (Figure 2b). The hole in pillar #2 remained empty, while in the case of pillars #3 and #4, an anchor was mounted in it. The threaded steel bar had a diameter of 32 cm, and was grouted using two types of mortar. In pillar #3, the anchor was mounted using gypsum mortar to represent a weak bond, while in the case of pillar #4, cement mortar was used to represent a strong bond.

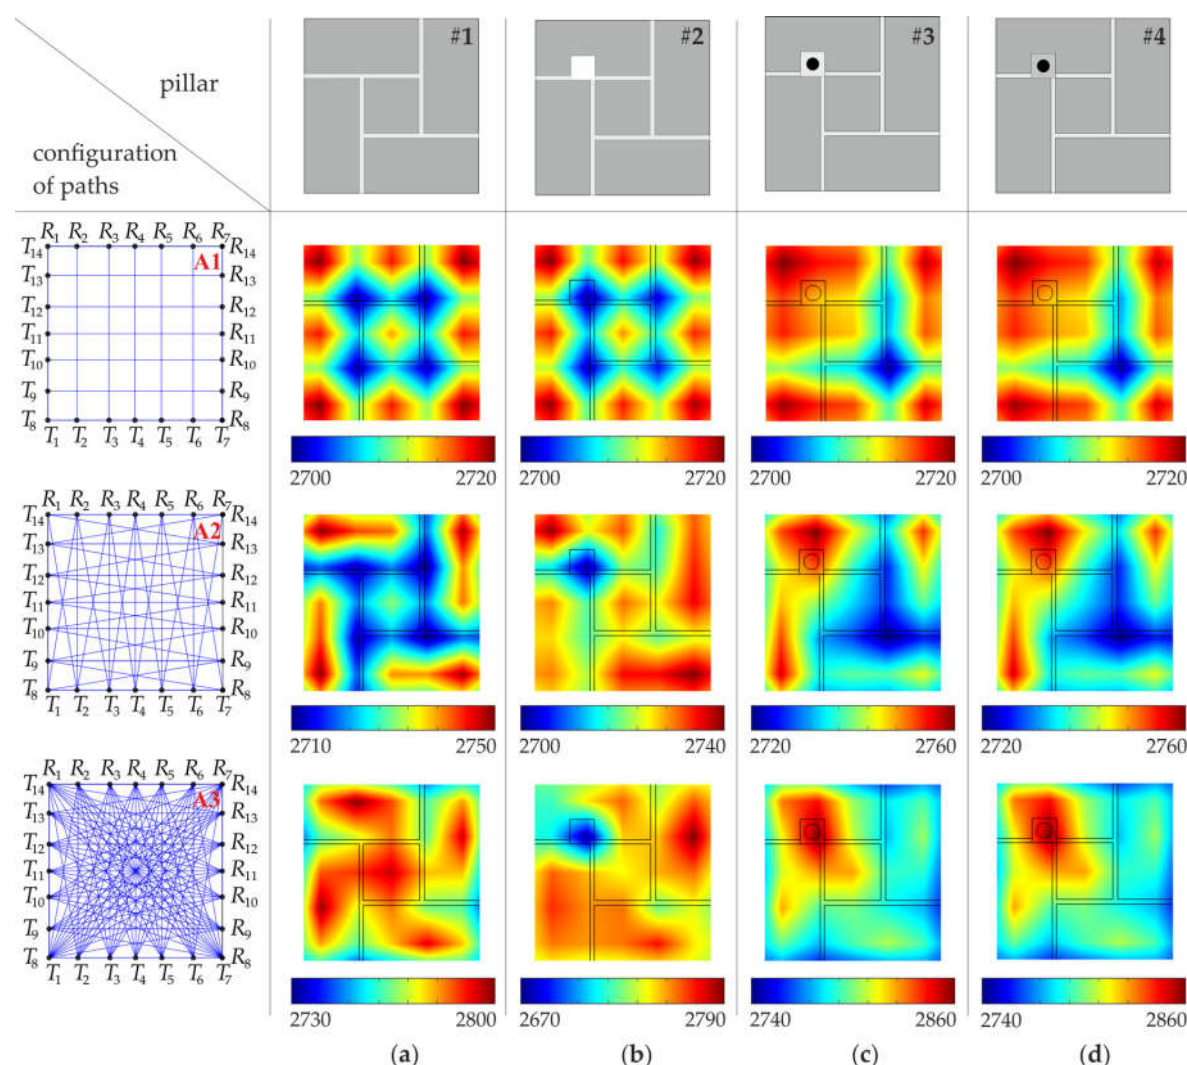
Figure 7. Tomographic velocity images (values in (m/s)), with a division into 49 pixels (configuration #A), obtained from FEM signals: (a) intact pillar; (b) pillar with the square hole; (c) pillar with the steel bar grouted by means of gypsum mortar; (d) pillar with the steel bar grouted by means of cement mortar.

Ultrasound tomography images, determined based on numerical FEM signals, are shown in Figures 7 and 8, with a division into 49 and 169 pixels, respectively (see Section 3.4). In general, the increase in the number of transmitters, as well as the increase in the number of paths, improved the resolution of the velocity maps and provided a more precise image of the internal structure of the pillars.

Tomograms for the intact pillar (#1) enabled the identification of the arrangement of joints (Figures 7a and 8a). Joints made of cement-lime mortar were characterized by a lower wave propagation velocity than the brick itself. The impact of the existence of joints on the tomographic images was visible, regardless of the number of transmitters used and the number of measurement

paths. However, maps created based on the simplest configurations of paths (#A.1, #B.1) did not give satisfactory results regarding precise joint localization. The use of vertical and horizontal wave paths enabled only the identification of the directions of the mortar joints. More accurate tomographic images were obtained when a larger amount of measurement data was collected. Increasing the number of paths (configurations #A.2-A.3 and #B.2-B.3) allowed the position of joints in the considered cross-section and the exact brick arrangement pattern to be determined.

Tests conducted for the pillar with the hole (pillar #2) allowed its position to be estimated, but only when a sufficiently large number of ray paths was used (Figures 7b and 8b). In the case of configurations of vertical and horizontal paths (configurations #A.1 and #B.1), the obtained tomographic images were very similar to those obtained for the intact pillar. To obtain the precise localization of the hole, the configuration, including all paths between the transmitting point and receiving points, were required. For such configurations (#A.3 and #B.3), a clear area, with a lower value of the velocity, can be observed. It was also possible to identify the arrangement of mortar joints, especially in the case of the image divided into 169 pixels.

The results for the pillars with the steel bar grouted by means of gypsum cement mortar are shown in Figures 7c and 7d (49 pixels) and Figures 8c and 8d (169 pixels). Tomographic velocity images of the simplest paths differed considerably between configuration #A.1 and #B.1. In the case

of configuration #A.1, no path crossed the steel bar, therefore, it was not possible to localize the bar. However, since two paths passed directly along the joints, two straight lines with lower velocities appeared in the map, indicating the direction of the mortar joints. When 26 instead of 14 horizontal and vertical paths were used, two perpendicular paths crossed the steel bar. Therefore, for configuration #B.1, two longitudinal areas with a higher velocity appeared on the maps. These lines were the effect of blurring, which occurs in linear tomography. They indicated the presence of the bar but did not allow for its exact localization. The precise localization was achieved after considering more paths crossing the bar (configurations #A.3 and B.3). As a result, a distinct area with higher velocity values can be observed around the bar position. It should also be noted that the maps for pillars #3 and #4 are almost the same. This means that the main influence on the velocity distribution was the presence of the bar, and therefore, it was not possible to determine the type of mortar (gypsum or cement) used.
