Article

Advantages of the Application of the Temper Bead Welding Technique During Wet Welding

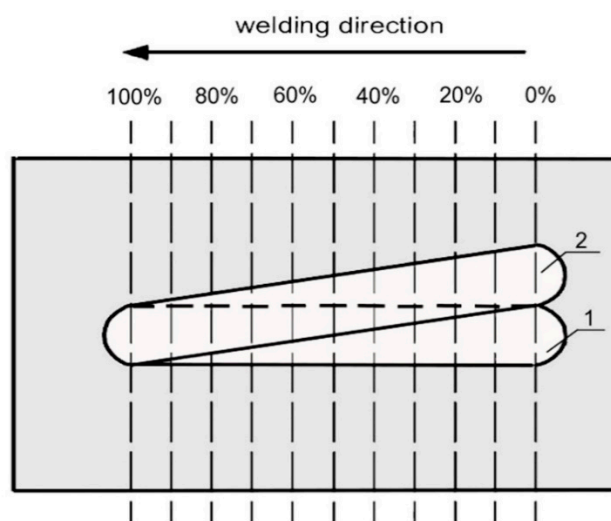
Figure 1. Scheme of the temper bead welding (TBW) technique specimen, 1—first (tempered) padding weld, 2—second (tempering) padding weld.

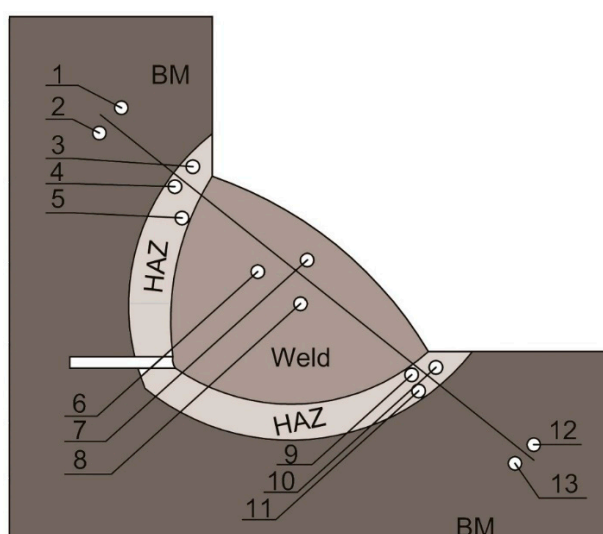
**Figure 2.** Hardness point distribution in the CTS specimens.

The hardness measurement scheme for CTS testing is presented in Figure 2. Figure 3 shows the regions of the TBW specimens in which the hardness was measured. The hardness measurements in the first padding weld of the normalization area of HAZ (HAZN) and the overheated area of the HAZ (HAZO) were located in the HAZ at the axis of the first bead.

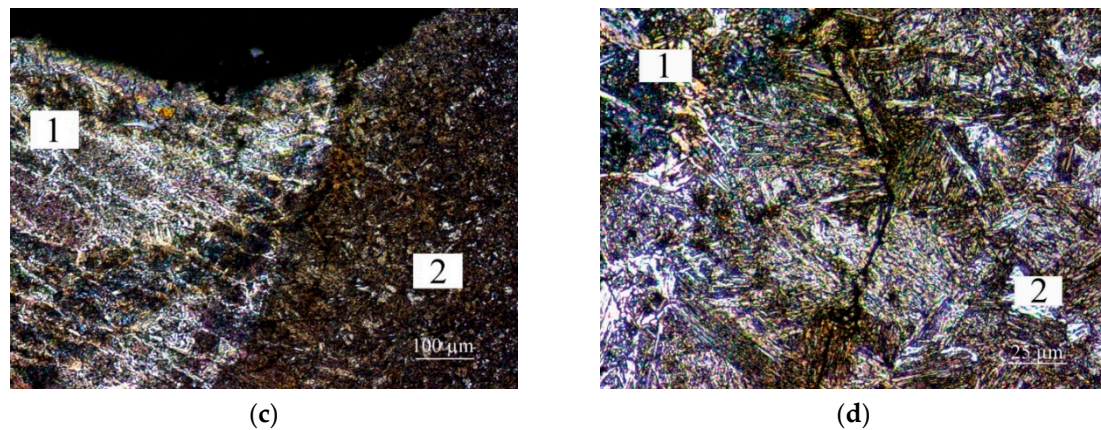
Figure 4. Cont.

Figure 4. Results of CTS microscopic testing shows cracks in HAZ, 1—weld metal, 2—HAZ, (a) Specimen 1; (b) Specimen 2; (c) Specimen 3; (d) Specimen 6. Etch. Nital 4%.

After non-destructive testing, second welds from specimens 1, 2, 5 and 6 were rejected from further examinations due to significant imperfections. The remaining welds were capable of undergoing further examinations. In the HAZ of each specimen, acicular and martensitic structures were found, which are a result of rapid cooling during welding in the water. The short cooling time also caused high residual stresses and limited the extraction of diffusible hydrogen in the welding environment. The weld metal structure was built of dendrites. The results of the microscopic examination of CTS specimens are presented in Figure 4. During macroscopic testing, cracks in the HAZ of the two specimens (the first weld in specimen 4 and specimen 6) and in weld of one specimen (first weld in specimen 4) were observed. The cracks in the HAZ were initiated in the weld root and propagated along approximately 50% of the length of the fusion line. This area was characterized by an overheated, coarse grain, martensitic structure as is shown in Figure 4a,b. The cracks were observed in the welded joints that were made with the lowest value of heat input (ql). Microscopic examination of S460ML steel showed that cracks occurred in all joints welded in the water environment. These cracks were located in the HAZ, along the fusion line. It was estimated that the total length of these cracks were 30%–40% of the total length of the fusion line. Cracks in the weld also were revealed.

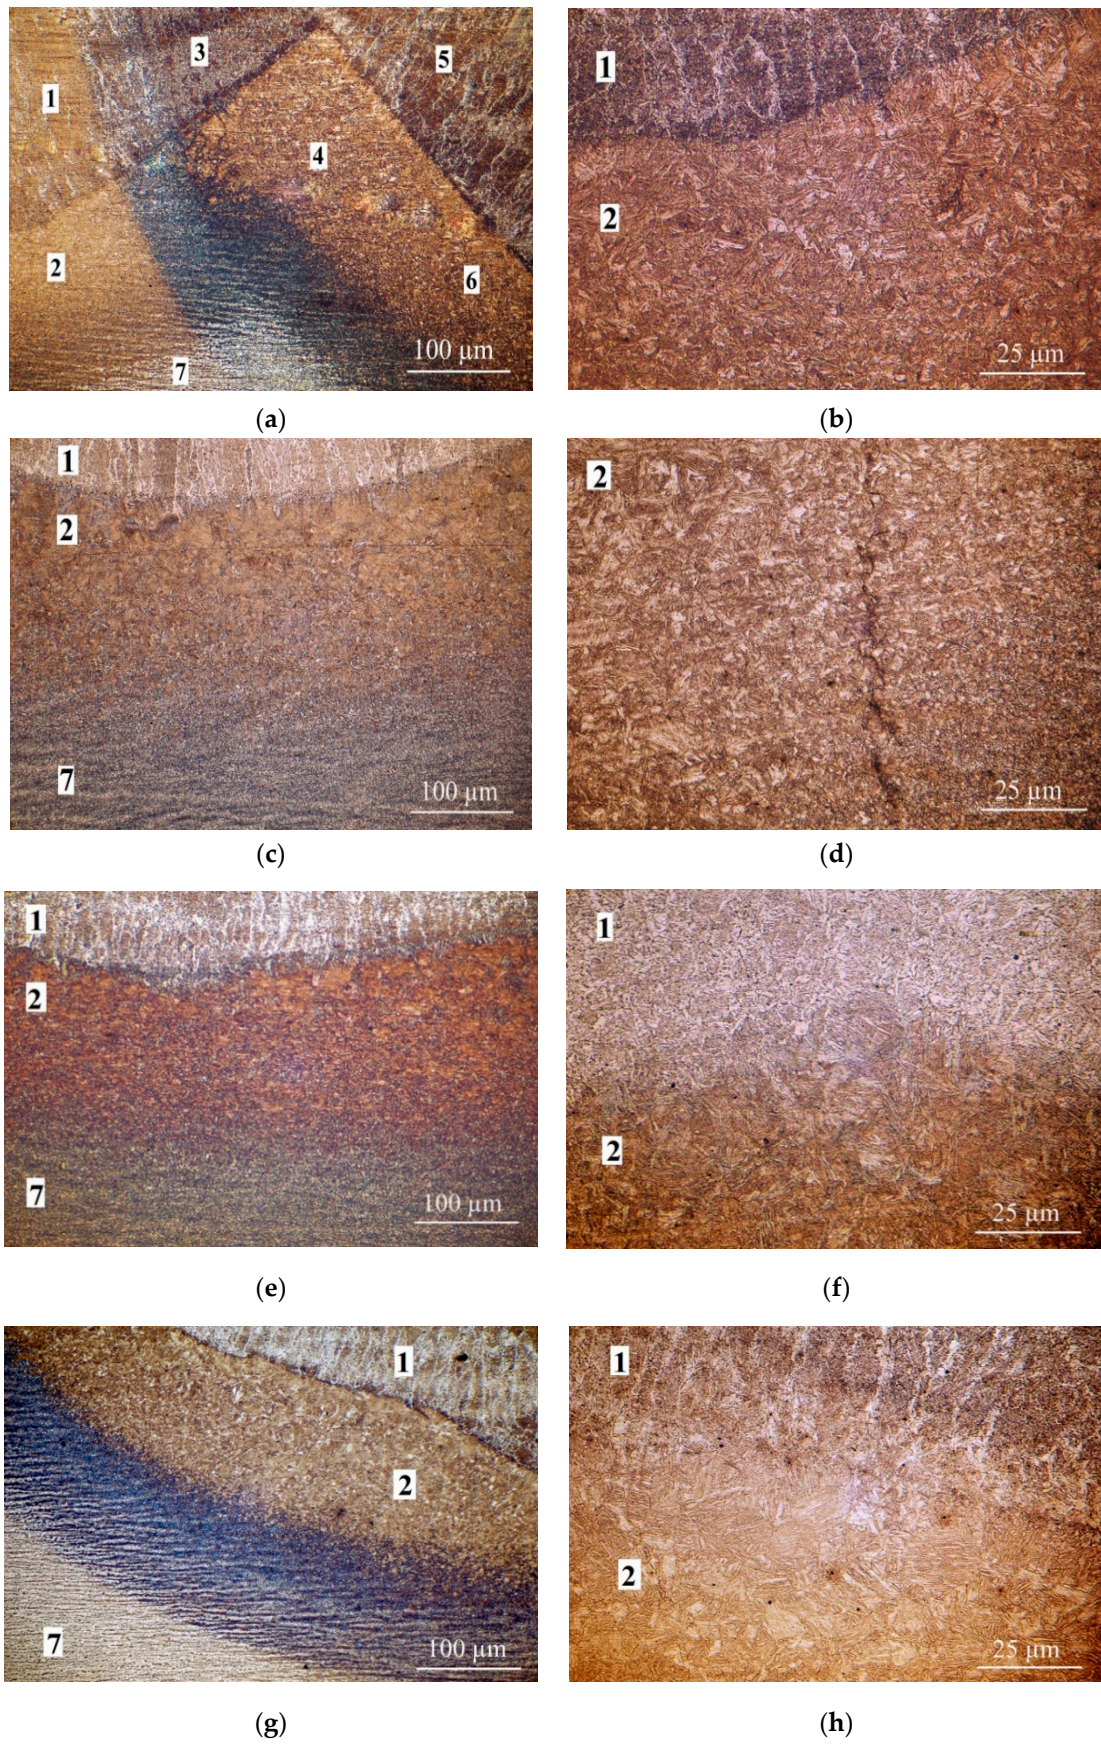
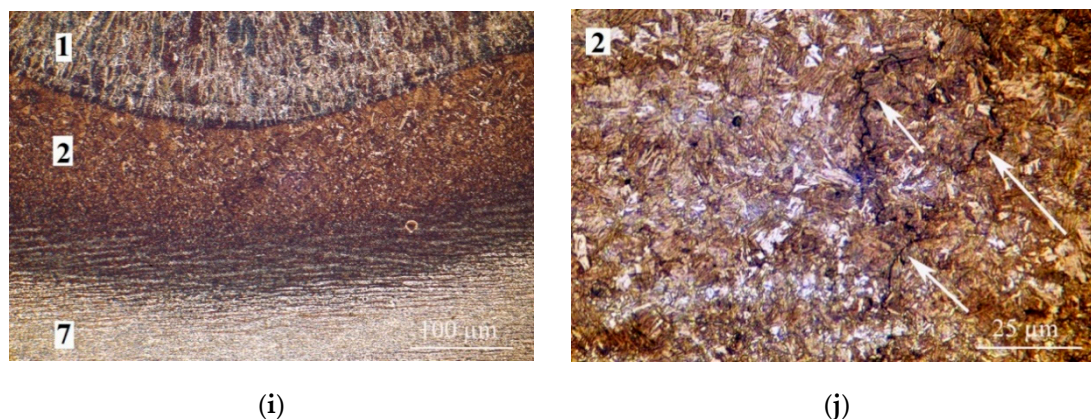
Figure 6. Cont.

Figure 6. Results of TBW microscopic testing; 1—first bead, 2—HAZ under first bead, 3—area of the HAZ of the second bead overlapping the first bead, 4—HAZ of the second bead overlapping the HAZ of the first bead, 5—second bead, 6—HAZ under the second bead, 7—base metal. (a,b) pitch 11%; (c,d) pitch 43%; (e,f) pitch 55%; (g,h) pitch 73%; (i,j) pitch 100%. Etch. Nital 4%.

The results of the microscopic testing are presented in Figure 6. The welds in each of these specimens showed dendritic structures (Figure 6a, area 1). There was bright, fine-grained ferrite arranged in columns, from which grew acicular ferrite at the boundaries of the dendrites. Inside the dendrites there were fine ferrite grains. The structure of the HAZ was different. Near the fusion line, there were expanded quasiperlite grains with a structure following the Widmannstätten system (e.g., Figure 6b,c, area 2). The structure of this zone also indicated the presence of bainitic hardening structures and low-carbon martensite (Figure 6d). In the areas located the furthest distance from the fusion line, there were normalization structures with fine ferrite and pearlite. In all specimens, changes due to the tempering bead were observed. With the highest value of the pitch between two beads, there was a partial disappearance of the structure of the dendritic base bead and the formation of a ferritic fine-grained structure (e.g., Figure 6e,f, area 1). In the HAZ, the heat of the tempering beads refined and tempered the coarse-grained zone of the first bead (Figure 6g). When the pitch increased, the grain size decreased. TBW provided local heat treatment of the joints. The maximum hardness values for wet welding appeared in the coarse grained HAZ [37]. The grain size decreased during TBW (Figure 6h,i, compare with Figure 6a–d), which led to a reduction of hardness in the HAZ. The pitch increased and the number of cracks decreased. However, TBW could not repair the microcracks that occurred during the welding of the first bead and could even propagate these cracks (Figure 6j). Cold cracks can occur up to 48 h after welding is completed. TBW was used in the 120 s after first bead was laid, thus this technique reduced the probability of the occurrence of these cracks.
