Article

# Advantages of the Application of the Temper Bead Welding Technique During Wet Welding

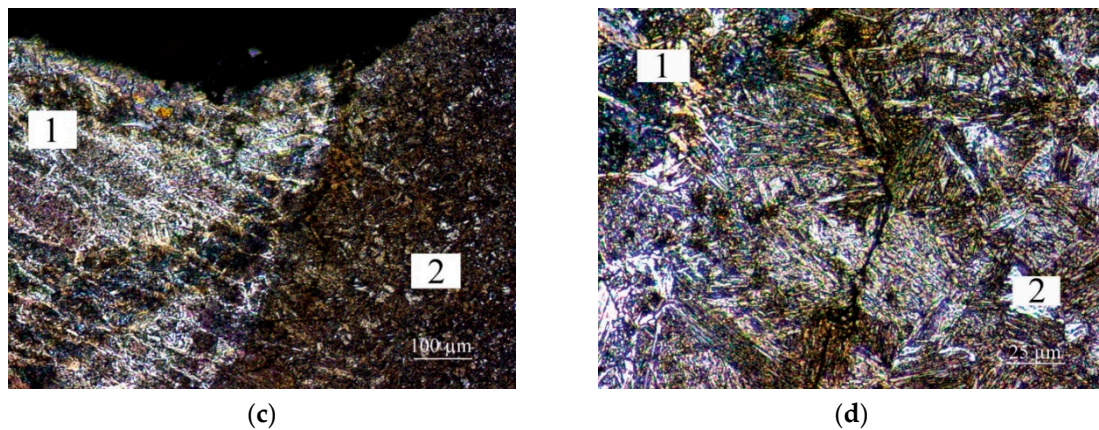
**Figure 4.** Results of CTS microscopic testing shows cracks in HAZ, 1—weld metal, 2—HAZ, (a) Specimen 1; (b) Specimen 2; (c) Specimen 3; (d) Specimen 6. Etch. Nital 4%.

After non-destructive testing, second welds from specimens 1, 2, 5 and 6 were rejected from further examinations due to significant imperfections. The remaining welds were capable of undergoing further examinations. In the HAZ of each specimen, acicular and martensitic structures were found, which are a result of rapid cooling during welding in the water. The short cooling time also caused high residual stresses and limited the extraction of diffusible hydrogen in the welding environment. The weld metal structure was built of dendrites. The results of the microscopic examination of CTS specimens are presented in Figure 4. During macroscopic testing, cracks in the HAZ of the two specimens (the first weld in specimen 4 and specimen 6) and in weld of one specimen (first weld in specimen 4) were observed. The cracks in the HAZ were initiated in the weld root and propagated along approximately 50% of the length of the fusion line. This area was characterized by an overheated, coarse grain, martensitic structure as is shown in Figure 4a,b. The cracks were observed in the welded joints that were made with the lowest value of heat input ( $ql$ ). Microscopic examination of S460ML steel showed that cracks occurred in all joints welded in the water environment. These cracks were located in the HAZ, along the fusion line. It was estimated that the total length of these cracks were 30%–40% of the total length of the fusion line. Cracks in the weld also were revealed.

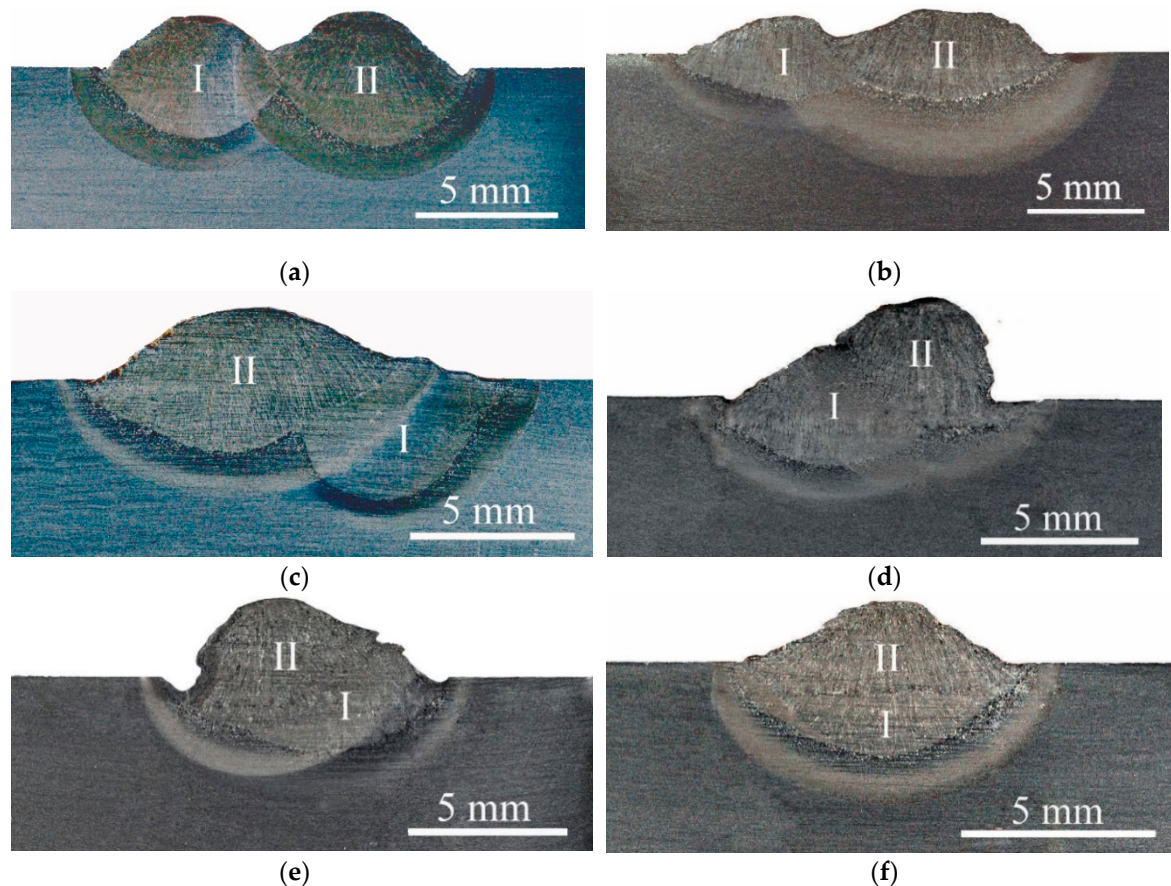
**Figure 5.** Results of the TBW macroscopic testing, I—first (tempered) bead, II—second (tempering) bead, (a) pitch 11%; (b) pitch 19%; (c) pitch 43%; (d) pitch 55%; (e) pitch 73%; (f) pitch 100%. Etch. Nital 4%.

In the first step of the examination, macroscopic tests were performed. The main aim of these examinations was to calculate the pitch between the two beads. After the macroscopic testing of specimens with a pitch of; 11%, 19%, 43%, 55%, 73%, and 100%, were selected for the next examinations. There were no cracks in these specimens. The results of the macroscopic testing are presented in Figure 5.

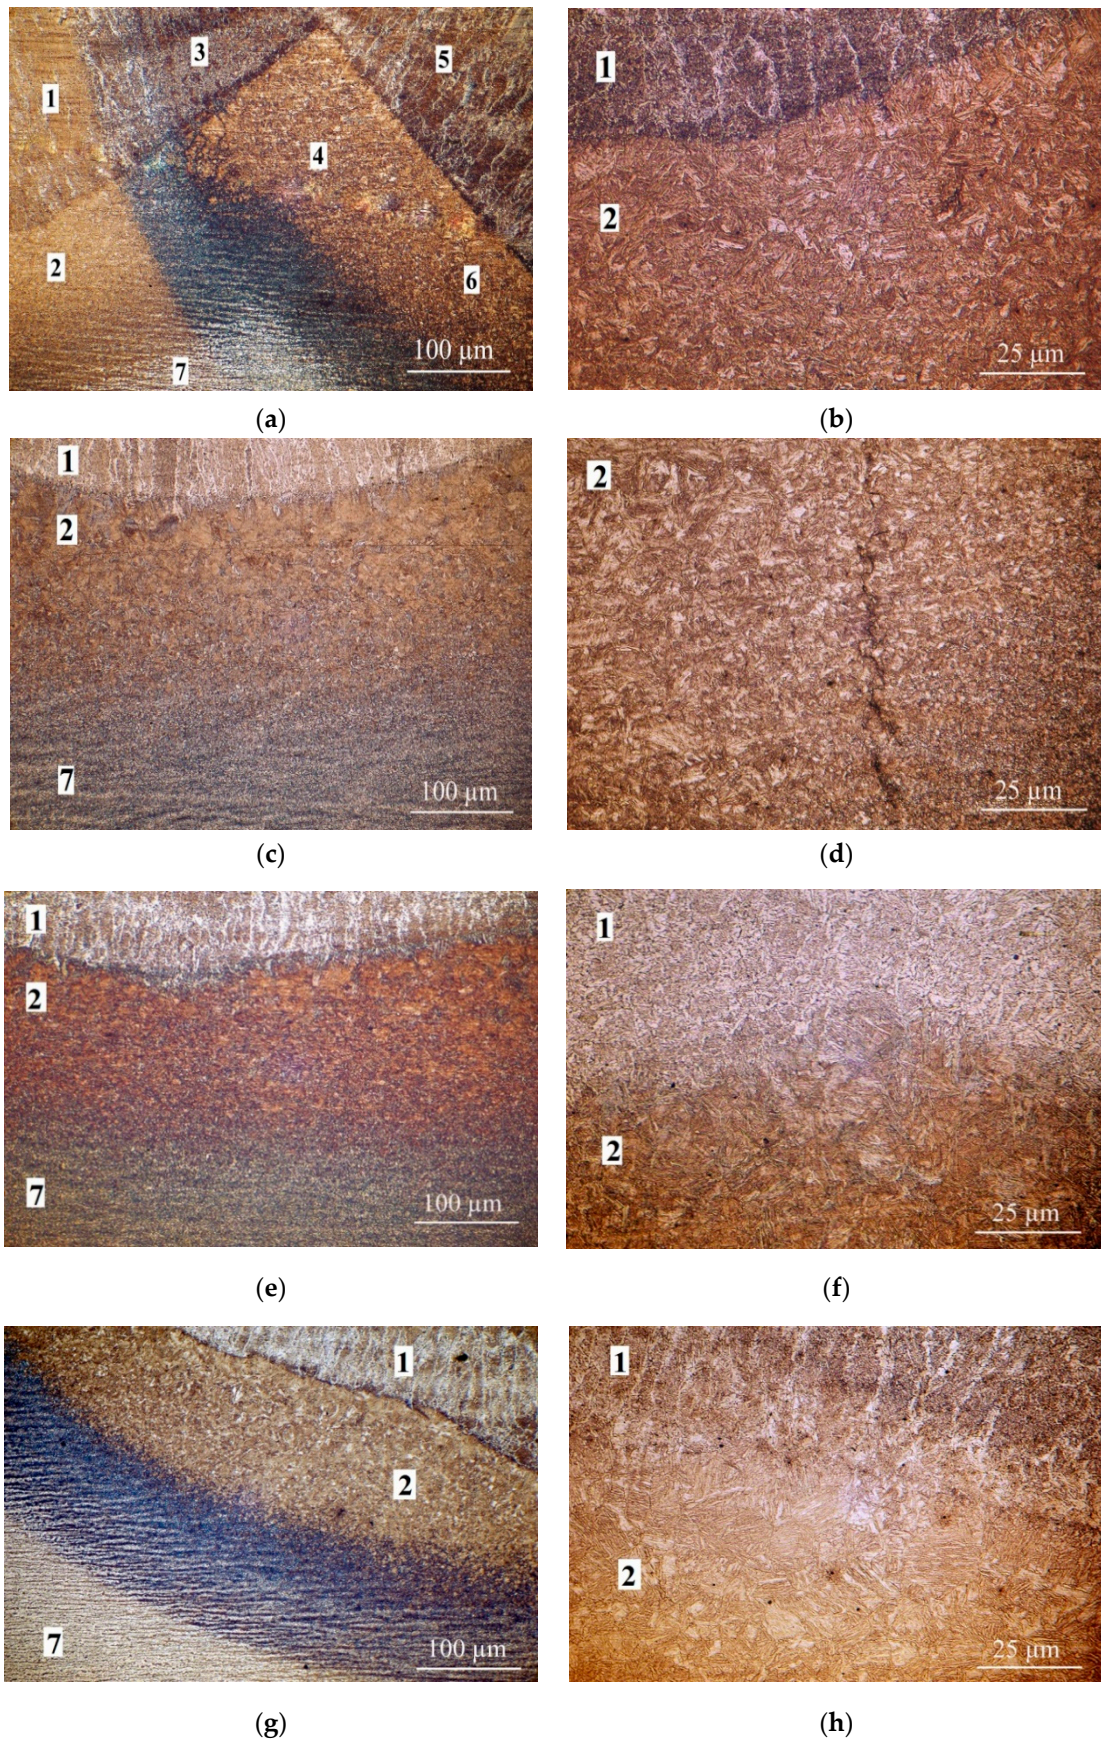
**Figure 6.** Results of TBW microscopic testing; 1—first bead, 2—HAZ under first bead, 3—area of the HAZ of the second bead overlapping the first bead, 4—HAZ of the second bead overlapping the HAZ of the first bead, 5—second bead, 6—HAZ under the second bead, 7—base metal. (a,b) pitch 11%; (c,d) pitch 43%; (e,f) pitch 55%; (g,h) pitch 73%; (i,j) pitch 100%. Etch. Nital 4%.

The results of the microscopic testing are presented in Figure 6. The welds in each of these specimens showed dendritic structures (Figure 6a, area 1). There was bright, fine-grained ferrite arranged in columns, from which grew acicular ferrite at the boundaries of the dendrites. Inside the dendrites there were fine ferrite grains. The structure of the HAZ was different. Near the fusion line, there were expanded quasiperlite grains with a structure following the Widmannstätten system (e.g., Figure 6b,c, area 2). The structure of this zone also indicated the presence of bainitic hardening structures and low-carbon martensite (Figure 6d). In the areas located the furthest distance from the fusion line, there were normalization structures with fine ferrite and pearlite. In all specimens, changes due to the tempering bead were observed. With the highest value of the pitch between two beads, there was a partial disappearance of the structure of the dendritic base bead and the formation of a ferritic fine-grained structure (e.g., Figure 6e,f, area 1). In the HAZ, the heat of the tempering beads refined and tempered the coarse-grained zone of the first bead (Figure 6g). When the pitch increased, the grain size decreased. TBW provided local heat treatment of the joints. The maximum hardness values for wet welding appeared in the coarse grained HAZ [37]. The grain size decreased during TBW (Figure 6h,i, compare with Figure 6a–d), which led to a reduction of hardness in the HAZ. The pitch increased and the number of cracks decreased. However, TBW could not repair the microcracks that occurred during the welding of the first bead and could even propagate these cracks (Figure 6j). Cold cracks can occur up to 48 h after welding is completed. TBW was used in the 120 s after first bead was laid, thus this technique reduced the probability of the occurrence of these cracks.
