# HYDRAULIC ANALYSIS OF CAUSES OF WASHOUT OF GDYNIA-ORŁOWO SEA-SHORE DURING THE FLOOD IN THE KACZA RIVER ESTUARY

Michał Szydłowski

Gdańsk University of Technology, Faculty of Civil and Environmental Engineering, Poland

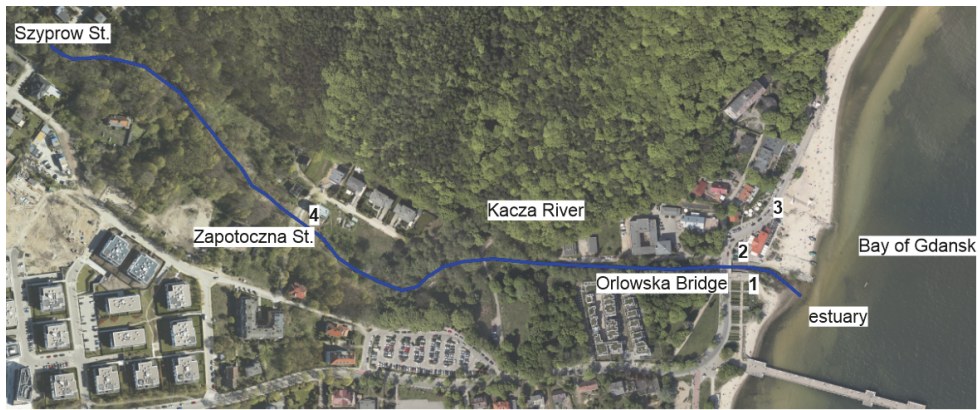
Fig. 1. The Kacza river estuary section with enumeration of flood- damaged places shown in Fig. 2. ( image prepared by these authors on the basis of an orthophotomap from geodesic resources of Gdynia city, Gdynia Municipal Council licence No. PND.6642.1.1697.2018\_2262\_N, without scale)

Gdynia area and how big values of water flow rate in the river were as there is no control over the Kacza river catchment basin. However, it is probable that summary rainfall height could be similar to that measured in the same time at the station Gdańsk Oliwa (170,2 mm) and Gdańsk Osowa (161,9 mm) [5]. The so high daily rainfall amount was a direct cause that the Kacza river overflowed its banks in many sections of its full length. The freshet wave propagation resulted in the damaging of many infrastructure objects located along the river's valley. The estuary section of the river suffered most, especially the sea- shore belt together with the beach close to the Orłowo pedestrian pier at the river's estuary (Fig. 1), which appeared to be washed out along a significant length.

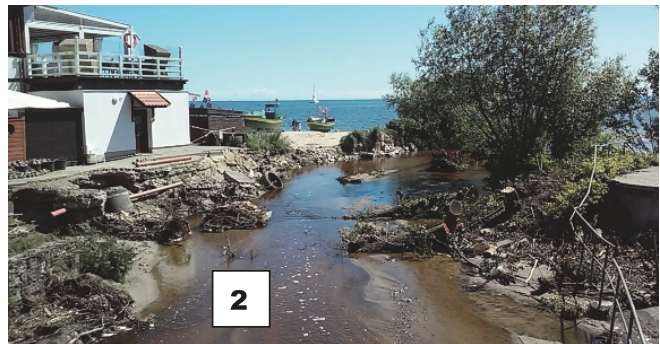
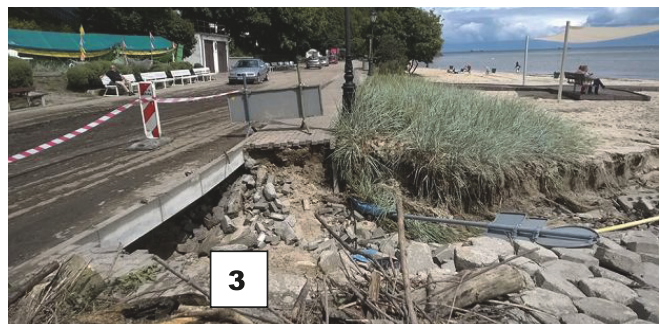
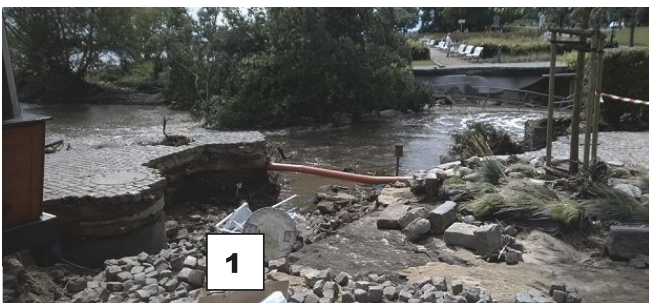
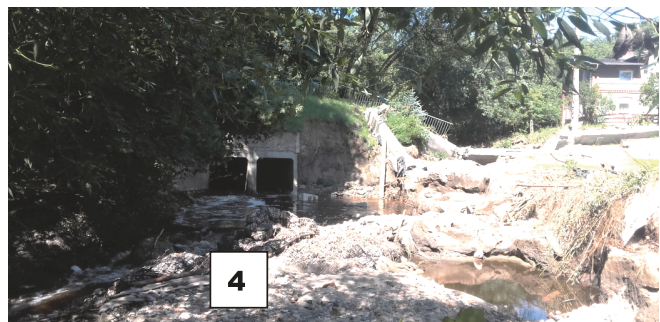
On the analyzed estuary section of the river (covering 800 m length from the Gdansk Bay coast) the greatest damages and losses were associated with heavy washout of banks and bed of the river and its valley beneath Szyprów street, water damming up and breaking the road embankment along Zapotoczna street, flooding the areas adjacent to the river –bed before the Orłowska street bridge as well as washout of the sea-shore belt together with the beach and touristic infrastructure below the bridge in Orłowska street. The photographs showing example damages resulting from the freshet run-off along the Kacza river estuary section are presented in Fig. 2.

Fig. 2. Damages in the Kacza river estuary area in Gdynia Orłowo as a result of the freshet in July 2016 (photos No. 1, 2, 3 – washout of sea-shore belt below Orłowska street bridge, photo No. 4 - breach in road embankment of Zapotoczna street. Location of subsequent shots – see Fig. 1. ( acc. this author's archive)

During the flood of July 2016, as a result of blocking the culvert outlet by floating trees, branches and bed load, the river valley above the embankment of the Zapotoczna street filled in with water and after exceeding the top of the embankment (abt. 4 m above the river bed) suffered a washout resulting in an uncontrolled water run-off to the river bed.

3. The blockage of the culvert inlet by floating broken wood waste, as indicated by eye-witnesses of the damage, should be deemed the direct cause of forming the breach in the Zapotoczna street embankment, that was confirmed by the calculations in variant 2. Simultaneously, as the numerical simulations proved, the increased water run-off after breaking the Zapotoczna street embankment could not cause the water flowing over the Orłowska street bridge, and thus could not prevent to a large extent against occurrence of the washout of sea-shore belt and beach.

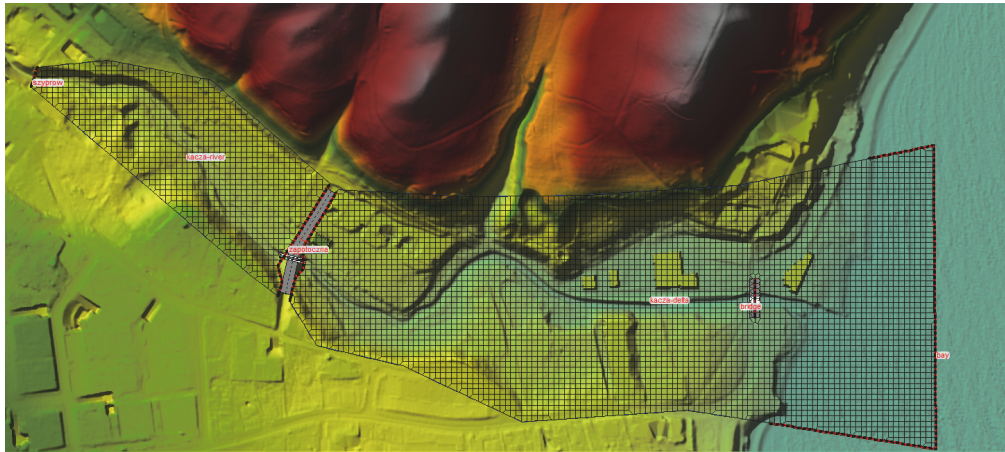
Fig. 3. The numerical model of the considered terrain around Kacza river (GMC licence No. PND.6642.1.1697.2018\_2262\_N) as well as the calculation area boundaries together with hydraulic engineering objects and sites where boundary conditions were set.

In the numerical model of the river there was represented also the hydraulic engineering infrastructure located in the river bed, which determines freshet flow course through the considered river fragment. Beneath Szyprów street two important engineering objects are situated – the culvert in the road embankment of Zapotoczna street and the bridge in the line of Orłowska street. The culvert in question is fitted with two square channels of  $1,5 \text{ m} \times 1,5 \text{ m}$  each whose bottom from the outlet side is placed on the ordinate of  $6,10 \text{ m}$  above sea level. Simultaneously the road embankment crossing the entire river valley has the lowest ordinate of its crown located  $10,0 \text{ m}$  above sea level. Such situation results in that when the

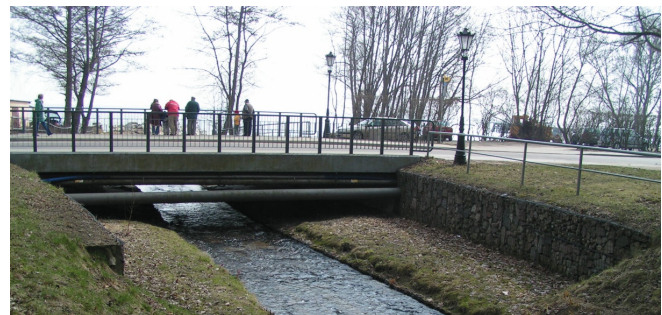
Fig. 4. The bridge over Kacza river in line of Orłowska street in Gdynia (a photo from this author's archive),

The second object (the bridge in line of Orłowska street) is built in the form of a reinforced concrete plate supported only on its heads (lack of abutments). Its breadth amounts to  $11,0 \text{ m}$  and the height to  $1,5 \text{ m}$ . The upper ordinate of the plate is close to that of the surrounding terrain. Below the bridge there are located pipelines which obstruct a significant part of the free cross-section area under the bridge from the side of inlet. (Fig. 4).

As results from the calculations, a factor of a decisive impact on the excessive damming-up of the water and its breaking through Orłowska street was the reduction in the free cross-section area under the bridge resulting from the installation of the pipelines across the river bed (Fig.4). The fact of taking into account the reduction of the free cross-section under the bridge during

4. The reduction in the cross-section of flow passage area under the bridge due to the engineering infrastructure (pipelines) installed across the river valley above the bridge, proved by the calculations in variant 3, should be taken as the direct cause of the excessive water damming-up before the Orłowska street bridge and consequently the water overflowing above it towards the beach. Only the cumulated effect of the natural rainfall freshet, the breach in the Zapotoczna street embankment and the reduced cross-section of flow passage area under the bridge caused that the ordinate of Orłowska street was exceeded which in consequence triggered the water flowing down the reinforcements of sea shore and beach toward the sea, which resulted in their damage.

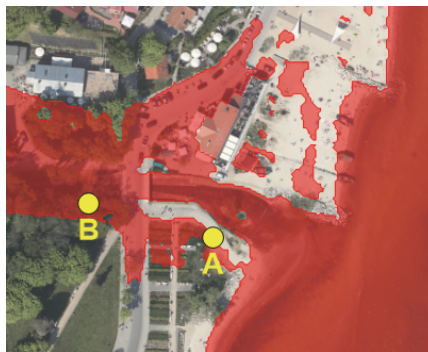
Fig. 6. Maximum depths [m] and range of flooded area in the region of Kacza river estuary and Gdynia- Orłowo beach together with depicted measurement points of maximum water level ordinates after the flood in July 2016 (A, B) (images prepared by this author on the basis of orthophotomap from municipal geodesic resources of Gdynia, Gdynia Municipal Council licence No. PND.6642.1.1697.2018\_2262\_N, without scale)

The differences in the calculated range of flooded area near the Orłowska street bridge and the beach are shown for particular simulation variants in Fig. 6. As can be seen, in successive variants the flooded area range increases and the zones of potential washing -out the sea shore belt and beach spread. Worth mentioning, that the flooded areas indicated in the last graph of Fig. 6 correspond to the location of the washout areas observed after the flood, shown in Fig. 1 (No. 1, 2 and 3). Simultaneously, neither in variant 1 nor 2 the flow streams north from the visible building and those on the southern side over the right bank of the river close to its estuary, were reproduced. This way the hypothesis has been proved on the decisive role of the reduced flow passage capacity of the cross-section under the Orłowska street bridge in forming the freshet run-off in the area of Kacza river estuary and its impact on the flood damages resulting in the washout of the sea-shore belt in Gdynia –Orłowo .

Comparing particular variants one can observe distinct differences in maximum values of the freshet wave hydraulic parameters. First of all values of the culmination flow resulting from the damage in the road embankment of Zapotoczna street (variant 2 and 3) are, below the damaged object, significantly greater (by almost 7.5 m<sup>3</sup>/s) than the crest of the wave running through the intact object (variant 1). The maximum flows increased as a result of the damage are also observed in the river estuary above Orłowska street. However in variant 3 where the limited flow passage capacity under the bridge is taken into account the reduction of freshet wave culmination is greater due to the greater water damming-up before the bridge and the greater water retention in the flooded areas in the river valley. In the valley cross-section before Orłowska street the damage of the road embankment results, in case of the full water flow cross-section under the bridge (variant 2), in the water damming up to the ordinate of 2.80 m above sea level, that is greater by almost 0.3 m than that resulting from the simulation without taking into account the object's damage (variant 1), but still not exceeding the bridge plate top ordinate of 2.95 m above sea level and that of the adjacent terrain. This results in a lack of water flow over the road toward the beach. It means that the freshet wave itself and the forming of the breach could not be the only cause of the observed washout in the river estuary area.

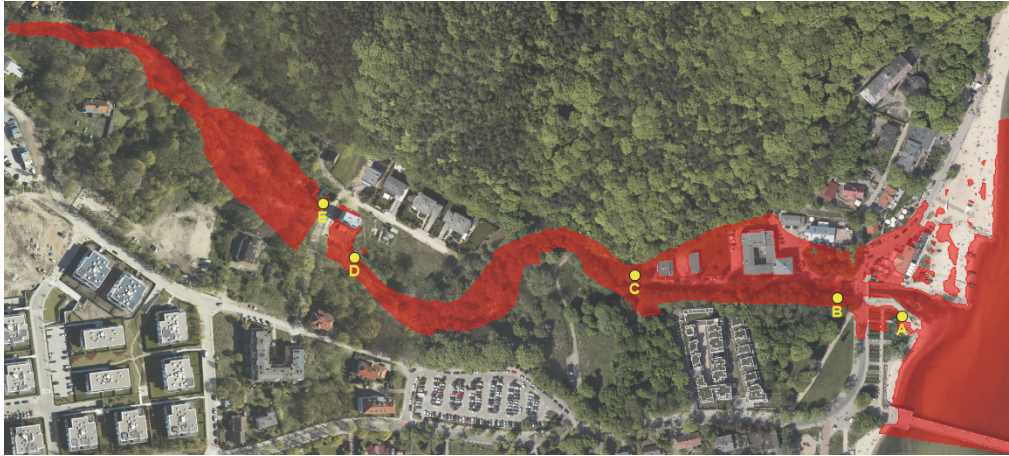
Fig. 7. Maximum range of flooded area along the whole analyzed section of Kacza river in variant 3 together with depicted measurement points (A, B, C, D, E) of maximum water level ordinates after the flood in July 2016 (image prepared by this author on the basis of orthophotomap from municipal geodesic resources of Gdynia, Gdynia Municipal Council licence No. PND.6642.1.1697.2018\_2262\_N, without scale)

In order to quantitatively verify the numerical simulation results as well as simultaneously evaluate the model, a comparison was made between the calculated maximum water level ordinates and the geodesic-measured ordinates of maximum water level in the valley after the flood in July 2016. The measurements were conducted by a team of Gdansk University of Technology during its on-site visit [9]. The points where the measurements were taken are denoted by letters A through E in Fig. 6 and 7. Point A is placed beneath Orłowska street on the right side of the river away its main bed ; point B is placed above the Orłowska street bridge on the right flooding area of the river ; point C is situated on the left side of the river directly at its main bed; point D lays directly below the road embankment of Zapotoczna street; point E is placed above the road embankment. The common list of measurement and calculation results is given in Tab. 2.

Comparing the particular variants, one is able to find differences between the measured and calculated values as well as between the simulation results themselves. Starting the analysis from the upper run of the analyzed section of the river one can observe that in variant 1 where the simulation of blocking the culvert in the Zapotoczna street embankment (point E) is omitted, water run-off over the embankment top (10.0 m above sea level ) does not occur and no washout of its body happens. Such situation was reproduced in variants 2 and 3 where the calculated maximum water level ordinate is close to that observed. The difference between variant 1 and variant 2 and 3 can be also seen directly below the embankment (point D). In this place where occurrence of the breach in the embankment is not reproduced in the calculations (variant 1) the calculated value of water level ordinate is underestimated by 0.3 m in comparison to that measured. After taking into account the damage (variant 2 and 3) the difference decreases to 0.04 m in both the cases, that reflects well on correctness of reproduction of real situation by these simulations. The situation in the middle part of the analyzed section (point C) turned out to be similar. Here the simulation result of maximum water level ordinate in variant 1 is also underestimated by 0.12 m against that measured, whereas the taking into account presence of the breach gives

the same results in variant 2 and 3, however greater than that measured by 0.03 m. While in the points E, D and C there were observed differences between the results from variant 1 ( without the breach ) and those from variants 2 and 3 (with the breach), in points B and A some difference additionally appears between the simulation results from variant 2 ( with the breach in the Zapotoczna street embankment and the passable cross-section area under the Orłowska street bridge) and variant 3 ( with the breach and the partly blocked cross-section passage area under the bridge). And, in point B it can be observed that, out of the three simulations, the result from variant 3 is closest to that measured, and in point A ( placed directly near the beach, below the bridge ) the flooding of this area was reproduced only in variant 3, whereas neither in variant 1 nor in variant 2 the flow over the bridge was properly reproduced. Generally, only the results achieved in the last calculation variant may be considered quantitatively close to the measurements, therefore credible, that has been the aim of validation of the model.
