# Non-Destructive Testing of a Sport Tribune under Synchronized Crowd-Induced Excitation Using Vibration Analysis

**Abstract:** This paper presents the concept of repairing the stand of a motorbike speedway stadium. The synchronized dancing of fans cheering during a meeting brought the stand into excessive resonance. The main goal of this research was to propose a method for the structural tuning of stadium stands. Non-destructive testing by vibration methods was conducted on a selected stand segment, the structure of which recurred on the remaining stadium segments. Through experiments, we determined the vibration forms throughout the stand, taking into account the dynamic impact of fans. Numerical analyses were performed on the 3-D finite element method (FEM) stadium model to identify the dynamic jump load function. The results obtained on the basis of sensitivity tests using the finite element method allowed the tuning of the stadium structure to successfully meet the requirements of the serviceability limit state.

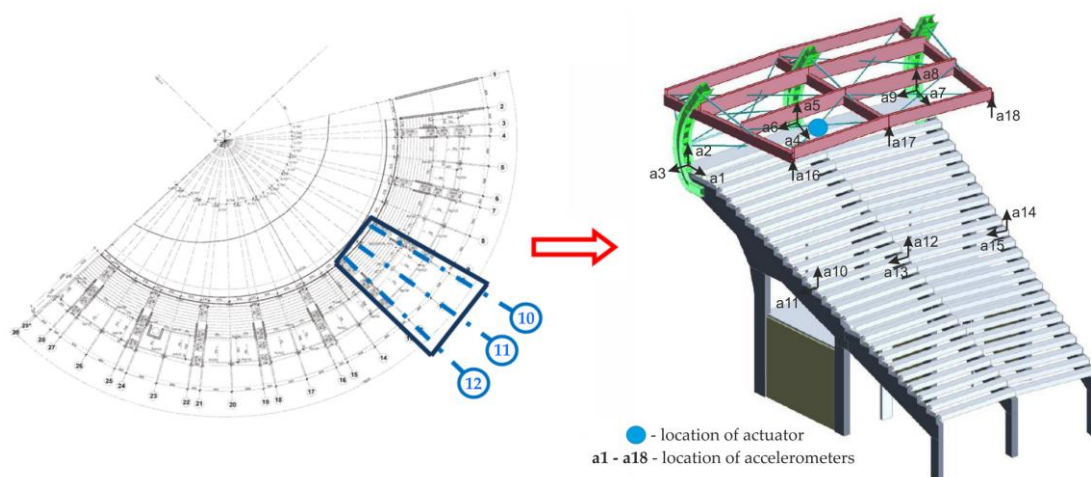
**Figure 4.** The stand section selected for field tests.

The measurements were conducted on a selected section of the stand, as shown in Figure 4. The experimental program included a sweep sine test and two types of people-induced vibrations, namely single jumps and synchronous Labado dancing.

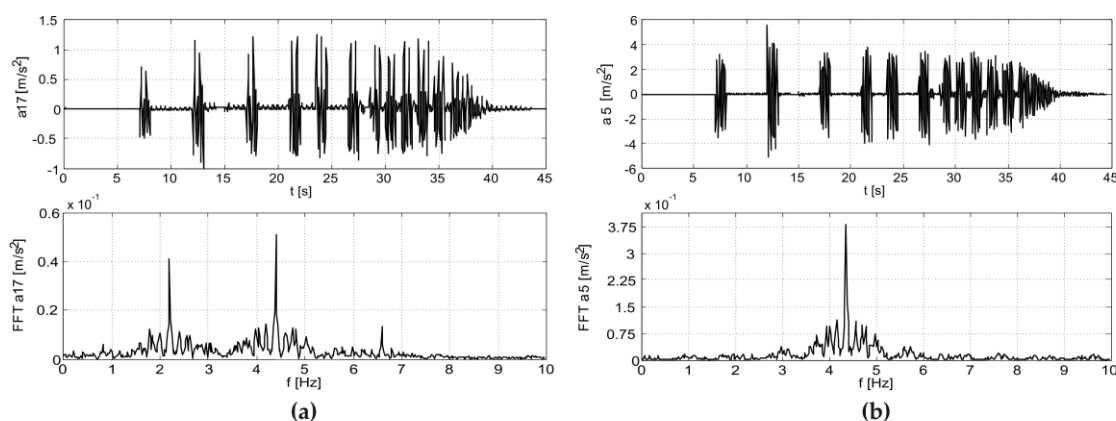
**Figure 20.** Results of numerical simulations from the excitation of vibrations by jumping fans (Scotland-type jumps): (a) girder, (b) roof.

In the further stage of the numerical analysis, the stadium structure was loaded with jumping fans. Each of the fans was replaced by a single concentrated force with a load value of 0.8 kN, as this load corresponded to the average human weight. A jump function determined during experimental research was assigned to every concentrated force. The duration time was equal to 40 s. The forces were set in the most unfavorable load combination, i.e., at the bottom of the stand (chairs on the whole BR1 beam width) and on the upper part of the stand (four rows above the cantilever section). Simulations of stand vibrations for the excitation form of non-synchronized Scotland-type jumps were carried out at the beginning (Figure 20). Afterwards, an analysis for the form of the synchronized Labado dance was performed (Figure 21).

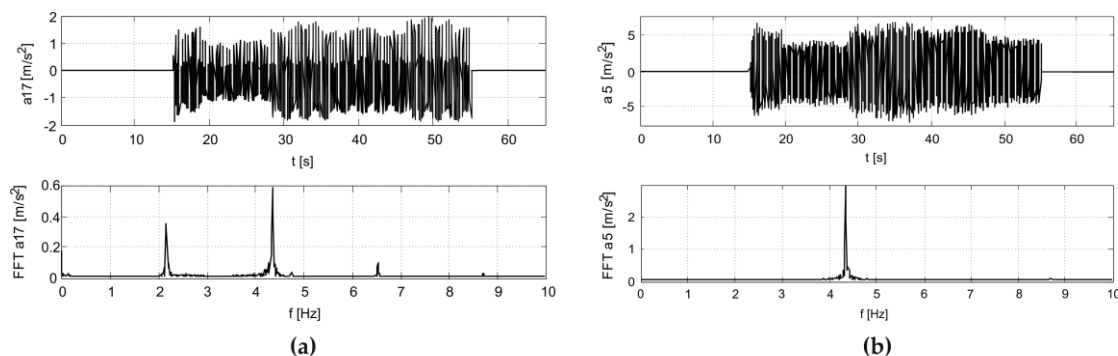
**Figure 21.** Results of numerical simulations from the excited vibrations caused by jumping fans (Labado dance): (a) girder, (b) roof.

On the basis of the results obtained during non-destructive tests and numerical simulations, it was concluded that as a result of dynamic interactions, the phenomenon of higher harmonic resonance occurred on the stand and the roof structure. The vibrations frequency at the end of the roof was equal to approximately 4.7 Hz, which coincides with the second harmonic of the excitation force, i.e., 4.4 Hz, caused by jumping fans. The form and dynamic characteristics of the Labado dance can be considered as vandalism. A large number of jumping fans with their synchronized movements drives the tribune structure's vibrations, and their regular dance could cause the collapse of the entire object. The results of non-destructive tests and numerical simulations showed a significant excess of the serviceability limit state.

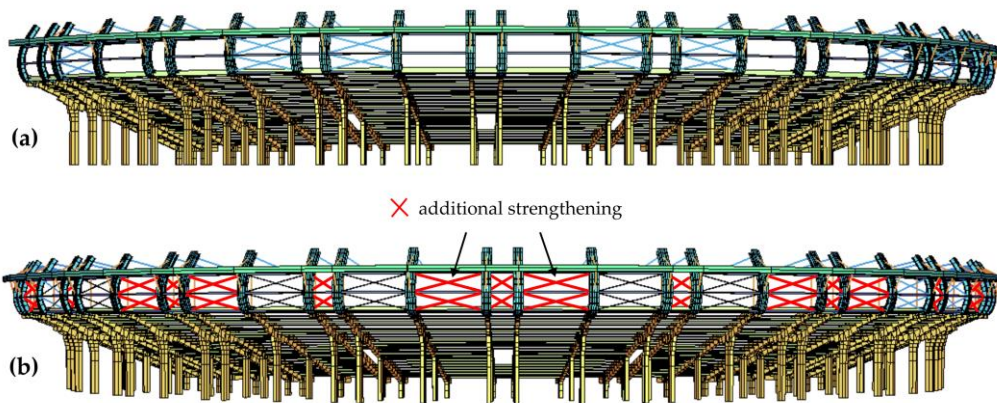
Figure 22. Additional wall bracings (a) before structural tuning, (b) after structural tuning.

An original method of stand structural tuning was proposed in response to the excess of the serviceability limit state. This method assumed the implementation of wall bracings stiffening the steel roofing columns, as well as roof bracings on the wooden roof structure (Figures 22 and 23). The main goal of the concept of bracing of all columns and roof girders was to significantly limit the free end of the wooden roof vibration amplitudes, and hence reduce the concrete cantilever displacements. The bracing cross-sections were the same as those of the bracings already installed in the stand structure. The bracings were made from Macalloy bar rods with a yield point of 520 MPa and tensile strength of 690 MPa.

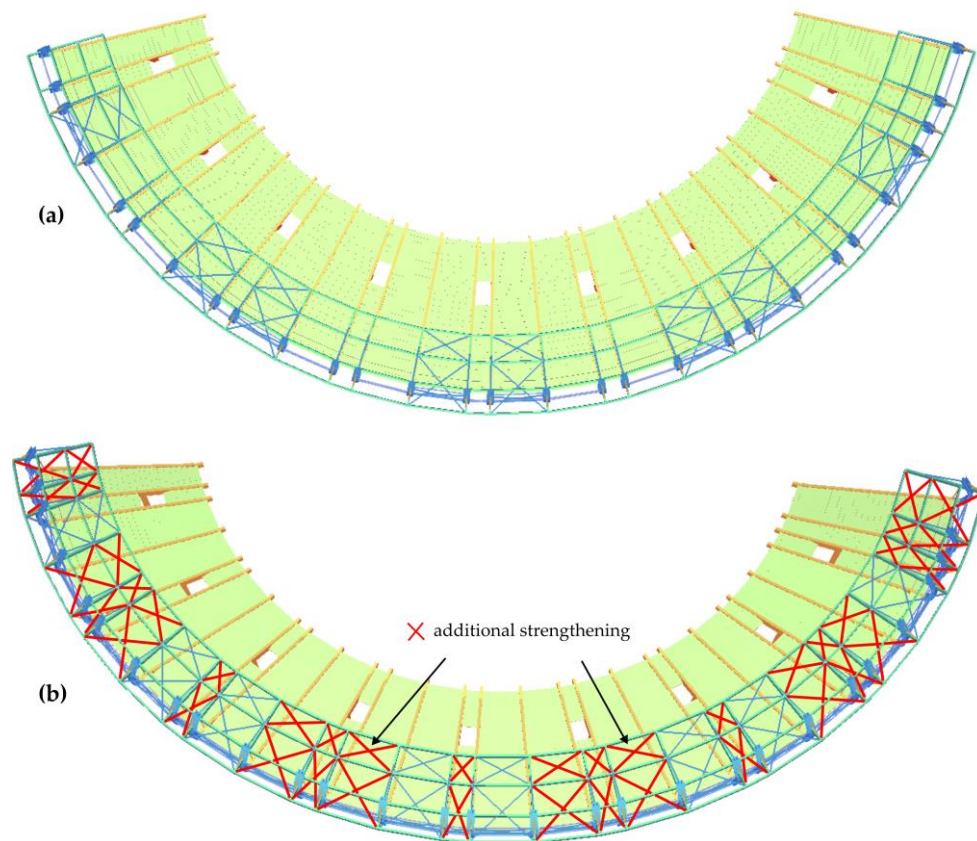
Figure 23. Additional roof bracings (a) before structural tuning, (b) after structural tuning.
