Non-Destructive Testing of a Sport Tribune under Synchronized Crowd-Induced Excitation Using Vibration Analysis

Abstract: This paper presents the concept of repairing the stand of a motorbike speedway stadium. The synchronized dancing of fans cheering during a meeting brought the stand into excessive resonance. The main goal of this research was to propose a method for the structural tuning of stadium stands. Non-destructive testing by vibration methods was conducted on a selected stand segment, the structure of which recurred on the remaining stadium segments. Through experiments, we determined the vibration forms throughout the stand, taking into account the dynamic impact of fans. Numerical analyses were performed on the 3-D finite element method (FEM) stadium model to identify the dynamic jump load function. The results obtained on the basis of sensitivity tests using the finite element method allowed the tuning of the stadium structure to successfully meet the requirements of the serviceability limit state.

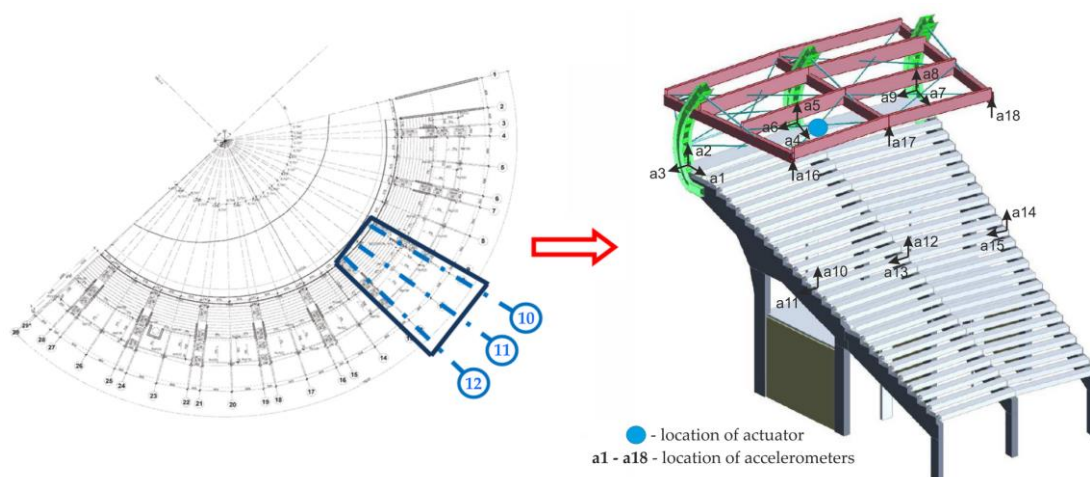
Figure 4. The stand section selected for field tests.

The measurements were conducted on a selected section of the stand, as shown in Figure 4. The experimental program included a sweep sine test and two types of people-induced vibrations, namely single jumps and synchronous Labado dancing.

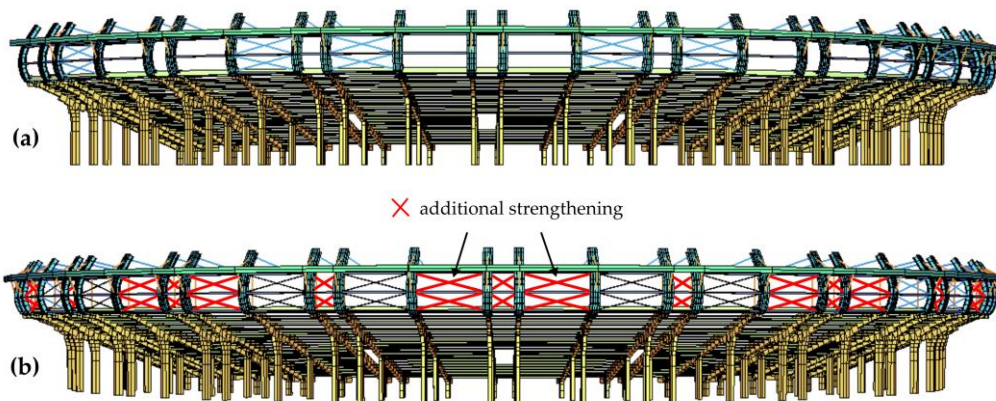
Figure 22. Additional wall bracings (a) before structural tuning, (b) after structural tuning.

An original method of stand structural tuning was proposed in response to the excess of the serviceability limit state. This method assumed the implementation of wall bracings stiffening the steel roofing columns, as well as roof bracings on the wooden roof structure (Figures 22 and 23). The main goal of the concept of bracing of all columns and roof girders was to significantly limit the free end of the wooden roof vibration amplitudes, and hence reduce the concrete cantilever displacements. The bracing cross-sections were the same as those of the bracings already installed in the stand structure. The bracings were made from Macalloy bar rods with a yield point of 520 MPa and tensile strength of 690 MPa.

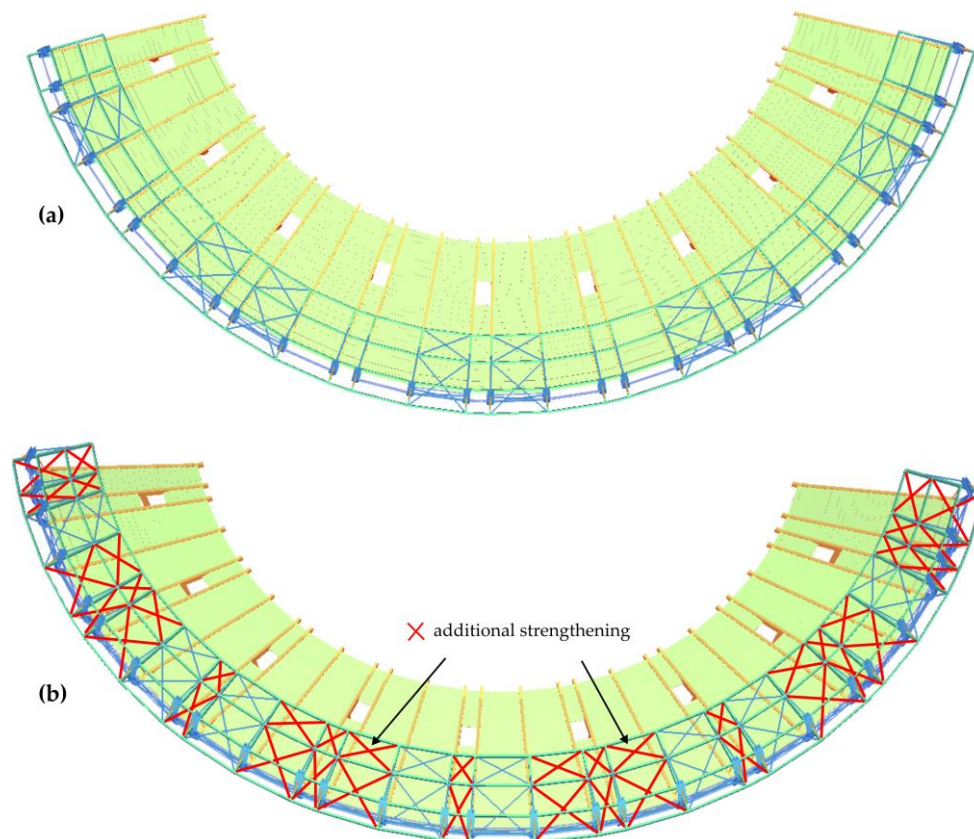
Figure 23. Additional roof bracings (a) before structural tuning, (b) after structural tuning.

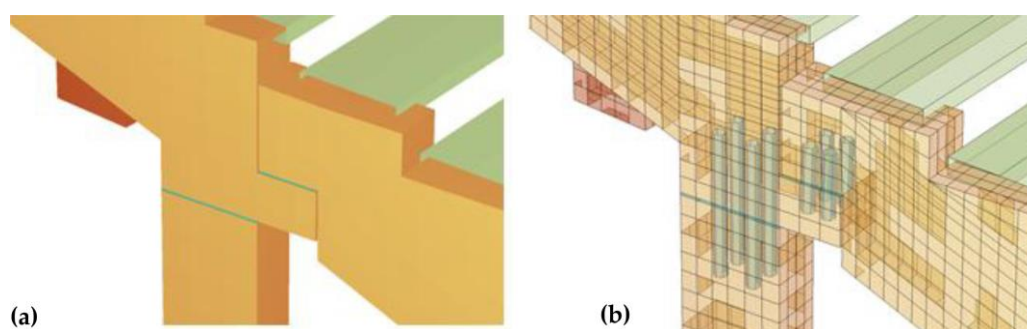
Figure 24. Detailed view of the stand's load-bearing beams: (a) support, (b) connection.

The stand FEM model with additional roof bracings and vertical bracings was implemented in SOFiSTiK software. The beam stand model was made on the basis of the object design documentation (Figure 24). The basic model parameters were determined on the basis of detailed models with the use of solid elements, in which the location of reinforcement bars and details of beams support, such as elastomer pads and anchors, were taken into account. The models include the scratching of concrete elements by reducing the value of the concrete modulus of elasticity. The FEM model parameters were updated on the basis of the obtained measurement data.

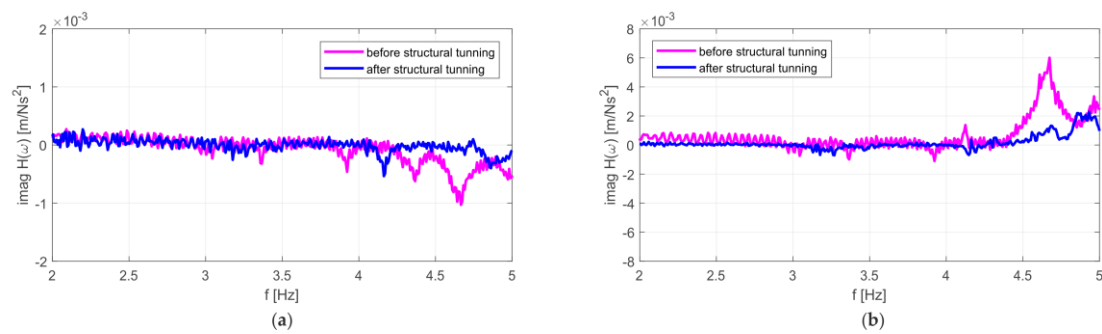
Figure 28. Experimental transition functions for the end of the concrete cantilever (a) before and (b) after stand structural tuning.

Repeated in situ tests were carried out in order to verify the correctness of the original concept of stadium stand tuning. The results of measurements made after structural tuning are shown in Figures 28 and 29. It can be seen that that frequencies identified during crowd-induced vibrations are similar to the measurements before tuning (see Figures 9 and 10), because the same nature of the jumping load. It is important, however, that the natural frequencies of the structure were shifted after structural tuning (see Figure 28), decreasing resonance significantly. The individual resonance zones moved towards the higher frequencies.
