# Stability Assessment of Coastal Cliffs Incorporating Laser Scanning Technology and a Numerical Analysis

**Abstract:** We investigated the cliff coast in Jastrzebia Gora, Poland. The measurements that were taken between 2014 and 2018 by applying terrestrial, mobile, and airborne laser scanning describe a huge geometric modification involving dislocations in a 2.5 m range. Differential maps and a volumetric change analysis made it possible to identify the most deformed cliff's location. Part of the monitoring of coastal change involved the measurement of a cliff sector in order to determine the soil mass flow down the slope. A full geometric image of the cliff was complemented by a stability assessment that incorporated numerical methods. The analysis showed that the stability coefficients, assuming a particular soil strata layout and geotechnical parameters, are unsafely close to the limit value. Moreover, the numerical computations, which were performed under simplifying assumptions, were not able to capture a multitude of other random factors that may have an impact on the soil mass stability. Thus, displacements of both reinforced soil and gabions were detected that are intend

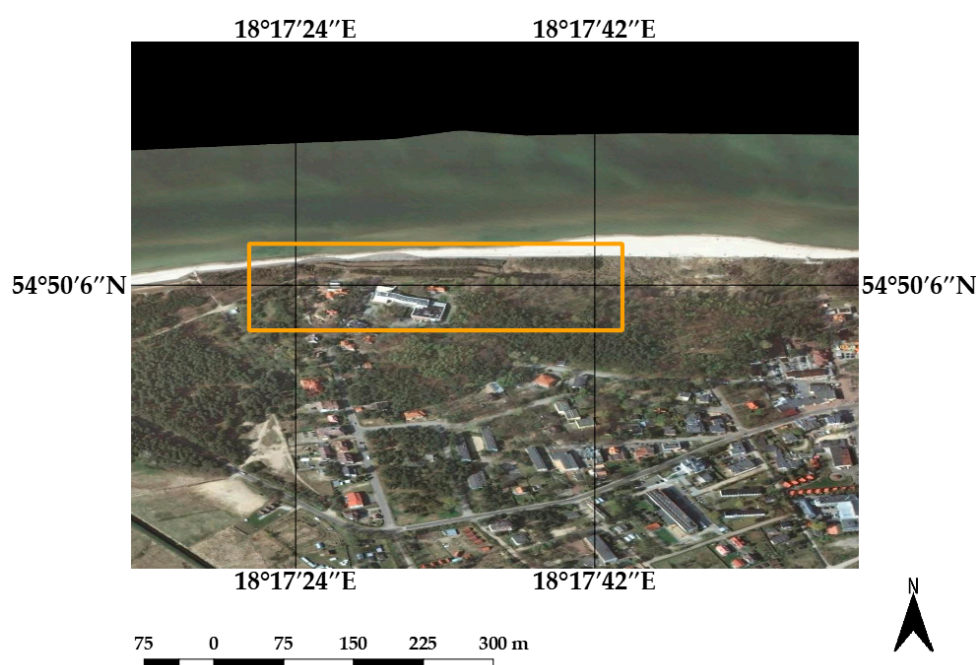
**Figure 1.** An image of the investigated area.

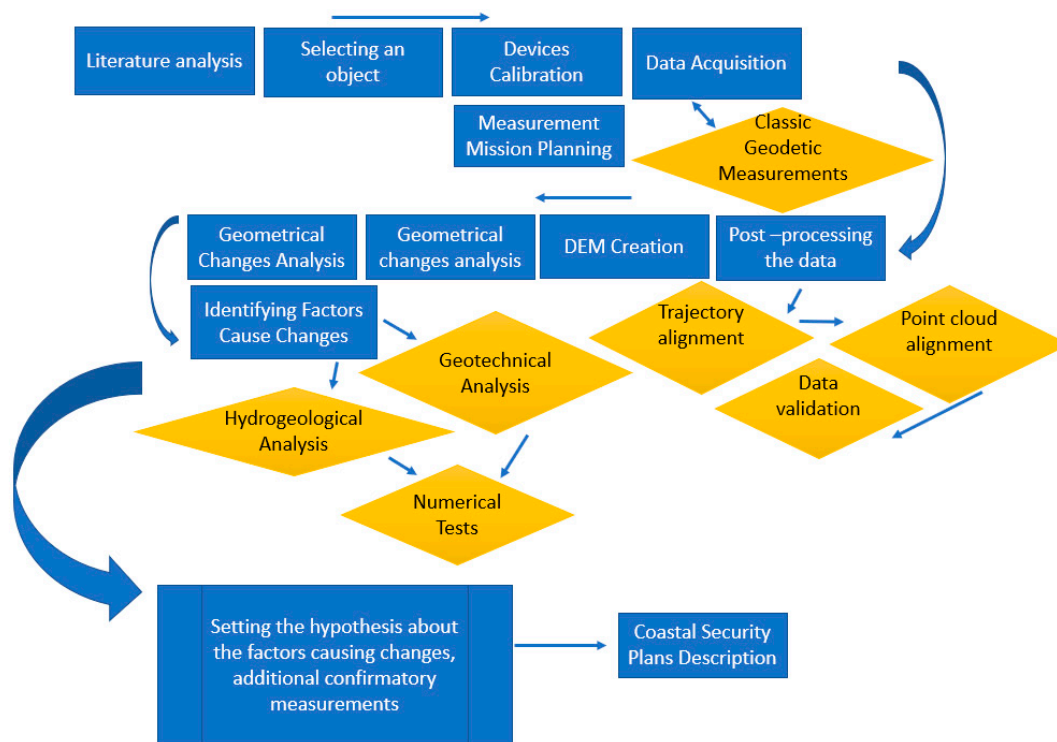
Figure 7. A flowchart of the research.

As shown in the scheme in Figure 7, we first performed a review of the state-of-the-art publications on the subject of coastal changes. Based on a prior study, we chose the investigation zone to carry out measurements and a computational solution for the accurate estimation of the displacement range and the origin. The measurement methods include classical surveying techniques that employ GNSS receivers and the Terrestrial, Mobile, and Airborne scanning systems.

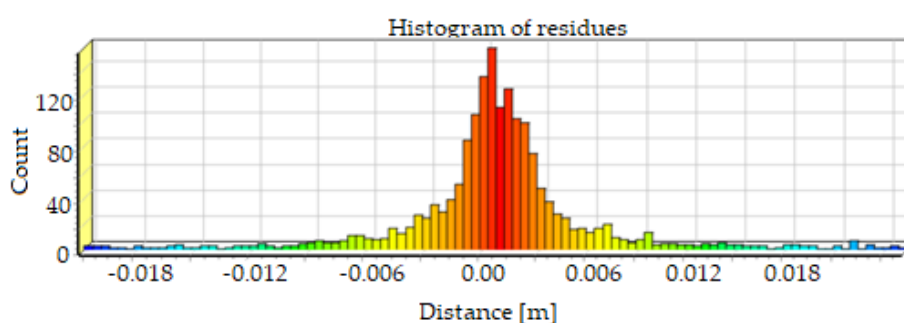
**Figure 13.** A histogram of the residues that resulted from the alignment of two point clouds on objects that have not moved in time.

We analysed the accuracy of the measured points in the form of sewer pipes that were located at the top of the cliff. We wanted to achieve greater accuracy (at the level of 1 cm) to check our assumptions about the landslide's origin and to verify whether there is a threat of a landslide being initiated (the elevation should decrease locally in this case). First, we analysed a histogram of the distance among control points and then checked the quality of the alignment by creating cross-sections through buildings that the landslide did not have an impact on (in theory, they should be located in exactly the same place). Figure 13 shows the histogram of the distance among control points. Figure 14 shows the analysed building cross-sections.

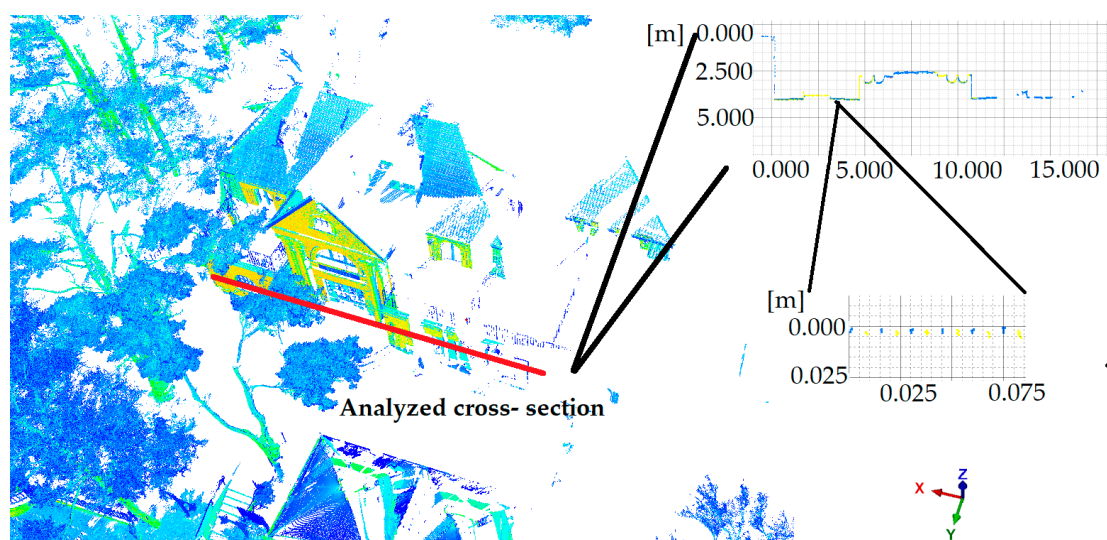
**Figure 14.** The structure of points between two elements representing the same object that has not changed in time (yellow colour represents point cloud from 2017 and blue—from 2018).

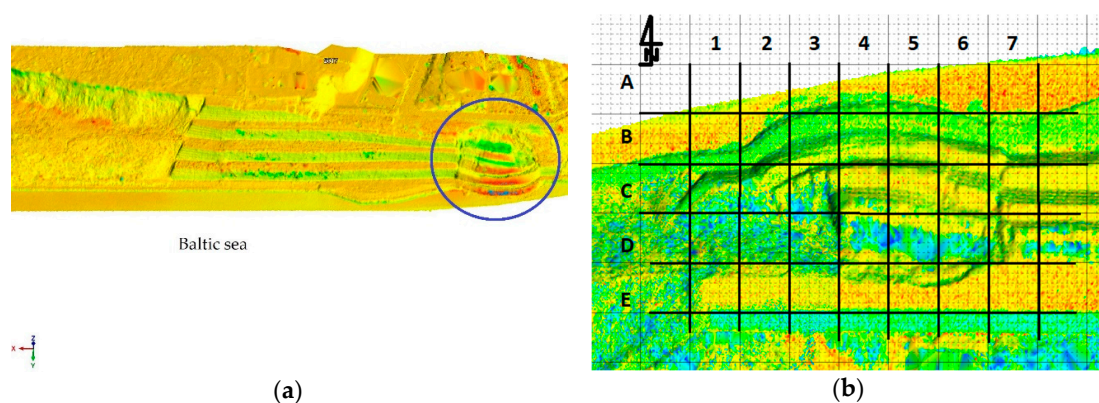
Figure 17. (a) The location of the highest variations; (b) the defined  $10\text{ m} \times 10\text{ m}$  grid.

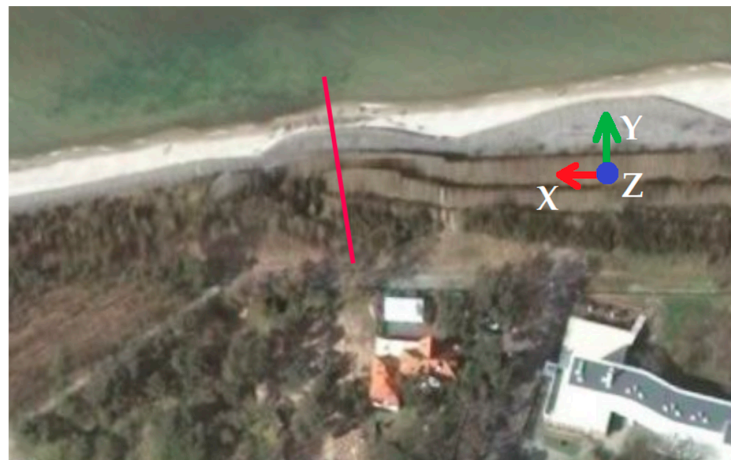
Figure 19. The location of the geometric analysis, marked on an orthophotomap.

Based on the volumetric results, we chose for further investigation a section between the mesh columns marked C and D. The deviations in the same section (as shown in Figure 19) that were obtained

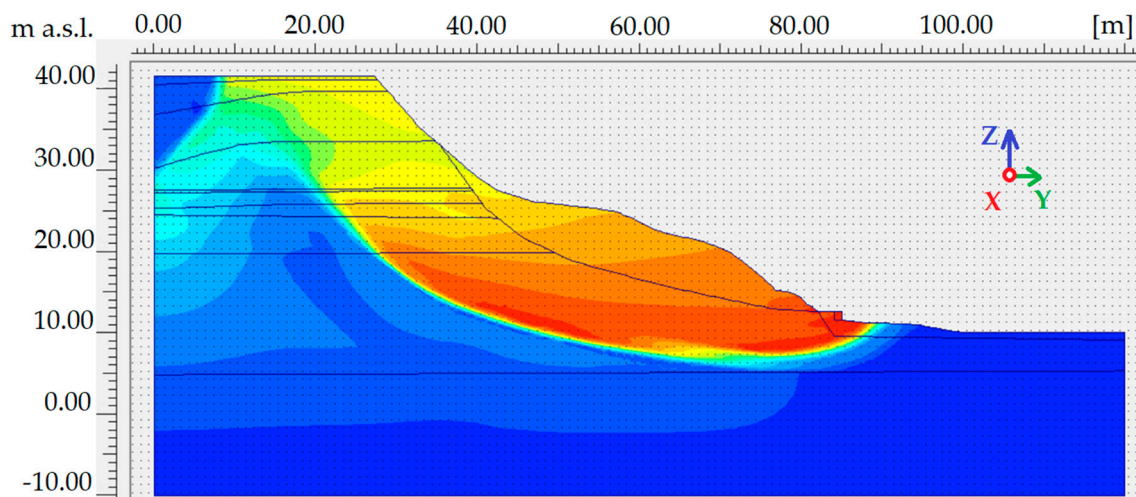
**Figure 21.** The global failure mechanism: calculations for the actual groundwater table (dimensions in meters) (source: Reference [48]). Blue colour: no displacement, red: maximum displacement.

cohesion). The analysis showed that, for the initial case (no elevation in the water table), the most sensitive parameters were the friction angle and the cohesion in the bottom layer (the clay from which the cliff is built). This is logical, as this scenario triggers a path that leads to the cliff's destruction (see Figure 21).
