Stability Assessment of Coastal Cliffs Incorporating Laser Scanning Technology and a Numerical Analysis

Rafal Ossowski, Marek Przyborski

Faculty of Civil and Environmental Engineering, Gdansk University of Technology, 80-233 Gdansk, Poland

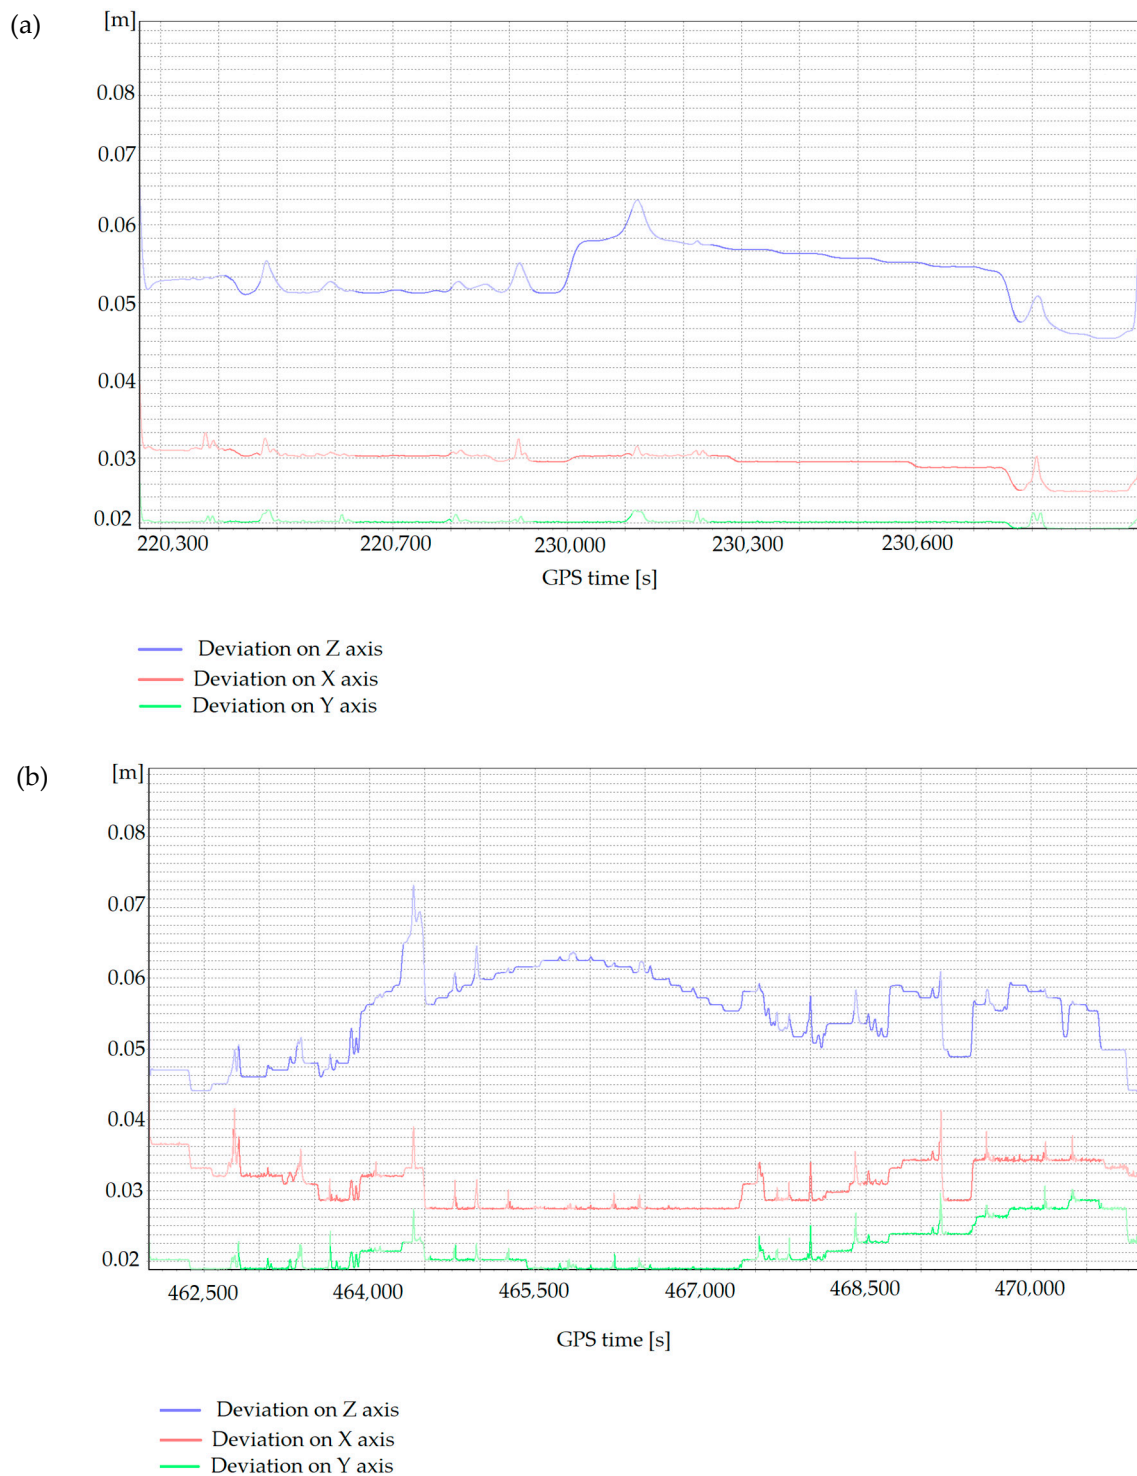
Figure 11. Deviations from the approximated trajectory on each axis for (a) the flight from 2014 and (b) the flight from 2017.

Furthermore, analyses of the airborne system’s data were conducted. Figure 11 shows a diagram of the INS position deviation based on trajectory, and Table 3 shows a histogram of differences among control points. As can be noticed in Figure 11a, which shows the deviation from the flight that was performed in 2014, the elevation has the highest value of deviation of 6 cm. Figure 11b, which shows the deviation from the flight that was performed in 2017, has similar values to those in Figure 11a. This means that the trajectory was correctly aligned. An assessment of the accuracy was carried out after establishing individual records of scans between them and the EPSG:2177 coordinate system. The resulting differences between the accuracy of alignment of individual axes result primarily from

the measurement characteristics, where the aircraft fluctuated, but also from the emerging drift of the device. Seen offsets can be removed during strip-adjustment procedures.

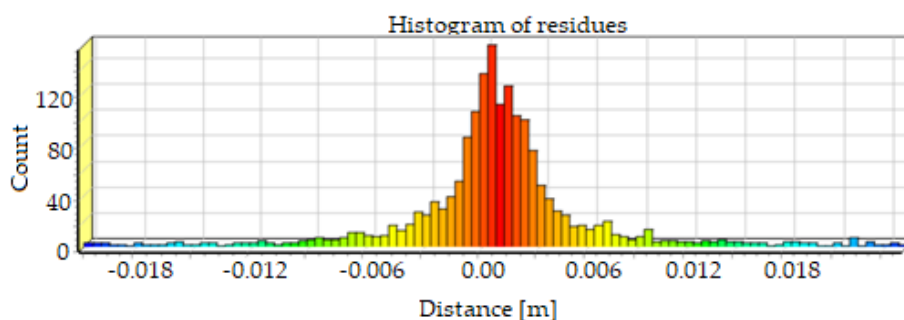
Figure 13. A histogram of the residues that resulted from the alignment of two point clouds on objects that have not moved in time.

We analysed the accuracy of the measured points in the form of sewer pipes that were located at the top of the cliff. We wanted to achieve greater accuracy (at the level of 1 cm) to check our assumptions about the landslide's origin and to verify whether there is a threat of a landslide being initiated (the elevation should decrease locally in this case). First, we analysed a histogram of the distance among control points and then checked the quality of the alignment by creating cross-sections through buildings that the landslide did not have an impact on (in theory, they should be located in exactly the same place). Figure 13 shows the histogram of the distance among control points. Figure 14 shows the analysed building cross-sections.
