Stability Assessment of Coastal Cliffs Incorporating Laser Scanning Technology and a Numerical Analysis

Rafal Ossowski, Marek Przyborski

Faculty of Civil and Environmental Engineering, Gdansk University of Technology, 80-233 Gdansk, Poland

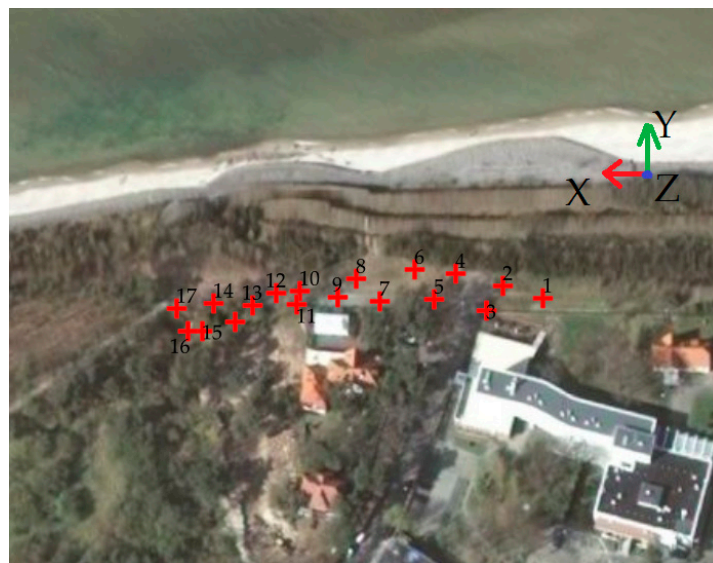
Figure 6. Locations of the measurement points.

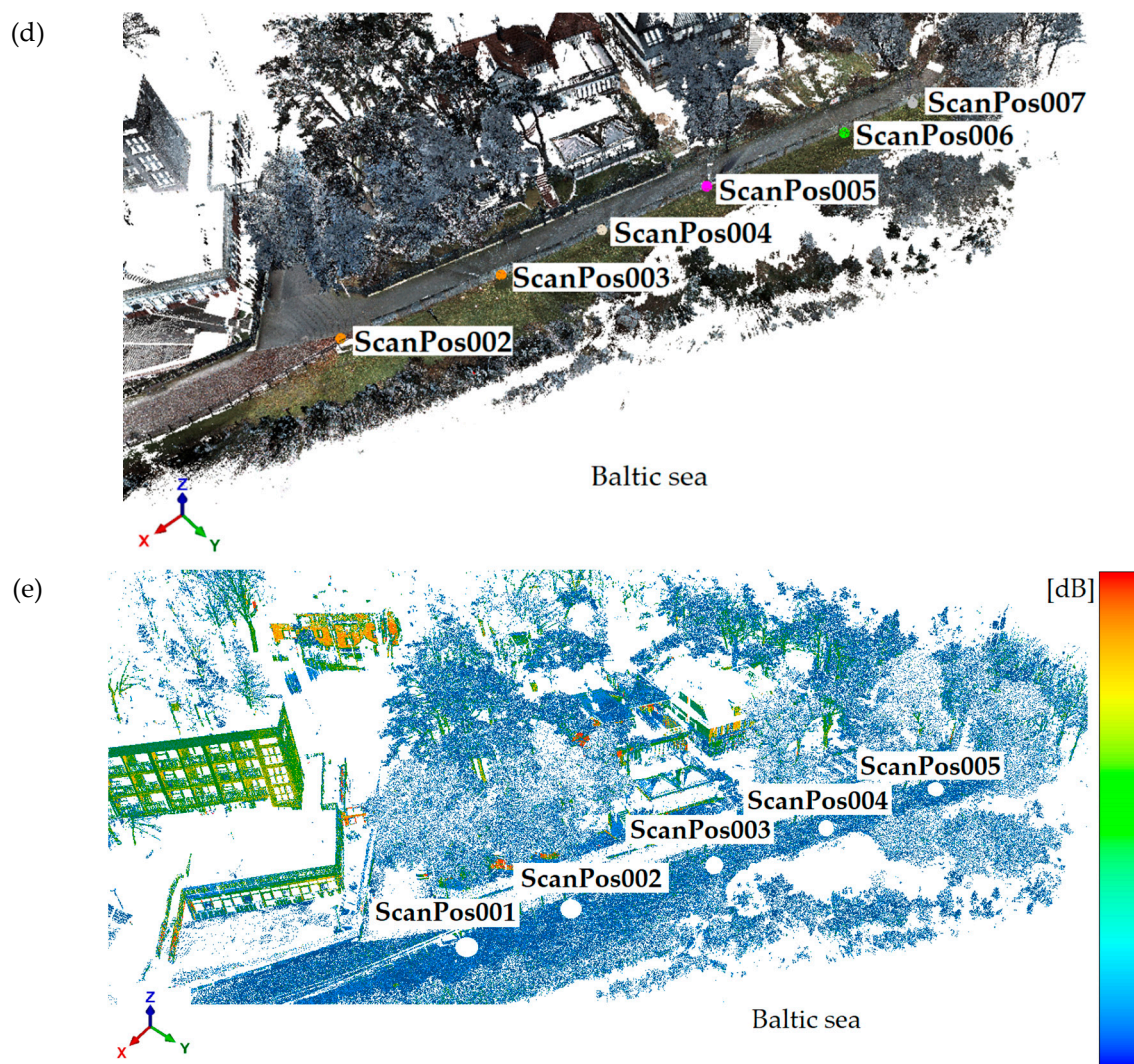
Figure 8. The scanner locations for the (a) February 2015, (b) March 2017, (c) July 2017, (d) November 2018, and (e) March 2018 measurement missions.

Figure 8 presents the location of the scan positions for each of the February 2015, March 2017, and July 2017 measurement missions and the deployment of positions in the local system in November 2017 and March 2018. The point density for each measurement mission was equal 4200 pts/m². In Figure 8a–c,e respectively, colours are presented as a function of light reflection amplitude, while Figure 8d shows the fragment of the upper part of the cliff in RGB (Red-Green-Blue) colours.

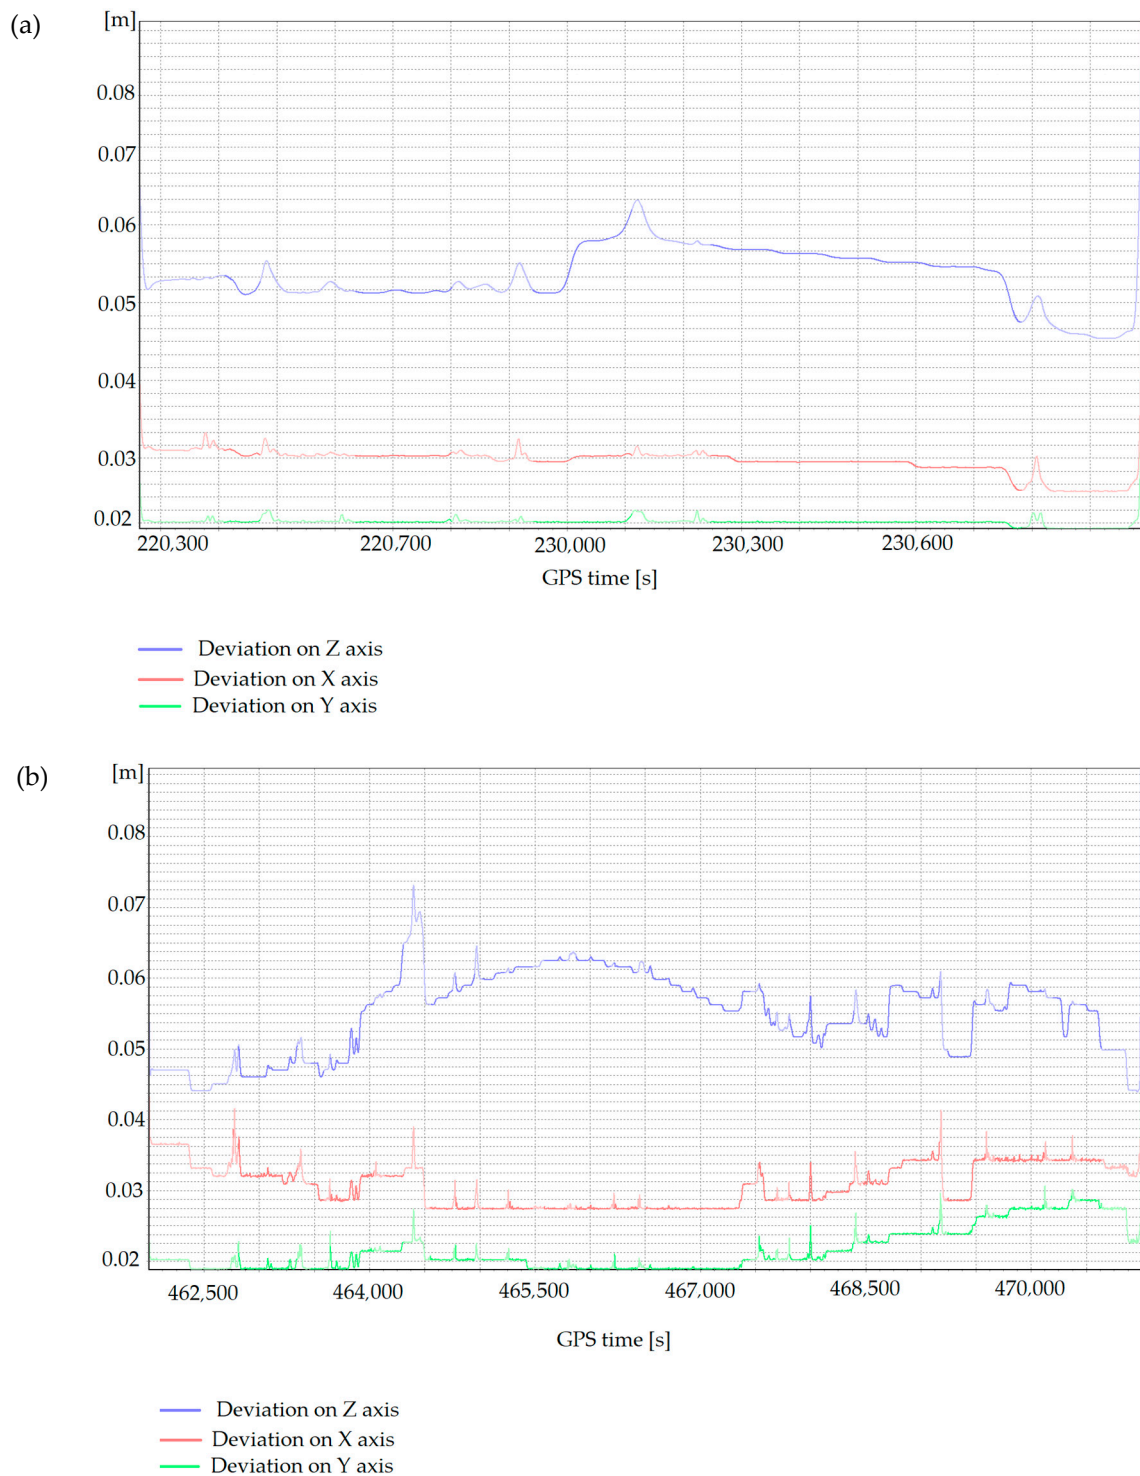
Figure 11. Deviations from the approximated trajectory on each axis for (a) the flight from 2014 and (b) the flight from 2017.

Furthermore, analyses of the airborne system’s data were conducted. Figure 11 shows a diagram of the INS position deviation based on trajectory, and Table 3 shows a histogram of differences among control points. As can be noticed in Figure 11a, which shows the deviation from the flight that was performed in 2014, the elevation has the highest value of deviation of 6 cm. Figure 11b, which shows the deviation from the flight that was performed in 2017, has similar values to those in Figure 11a. This means that the trajectory was correctly aligned. An assessment of the accuracy was carried out after establishing individual records of scans between them and the EPSG:2177 coordinate system. The resulting differences between the accuracy of alignment of individual axes result primarily from

the measurement characteristics, where the aircraft fluctuated, but also from the emerging drift of the device. Seen offsets can be removed during strip-adjustment procedures.

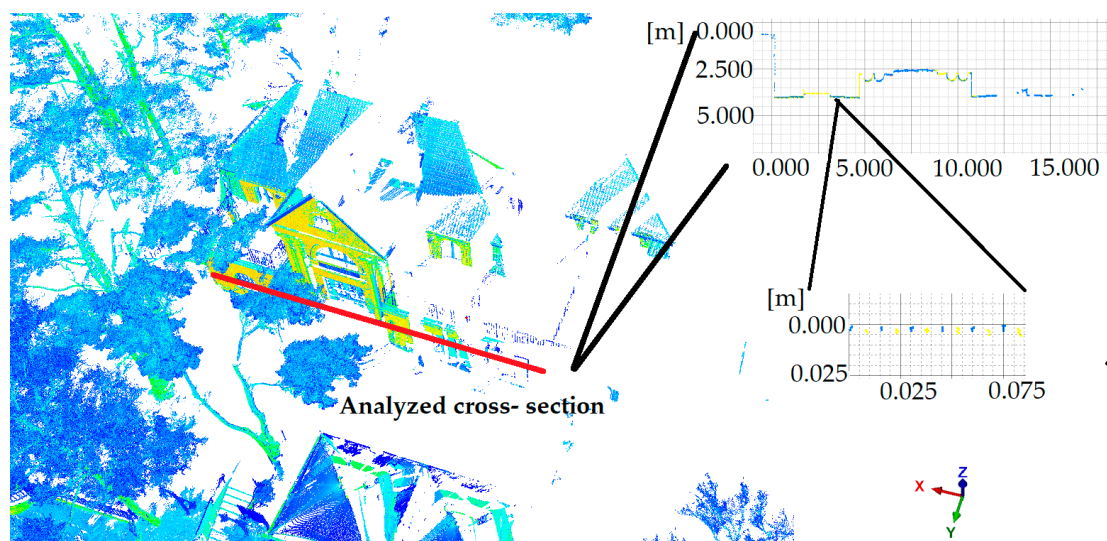
Figure 14. The structure of points between two elements representing the same object that has not changed in time (yellow colour represents point cloud from 2017 and blue—from 2018).

We analysed the accuracy of the measured points in the form of sewer pipes that were located at the top of the cliff. We wanted to achieve greater accuracy (at the level of 1 cm) to check our assumptions about the landslide's origin and to verify whether there is a threat of a landslide being initiated (the elevation should decrease locally in this case). First, we analysed a histogram of the distance among control points and then checked the quality of the alignment by creating cross-sections through buildings that the landslide did not have an impact on (in theory, they should be located in exactly the same place). Figure 13 shows the histogram of the distance among control points. Figure 14 shows the analysed building cross-sections.
