Finite element modelling of a historic church structure in the context of a masonry damage analysis

Marcin Kujawa^{a,*}, Izabela Lubowiecka^a, Czesław Szymczak^b

ABSTRACT

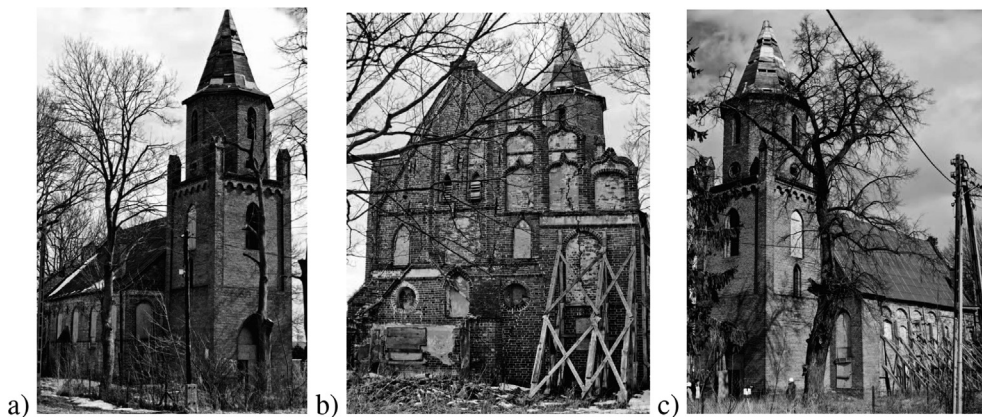
Fig. 2. Views of the church (a) north-west, (b) east, (c) west-south.

In the XIX century, two brick buttresses were built in the western corner of the south wall and in the east wall (see Fig. 4). In 2009, during the renovation, three columns of concrete were built into the southern inner wall (see Figs. 3 and 4). These three pillars are not founded on any foundation. The eastern wall is also comprised of two layers, and some vertical cracks of significant width are observed on it (see Figs. 2 and 15).

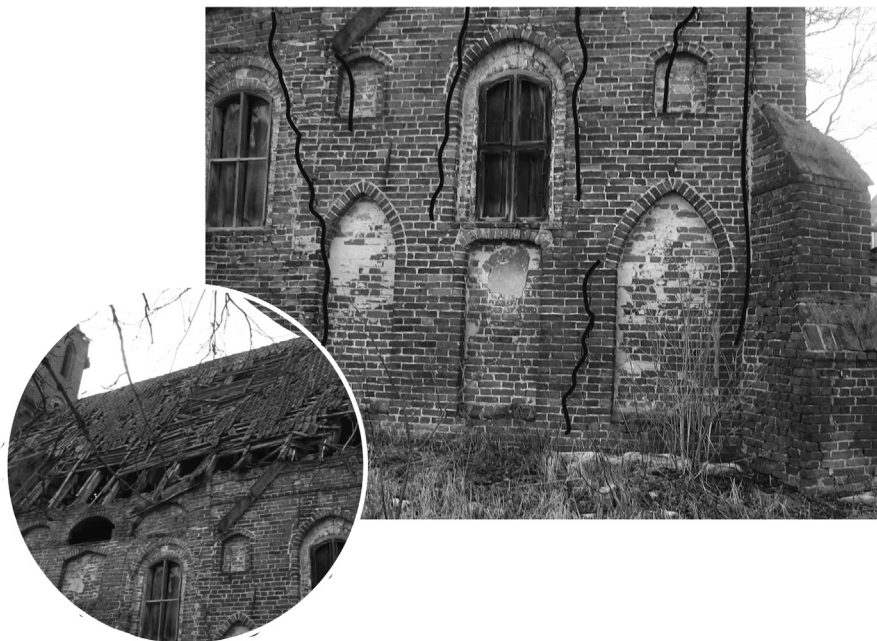
Fig. 5. View of the south wall and roof over the wall.

The roof of the church is made of wood (see Figs. 5–7). The main destroyed roof timber truss is considered in analysis here (see Fig. 7). The roof of the tower is omitted. The material of the truss is modelled in a simplified manner as elastic and isotropic even if wood is known as an anisotropic material. Because the church is a structure that was built centuries ago, the material may also have

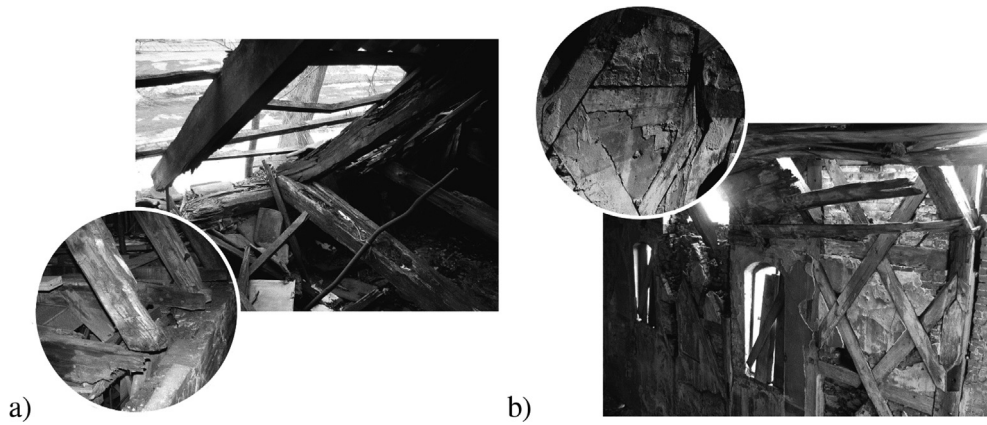
Fig. 6. Damage to (a) ceiling, rafter, wall beams and (b) timber wall frames (inner view of the south wall).

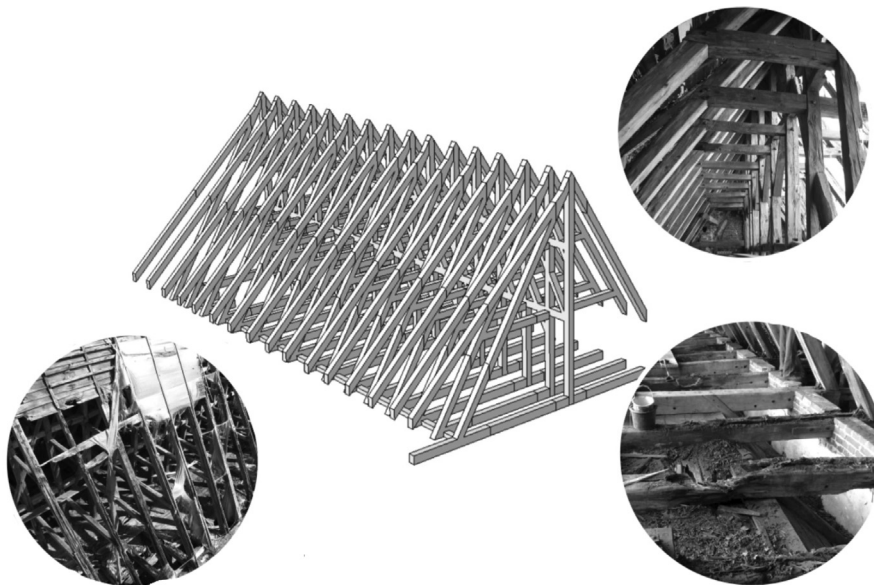
Fig. 7. Geometry of the timber roof: selected details.

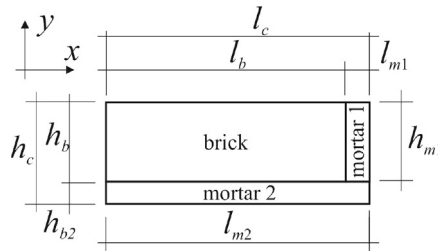
Fig. 10. Elementary cell in individual states.

The masonry church wall material modulus of elasticity was calculated using a homogenization algorithm described in papers [24,25]. In this method, an elementary cell is analyzed, where based on strain compatibility and stress balance equations of its components, the basic material properties of the entire element can be calculated. The cell is comprised of a brick and mortar attached along its two edges (see Fig. 10). The method assumes that the width and height of an elementary cell is greater than its thickness, which makes it possible to assume a plane stress state in the wall; the layout of bricks and joints in the wall is regular, and the stress gradient in the construction is small, with no concentrations.

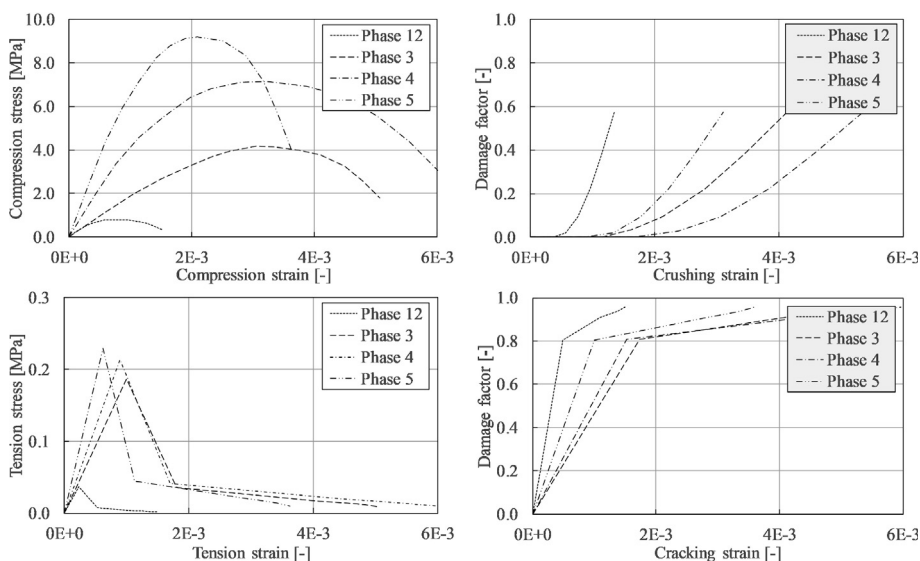
Fig. 11. Masonry properties: phase 1/2 (14th century), phase 3 (16th century), phase 4 (18th century), phase 5 (19th century).

1/2 and 3, 3% for material in phase 4 and 2.5% for material in phase 5). The values of the individual parameters are shown in Figs. 11 and 12.

Considering the material behaviour of the specific parts of the structure, the soil (basic and degraded), stone foundations and timber roof are modelled as linearly elastic (see Table 3), whereas the masonry walls (see Table 3 and Fig. 11) and concrete columns (see Fig. 12) are modelled as continuum plastic with damage and stiffness degradation in the sense of continuum damage mechanics. Plasticity-based damage constitutive modelling is widely used to describe the nonlinear properties of masonry structures and concrete. Such a model was first proposed for concrete analysis [37–39] and reinforced concrete (RC) structures [40] but also can be used to represent other brittle material behaviours such as for ceramic masonry structures [41,18,42]. The applied material model is described extensively in [36]. It assumes that the main two failure mechanisms are tensile cracking and compressive crushing of the masonry or concrete. The evolution of the yield (or failure) surface is controlled by two hardening variables $\tilde{\varepsilon}_t^{pl}$, which is a tensile equivalent plastic strain, and $\tilde{\varepsilon}_c^{pl}$, which is a compressive plastic strain. Both refer to failure mechanisms under tension and compression loading. It assumes that uniaxial tensile and compressive response of the brittle-like material is characterized by damage plasticity, as shown in Figs. 11 and 12.

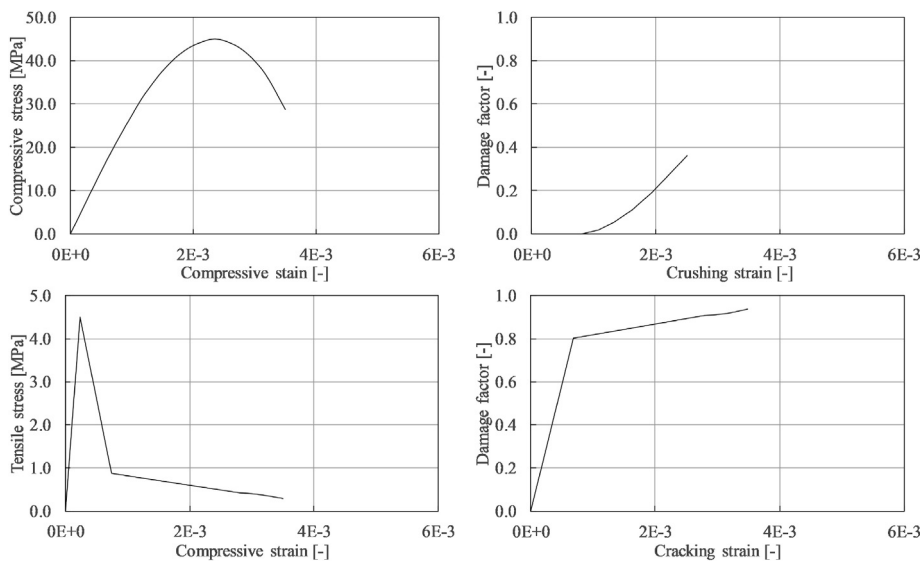
Fig. 12. Concrete properties.

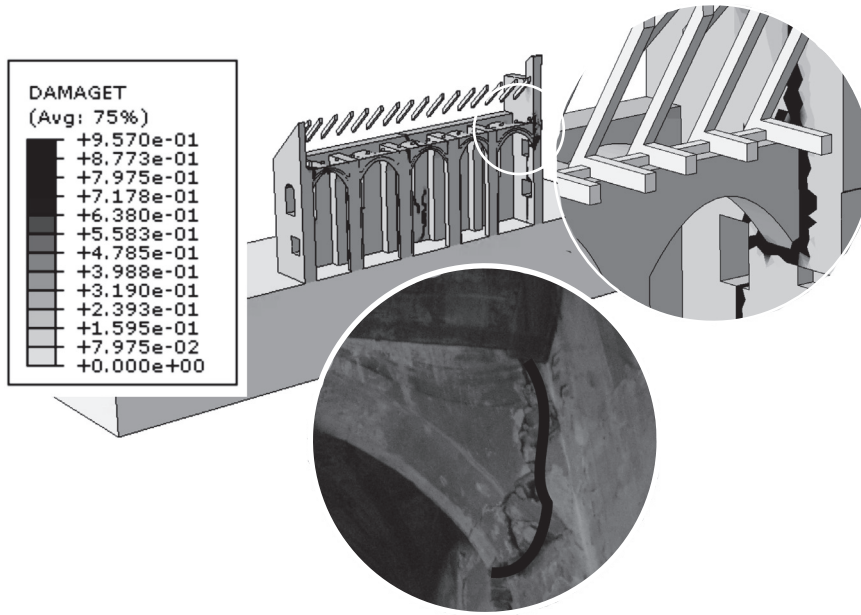
Fig. 16. Selected detail of main cracks on the arch of the inner nave compared with FEM solutions expressed by tension damage factor DAMAGET.

damage obtained from the numerical analysis. Similarly, the main damage to the east wall and the damage to the inner nave arch are presented together with the appropriate numerical results of the mechanical analysis in the Figs. 15 and 16.

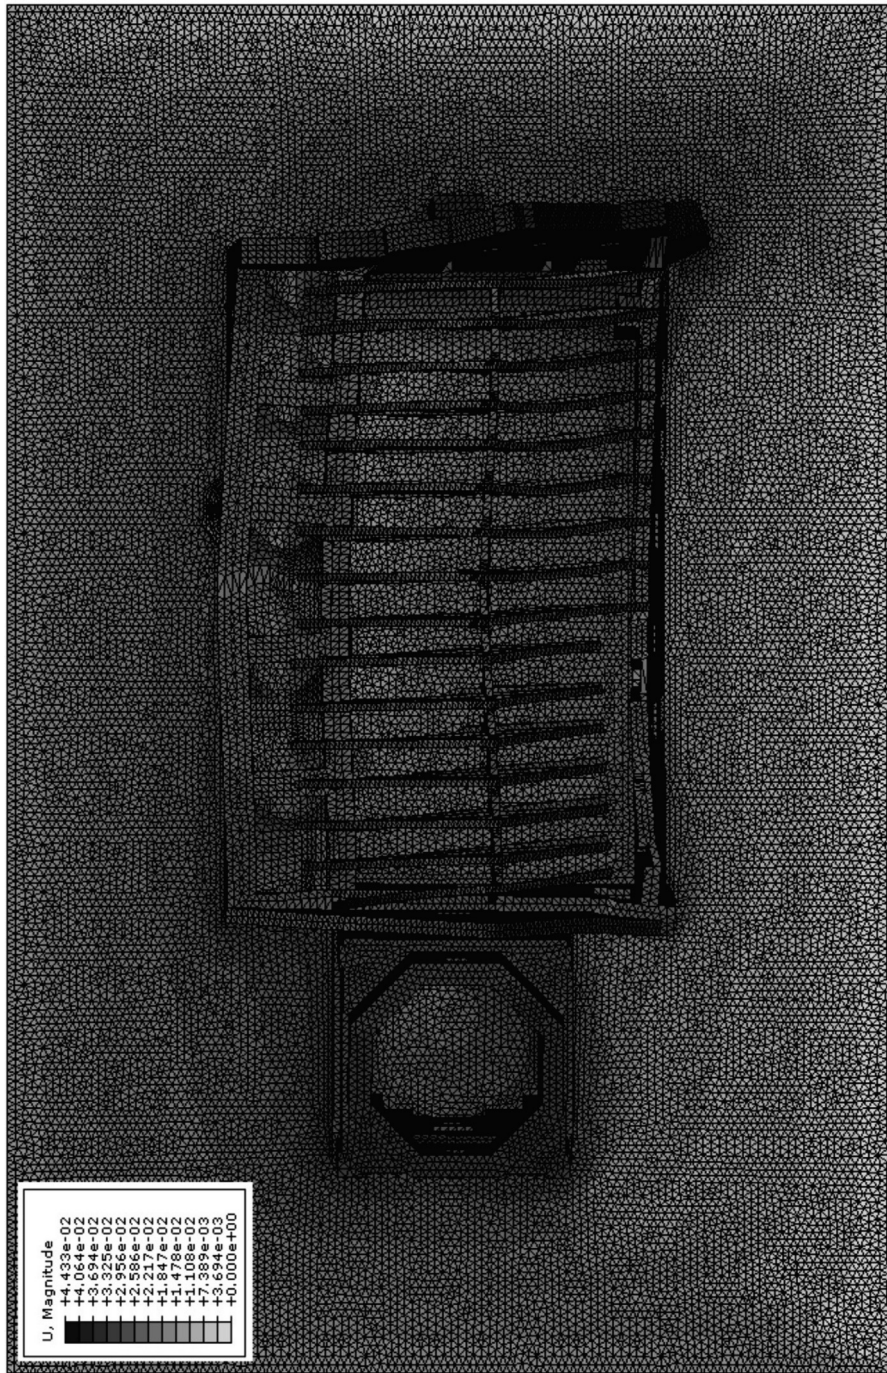
Fig. 17. Numerical solution - deformations [m] according to soil volume at $H = 6$ m ($L = 37$ m, $B = 24$ m).

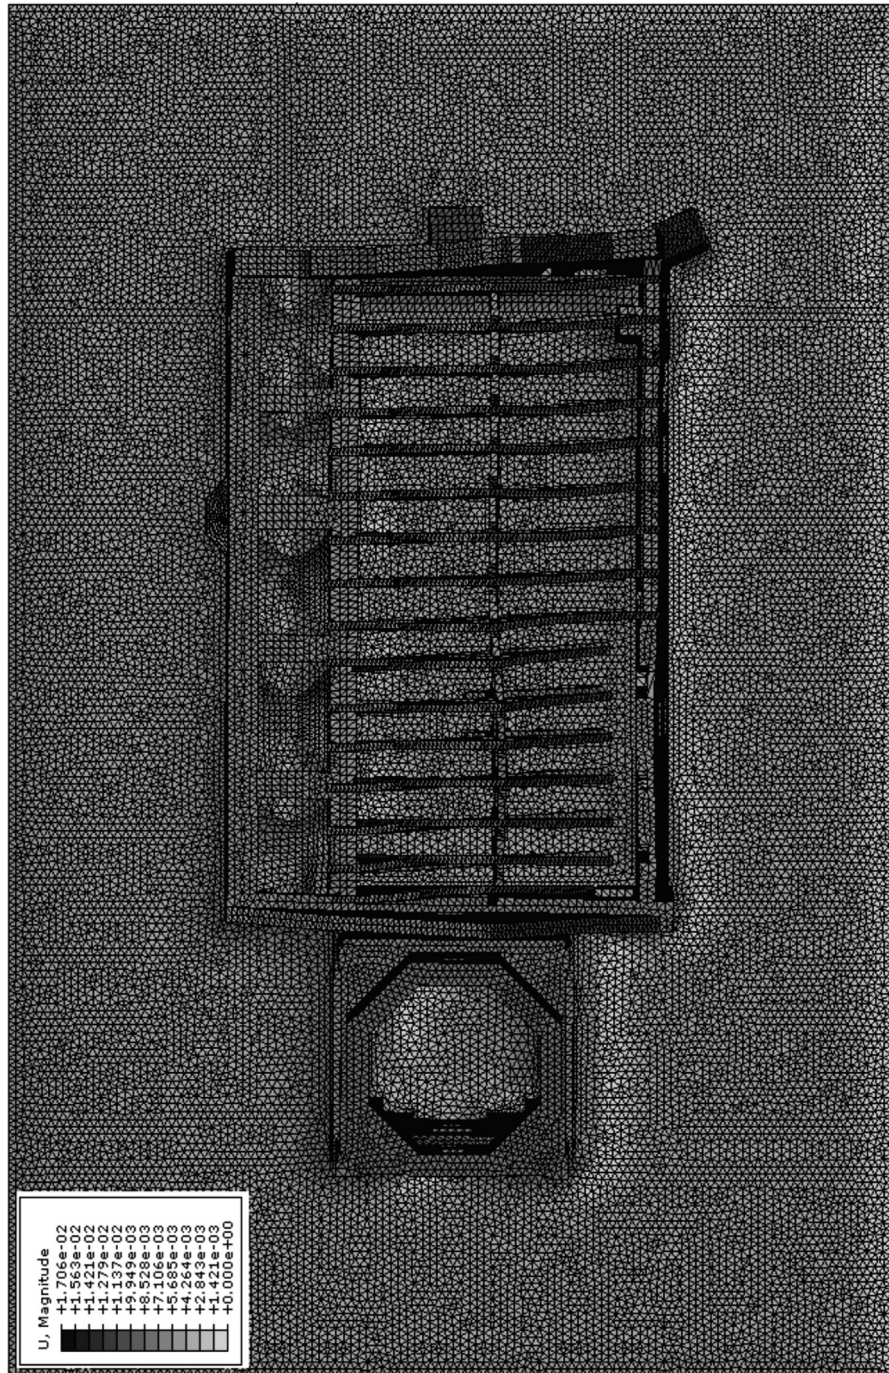
Fig. 18. Numerical solution – deformations [m] according to soil volume at $H = 1.5$ m ($L = 37$ m, $B = 24$ m).

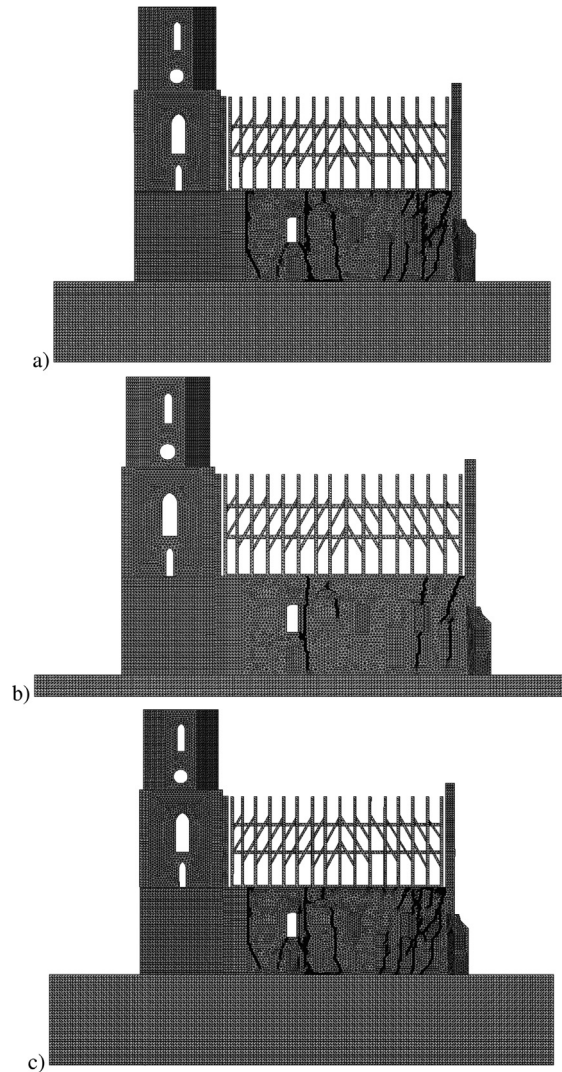
Fig. 19. Numerical solutions, view of the south wall – damage factor DAMAGET due to: (a) the soil volume at $H = 6$ m ($L = 37$ m, $B = 24$ m), (b) the soil volume at $H = 1.5$ m ($L = 37$ m, $B = 24$ m) and (c) the soil volume at $H = 7$ m ($L = 39$ m, $B = 26$ m).

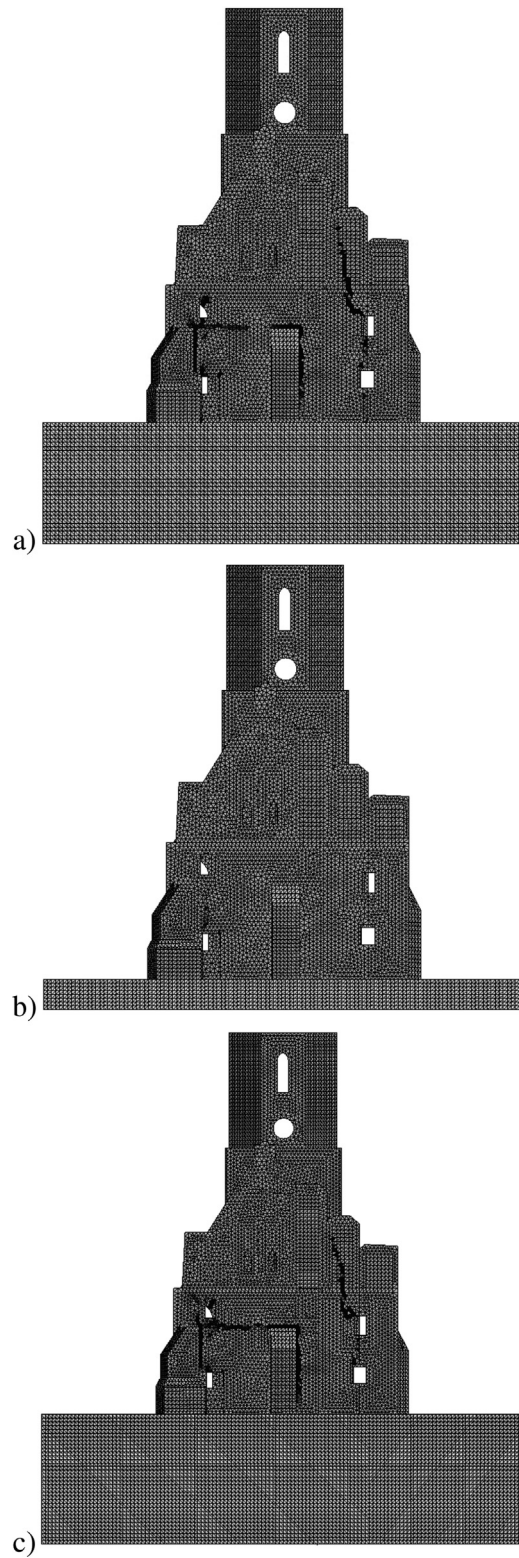
Fig. 20. Numerical solution, view of the east wall - damage factor DAMAGET for: (a) the soil volume at $H = 6$ m ($L = 37$ m, $B = 24$ m), (b) the soil volume at $H = 1.5$ m ($L = 37$ m, $B = 24$ m) and (c) the soil volume at $H = 7$ m ($L = 39$ m, $B = 26$ m).
