Condition of reinforced concrete structures and their degradation mechanism at the former Auschwitz concentration and extermination camp

The paper presents the results of investigations on reinforced concrete structures present in the former Auschwitz I and Auschwitz II-Birkenau concentration and extermination camp. Field inspection employing non-destructive method of reinforcement potential measurement according to the ASTM-C 876-15 standard, followed by laboratory investigations performed on genuine historic reinforced concrete samples collected from the former Auschwitz camp allowed assessment of the actual condition of this 70-year old construction material. Electrochemical potential measurements allowed mapping of the regions characterized by enhanced reinforcement corrosion risk and the regions of its immunity. Composition of concrete, water absorbency, content of detrimental salts, degree and profile of carbonation as well as mechanical properties were evaluated. The obtained results revealed the most common and probable mechanism responsible for degradation of the reinforced concrete structures in the former Auschwitz camp.

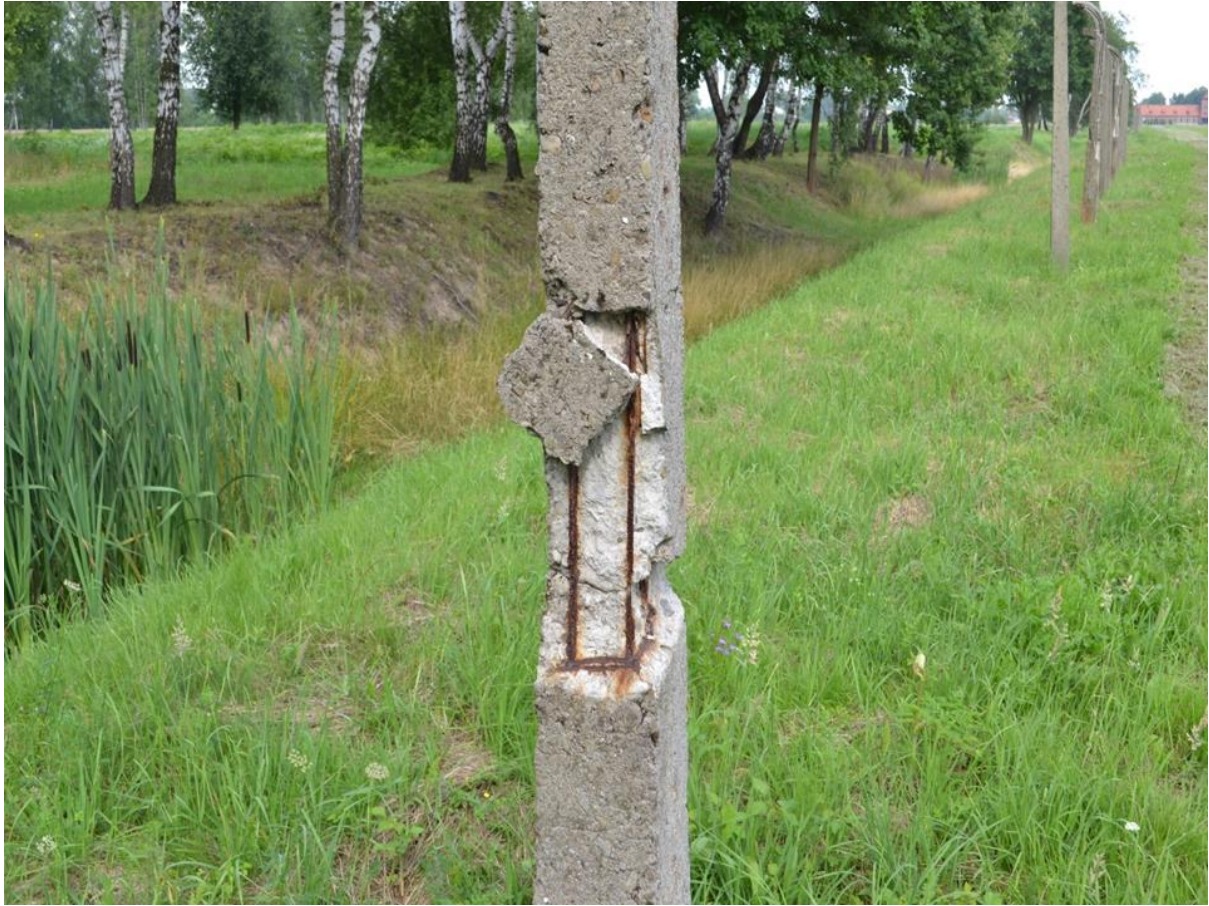
Figure 2

Fig. 2. Former Auschwitz II-Birkenau camp – example of reinforced concrete pole degradation due to atmospheric exposure for about seven decades.

This paper reports the results of investigation into concrete and reinforced concrete structures at the former Auschwitz camp. These type of materials were extensively utilized for construction of the former camp's infrastructure including walls and floors of the buildings, fences, pillars, building foundations and many more. The authors performed visual assessment of concrete elements present on the area, carried out electrochemical potential measurements of the reinforcing bars of selected camp structures and collected representative samples for laboratory investigation. Visual evaluation is not sufficient for reliable assessment of the state of reinforced concrete elements. Lack of periodical condition inspection, complex maintenance and restoration procedures contributed to delamination of concrete cover and heavy corrosion of steel reinforcement. Corrosion of the hidden reinforcement is one of the most common causes of concrete structure degradation and failure (Fig. 2). Hence this is what has been concentrated on here.

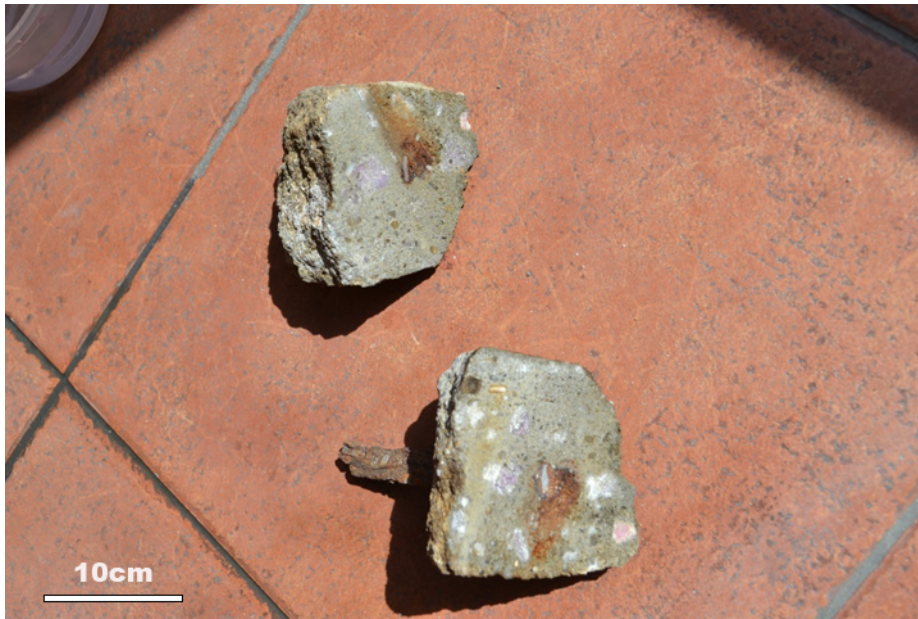
Figure 18

Elements that are smaller and thinner in cross-section suffer from complete carbonation after 70 years of atmospheric exposure. The phenolphthalein test (Fig. 18) as well as pH of aqueous extracts maintained within the range 8-11 suggest significant carbonation. This does not guarantee a passive state of the reinforcement, contributing to reinforcement corrosion and causing concrete to crack and spall.

Fig. 18. Smaller fragments of a ceiling of ruins of gas chamber subjected to phenolphthalein test. Lack of pink colour is the evidence of complete carbonation of the samples.
