## **Condition of reinforced concrete structures and their degradation mechanism at the former Auschwitz concentration and extermination camp**

The paper presents the results of investigations on reinforced concrete structures present in the former Auschwitz I and Auschwitz II-Birkenau concentration and extermination camp. Field inspection employing non-destructive method of reinforcement potential measurement according to the ASTM-C 876-15 standard, followed by laboratory investigations performed on genuine historic reinforced concrete samples collected from the former Auschwitz camp allowed assessment of the actual condition of this 70-year old construction material. Electrochemical potential measurements allowed mapping of the regions characterized by enhanced reinforcement corrosion risk and the regions of its immunity. Composition of concrete, water absorbency, content of detrimental salts, degree and profile of carbonation as well as mechanical properties were evaluated. The obtained results revealed the most common and probable mechanism responsible for degradation of the reinforced concrete structures in the former Auschwitz camp.

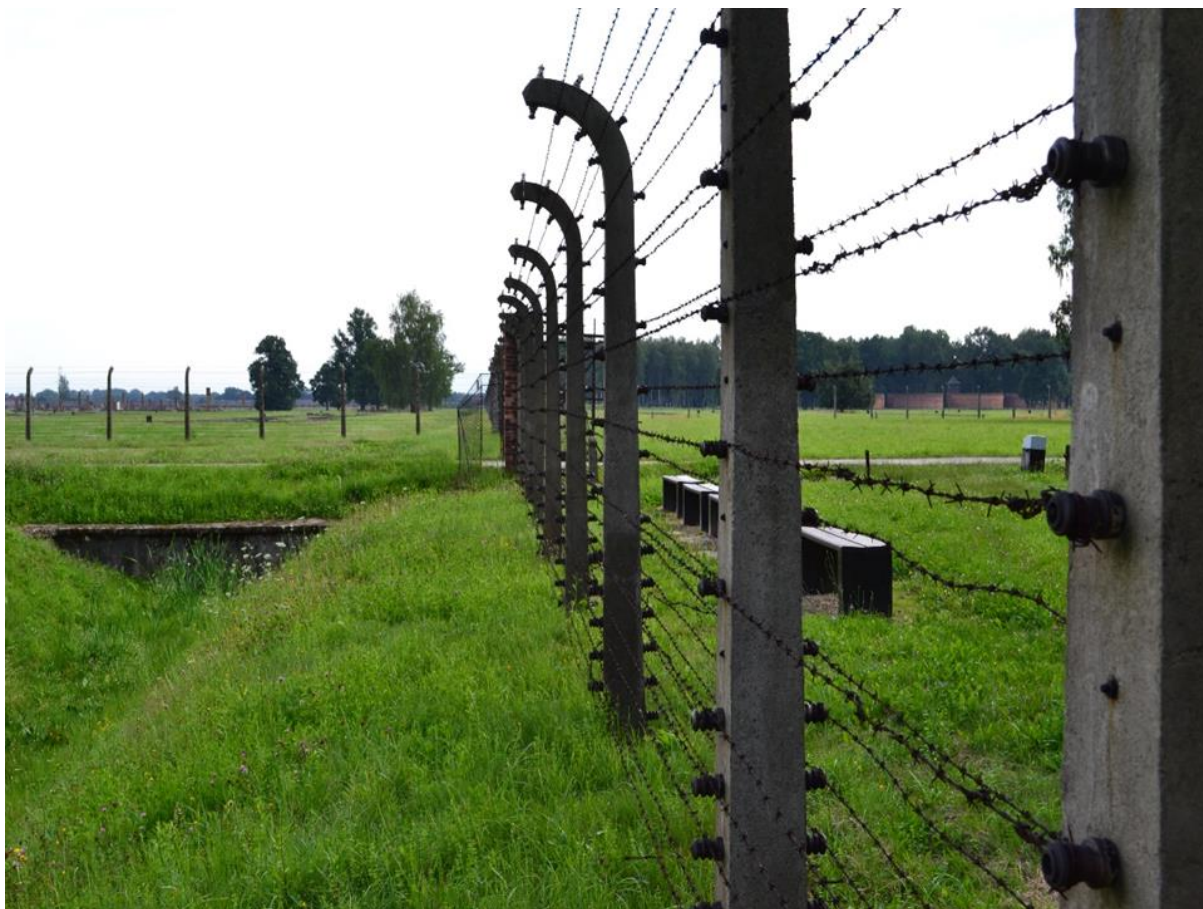
Figure 1

Fig. 1. Landscape of the former Auschwitz II-Birkenau camp with numerous concrete structures including poles of the electric fence and sewage channels.

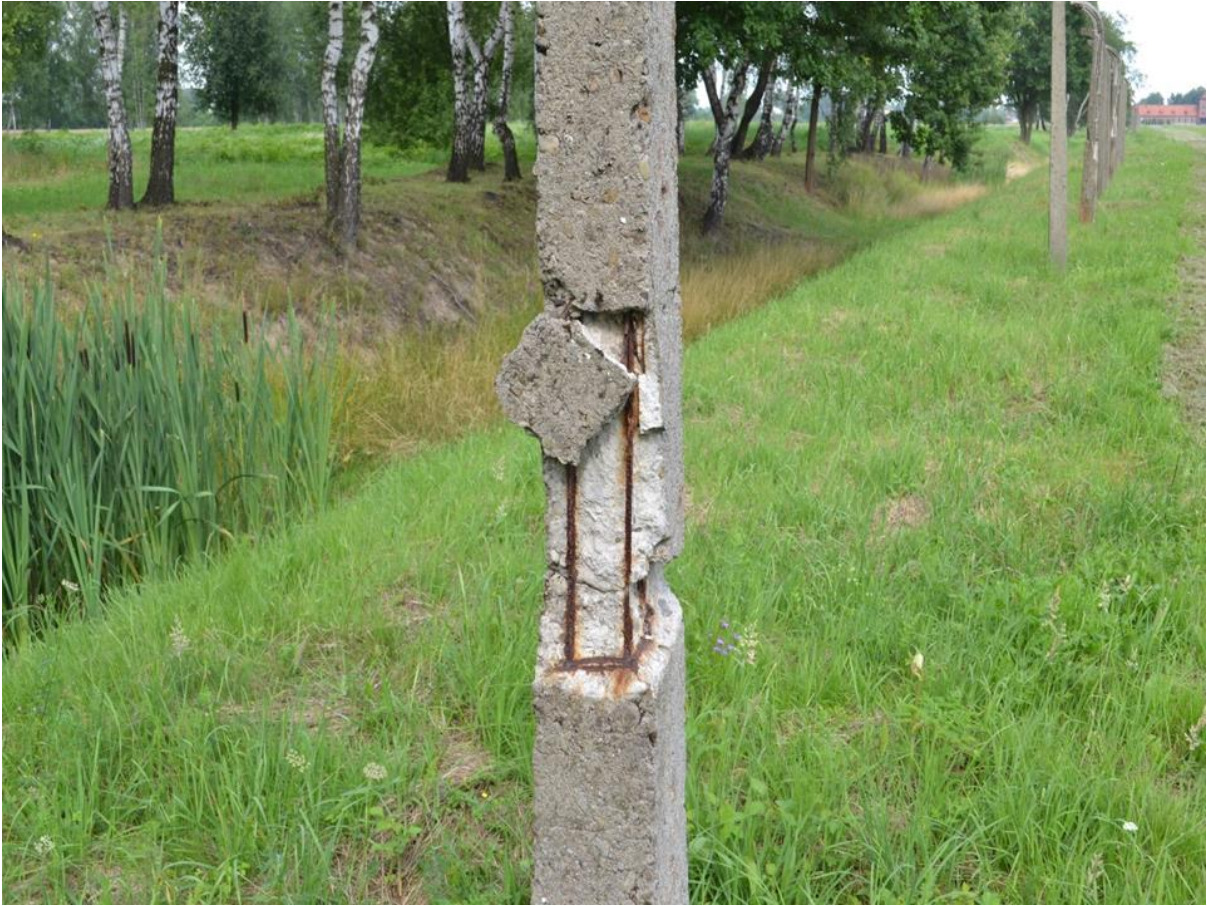
Figure 2

This paper reports the results of investigation into concrete and reinforced concrete structures at the former Auschwitz camp. These type of materials were extensively utilized for construction of the former camp's infrastructure including walls and floors of the buildings, fences, pillars, building foundations and many more. The authors performed visual assessment of concrete elements present on the area, carried out electrochemical potential measurements of the reinforcing bars of selected camp structures and collected representative samples for laboratory investigation. Visual evaluation is not sufficient for reliable assessment of the state of reinforced concrete elements. Lack of periodical condition inspection, complex maintenance and restoration procedures contributed to delamination of concrete cover and heavy corrosion of steel reinforcement. Corrosion of the hidden reinforcement is one of the most common causes of concrete structure degradation and failure (Fig. 2). Hence this is what has been concentrated on here.

Fig. 2. Former Auschwitz II-Birkenau camp – example of reinforced concrete pole degradation due to atmospheric exposure for about seven decades.

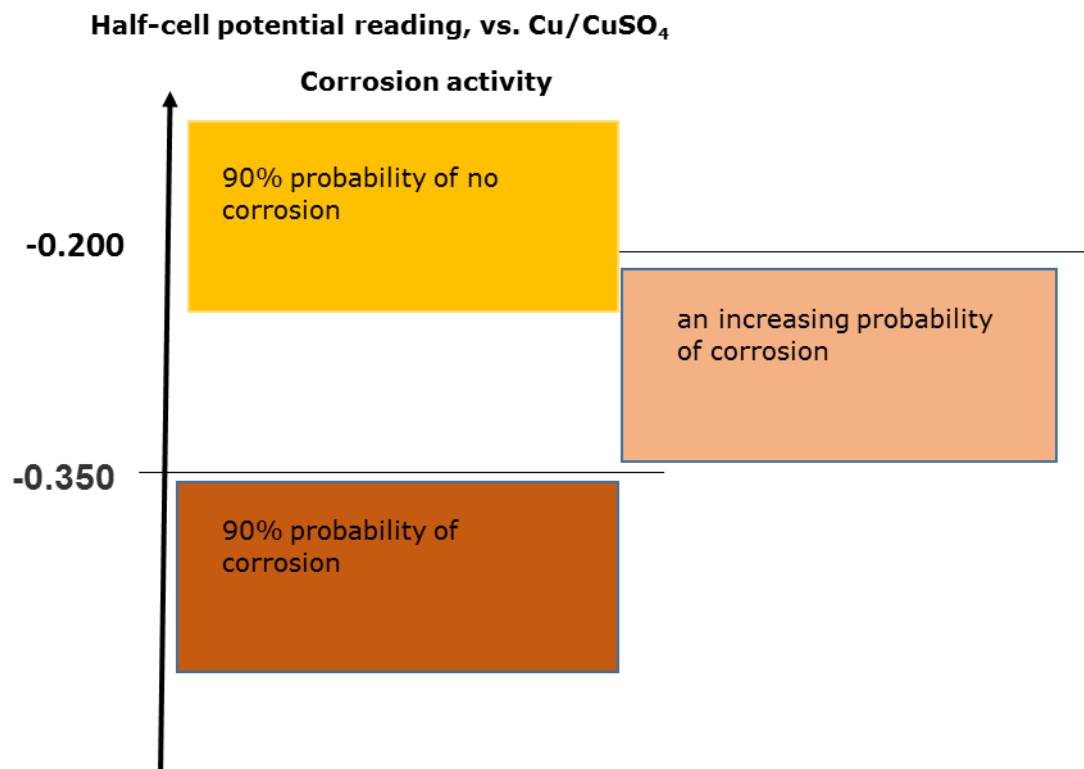
Electrochemical potential measurements were carried out in accordance with the standard mentioned in *Theoretical background* section. The measurement procedure involves utilization of a reference electrode, typically copper-copper sulphate (CSE) electrode, which is placed on the surface of the concrete structure under investigation and connected to the negative (ground) terminal of a voltmeter. The positive terminal of the voltmeter should be connected directly to the reinforcing steel bar. To achieve that one can use a section of

exposed reinforcement (which is quite common in case of historical, partially degraded structures) or remove some concrete to expose the reinforcing steel. In order to ensure electrolytic contact between the reference electrode placed on the concrete element surface and the reinforcing steel an electrical junction device was used. It is often a piece of sponge or fabric pre-wetted with low electrical resistance contact solution. In the case of measurements of extremely dry concrete, for instance indoor element examination, there may be a need for pre-wetting of concrete surface. Fig. 4 shows a scheme of reinforcement potential measurement set-up (a), an example of potential measurement execution on the remains of reinforced concrete fence pole (b) and reinforcement corrosion probability criteria (c). The potential measurement has a local character, which means it refers to and describes the condition of concrete-covered reinforcement that is localized underneath the reference electrode placed on the concrete surface (blue region indicated in Fig. 4a). In order to assess the state of the entire element the reference electrode should be transferred to the successive, neighbouring areas on the surface and the measurement procedure is repeated. As a result, one obtains a map of reinforcement potential illustrating the condition of all steel reinforcement embedded in concrete. It can be used for distinguishing between the regions, which call for renovation due to corrosion and the passive areas that do not require any intervention.

Fig. 4. Reinforcement potential measurement: (a) schematic set-up; (b) measurement of reinforcing steel potential on the remains of fence pole: 1 – voltmeter, 2 – copper-copper sulphate reference electrode, 3 – electrical junction fabric, 4 – electrical connection to reinforcement, and (c) reinforcement corrosion probability criteria.

- if the measured potential (E) is higher than -0.2V vs. CSE, there is a greater than 90% probability that no reinforcing steel corrosion is occurring in that area at the time of measurement;
- if  $-0.35\text{V} < E < -0.2\text{V}$  vs. CSE, corrosion activity of the reinforcing steel in that area is uncertain;
- if  $E < -0.35\text{V}$  vs. CSE, there is a greater than 90% probability that reinforcing steel corrosion is occurring in that area at the time of measurement.

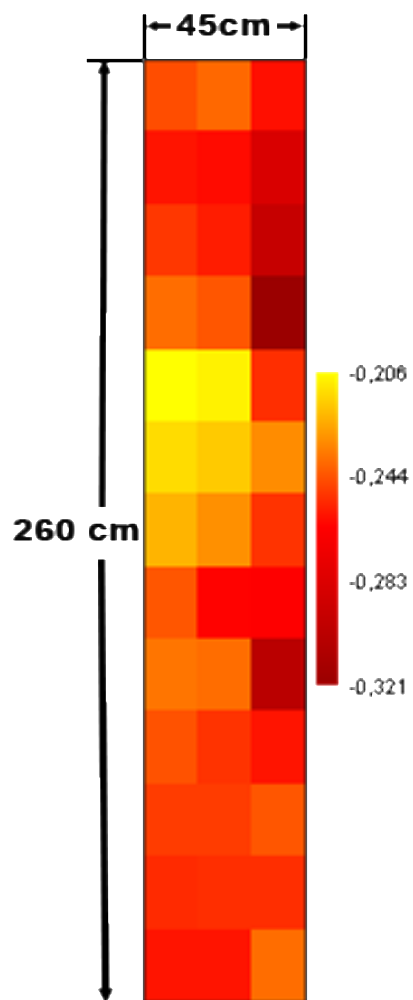
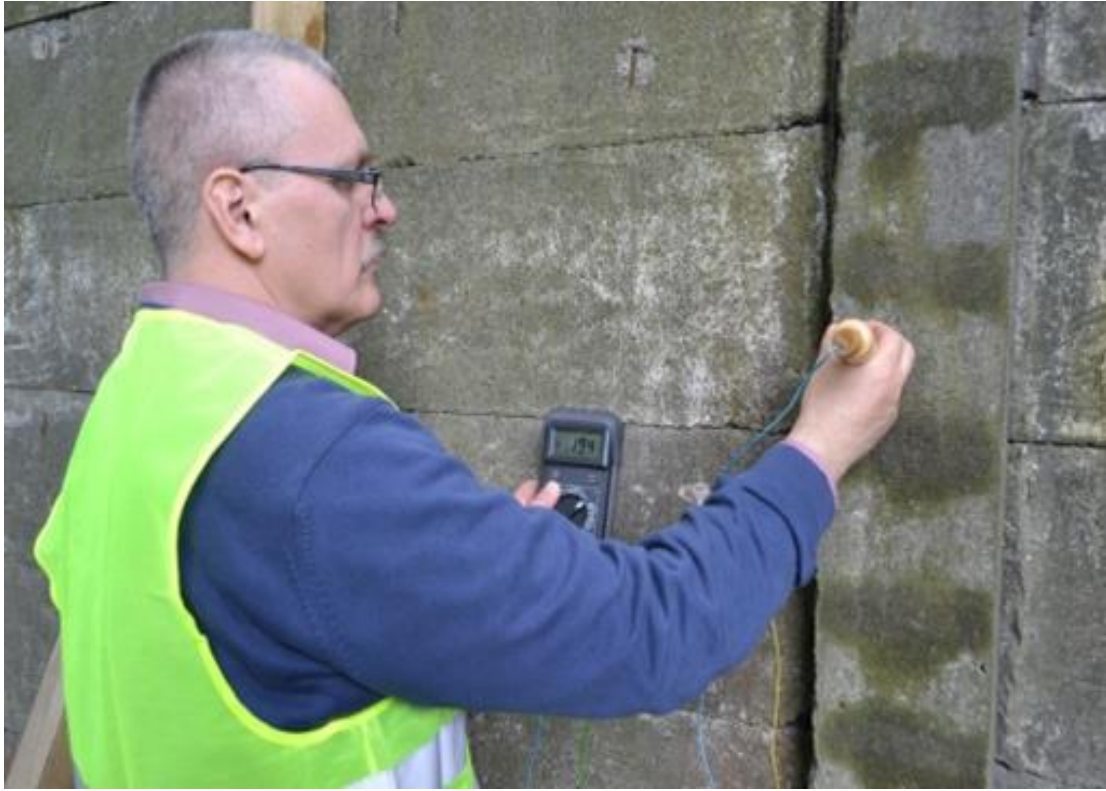
Fig. 6 presents investigation of electrochemical potential of reinforcing steel of a concrete pole of the fence located in a park outside the building of camp commandant in the former Auschwitz I. Potential measurements encompassed the entire height and width of the pole. Successive measurements formed a grid with 20cm spacing between measurements along vertical direction and 15cm spacing along horizontal direction. The grid was chosen in the way providing measurements at the position of reinforcements as well as in the locations where no reinforcement, just concrete was present underneath. Position of the reinforcement was identified prior to the measurements based on visual assessment of damaged bottom part of the pole, where the reinforcement had been revealed. The obtained potential map encompassing the entire pole height and width (Fig. 6a) shows that the reinforcement potential is between 0.206V and -0.312V, which according to the standard means that corrosion activity is uncertain. Generally, lower potential values are recorded along the right edge of the pole suggesting higher likelihood of corrosion. The measurement results are consistent with visual observations performed on site, which revealed no significant degradation of the pole. Only small concrete cracks running from the edge of the pole were detected. They probably resulted from mechanical stresses imposed by winds impacting the fence. However, neither large cracks penetrating the bulk of concrete cover nor any fragments of concrete spalling were noticed, which suggest at most moderate corrosion risk of embedded reinforcing steel.

Fig. 6. Electrochemical potential map (a) and potential measurement execution (b) on reinforced concrete pole of the fence in a park outside the building of Auschwitz camp commandant.

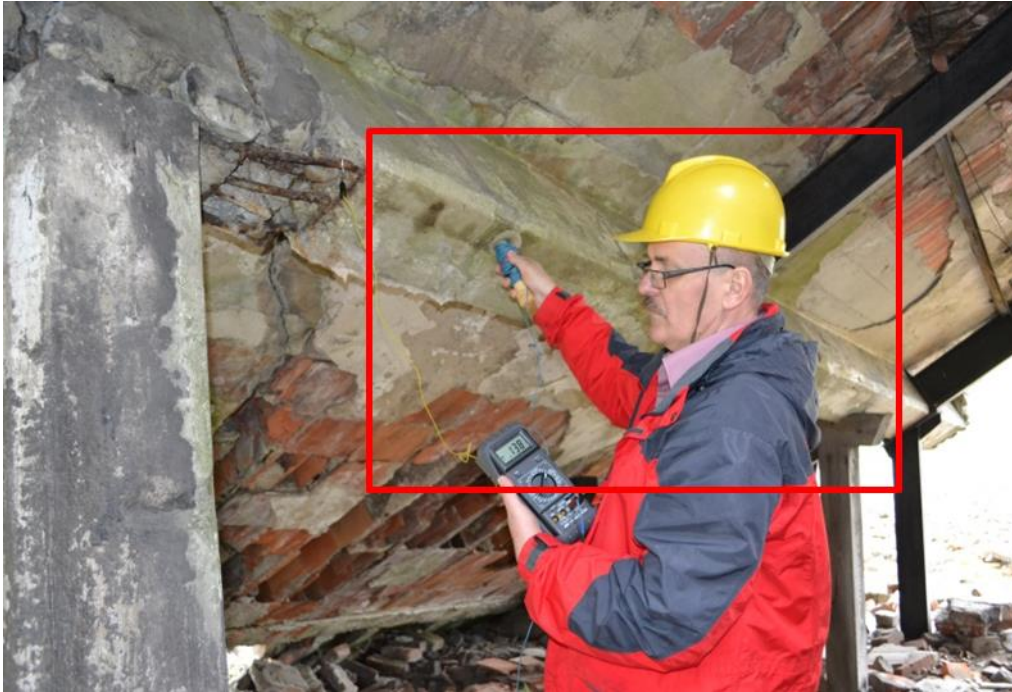
Investigation of electrochemical potential of the reinforcing steel of a concrete floor beam inside the ruins of crematorium no. 2 in the Auschwitz II-Birkenau is illustrated in Fig. 7.

Successive measurements formed a grid with 20cm spacing between measurements along the length of the beam and 15cm spacing along its width. The grid was chosen in the way providing measurements at the position of reinforcements as well as in the locations where no reinforcement, just concrete was present underneath. Position of the reinforcement was identified prior to the measurements based on visual assessment of damaged part of the beam, where the reinforcement had been revealed. The potential map encompassing a section of the beam 160cm x 45cm (Fig. 7a) reveals that the reinforcement potential is between -0.115V and -0.185V. The ASTM-C 876-15 standard classifies such situation as the one in which there is a greater than 90% probability that no reinforcing steel corrosion is occurring in that area at the time of measurement. Indeed, the examined fragment of the beam is characterized by high mechanical integrity, it is free of large cracks, protrusion and spalls. The reason could be that this floor beam is located inside the crematorium ruins (Fig. 7b) and hence it is not directly exposed to atmospheric precipitation. The latter could have contributed to impeding concrete degradation process. Moreover, further studies on depth of carbonation showed that such elements of the crematorium ruins as floors and beams possess a relatively thick layer of concrete cover over the reinforcing steel. Accordingly, the carbonation process has not reached the reinforcement yet, thus maintaining low corrosion risk.

Fig. 7. Electrochemical potential map (a) and potential measurement execution (b) on reinforced concrete floor beam inside the ruins of crematorium no. 2 in the Auschwitz II-Birkenau.

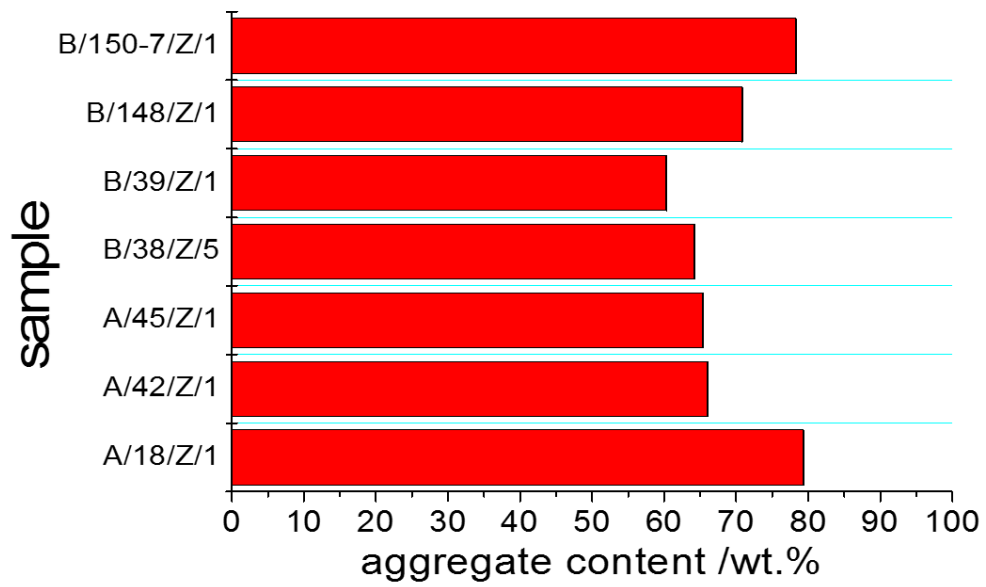
Figure 9

The investigation revealed that the percentage content of aggregate in concrete by weight is between 60.33% (retaining wall near the ruins of the crematorium no. 3 at the Auschwitz II-Birkenau) and 79.35% (ceiling of the cellar in the A-18 block at the Auschwitz I). A characteristic feature of concrete utilized for building of many elements, including Imhoff tanks, walls and floors of crematoria or firefighting reservoir, is the presence of relatively large amount of aggregate, mainly in the form of cobblestones.

Fig. 9. Percentage content of aggregate in analysed concrete samples.

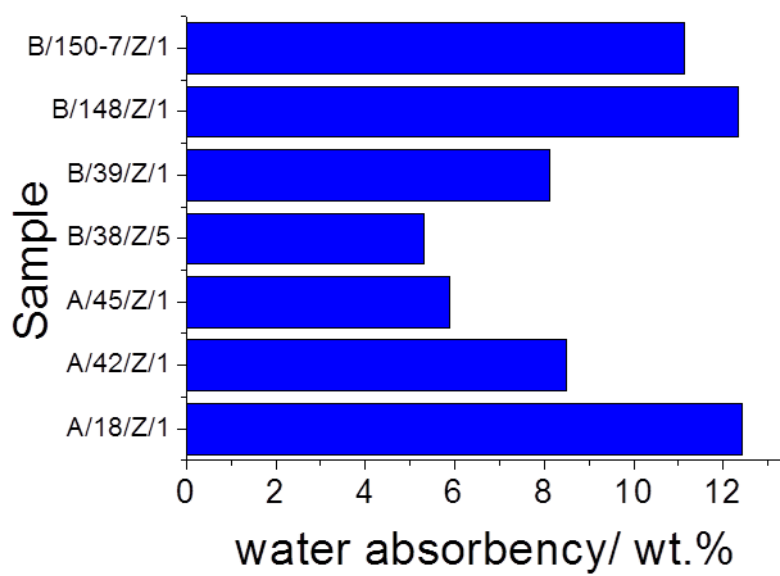
Figure 10

Fig. 10 illustrates water absorbency of the collected samples upon 24-hour exposure time in water. The highest absorbency of 12% is exhibited by concrete from the ceiling of the cellar in the A-18 block at Auschwitz I, concrete from Imhoff tank and firefighting reservoir at the Auschwitz II-Birkenau. Nevertheless, the obtained values of absorbency do not exceed the admissible thresholds for the engineering structures, so they do not constitute a risk of accelerated corrosion of the steel reinforcement.

Fig. 10. Percentage change of mass of collected concrete samples as a result of water absorbency upon 24-hour immersion in water.

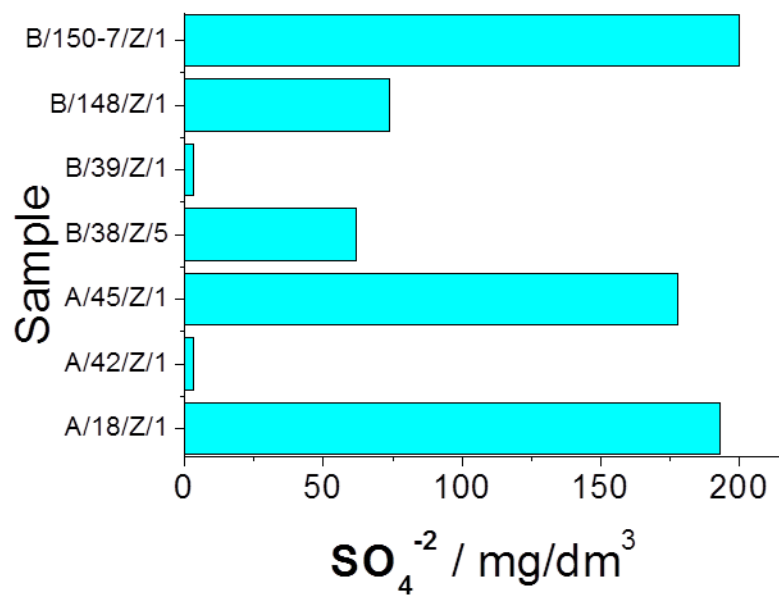
Figure 12

The content of sulphate ions is between  $3\text{mg/dm}^3$  and  $200\text{mg/dm}^3$  (Fig. 12). In this case it is impossible to find any territorial relation either with the Auschwitz I or with the Auschwitz II-Birkenau. The main reason of  $\text{SO}_4^{2-}$  ions presence is most probably connected with atmospheric pollution due to industrial plants and transportation routes localized nearby. Emission of sulphur oxides to the atmosphere, where they combine with water forming acid is a direct source of sulphate ions. Presence of these acidic species contributes to a decrease in alkalinity of concrete and this enhances the process of carbonation.

Fig. 12. Concentration of sulphate ions in analysed concrete samples.

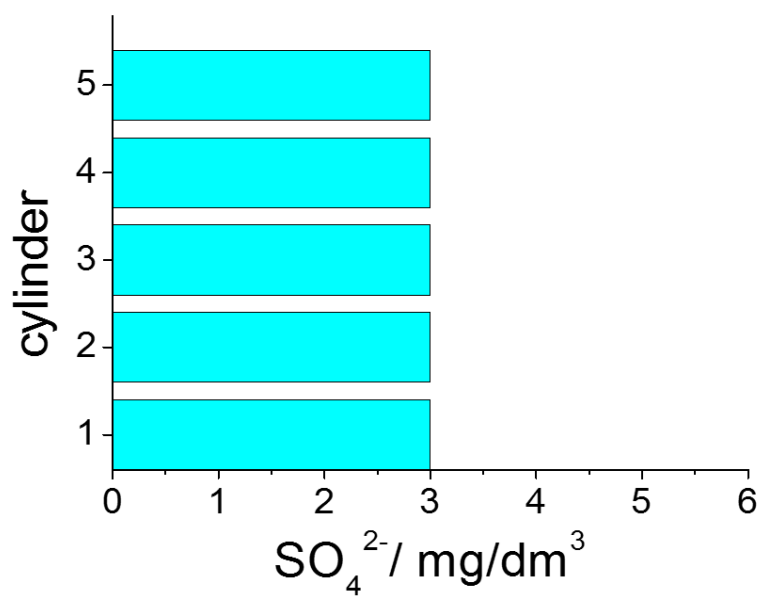
Figure 14

The concentration of sulphate ions is approximately constant along the entire depth profile and equal to  $3\text{ mg/dm}^3$ . It is suggested that the concentration of both chloride and sulphate is

relatively low and does not pose a serious risk to the reinforced concrete elements selected for analysis.

Fig. 14. Concentration of sulphate ions in particular cylinders of core sample from a ceiling of ruins of gas chamber in the former Auschwitz II-Birkenau camp. Cylinder no. 1 corresponds to the bottom part of sample remaining in contact with soil; cylinder no. 2 is the top one.

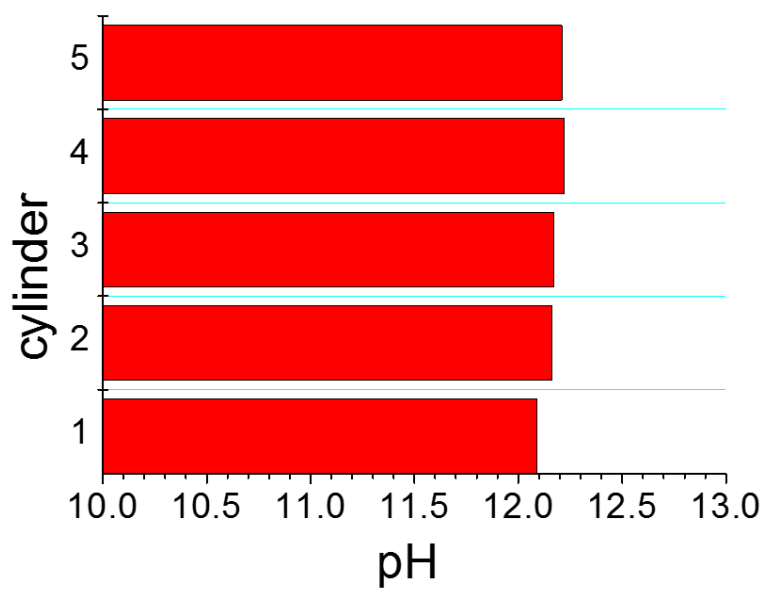
Figure 15

The samples of bigger dimensions (thickness of concrete cover above 20-25 cm) reveal resistance to carbonation – pH of the aqueous extracts is above 12, which means that passive state of the reinforcement is maintained. Fig. 15 presents depth profile of the pH of the aqueous extracts from the core sample taken from ceiling of ruins of gas chamber. No significant carbonation of thick samples is also confirmed by phenolphthalein test illustrated in Figs 16 and 17. Presence of pink colour is the evidence of lack of carbonation process due to maintenance of sufficiently high pH of concrete.

Fig. 15. pH of aqueous extracts from particular cylinders of core sample from a ceiling of ruins of gas chamber. Cylinder no. 1 corresponds to the bottom part of the sample remaining in contact with soil; cylinder no. 2 is the top one.

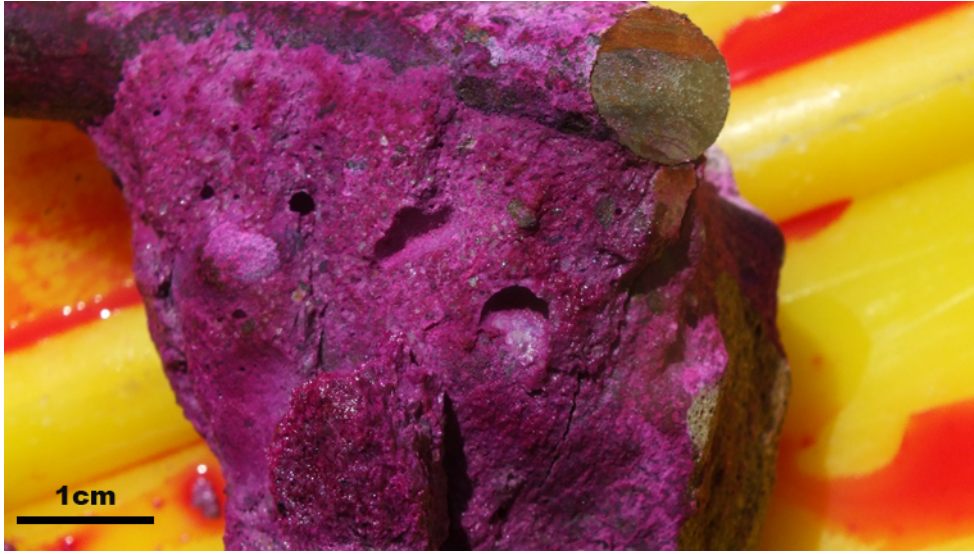
Figure 17

Fig. 17. A fragment of a ceiling of gas chamber in the former Auschwitz II-Birkenau camp collected from bulk of the billet and subjected to phenolphthalein test. Pink colour is the evidence of lack of carbonation process, also in vicinity of the reinforcing bar.

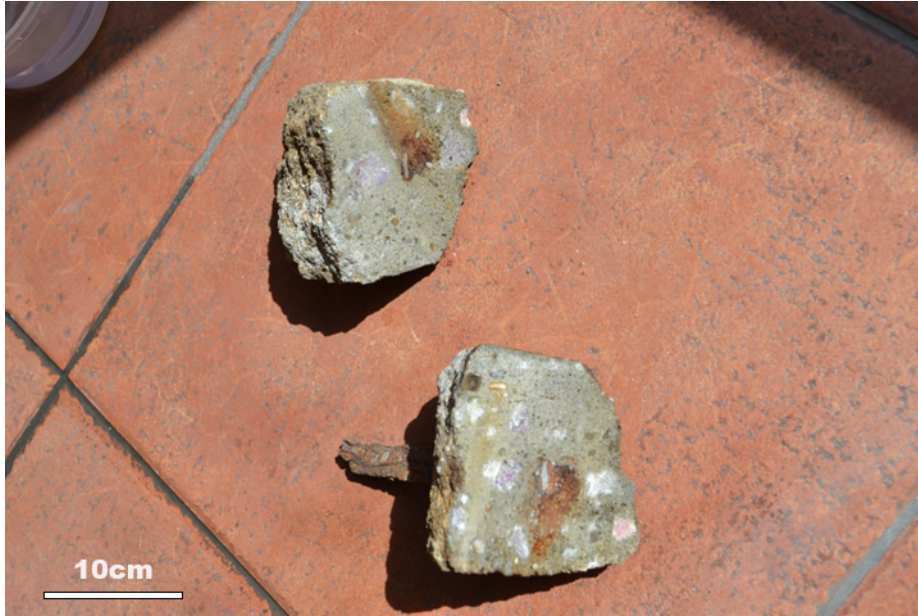
Figure 18

Elements that are smaller and thinner in cross-section suffer from complete carbonation after 70 years of atmospheric exposure. The phenolphthalein test (Fig. 18) as well as pH of aqueous extracts maintained within the range 8-11 suggest significant carbonation. This does not guarantee a passive state of the reinforcement, contributing to reinforcement corrosion and causing concrete to crack and spall.

Fig. 18. Smaller fragments of a ceiling of ruins of gas chamber subjected to phenolphthalein test. Lack of pink colour is the evidence of complete carbonation of the samples.
