# Short and Long Term Measurements in Assessment of FRP Composite Footbridge Behavior

**Figure 1.** Composite footbridge designed within the FOBRIDGE project.

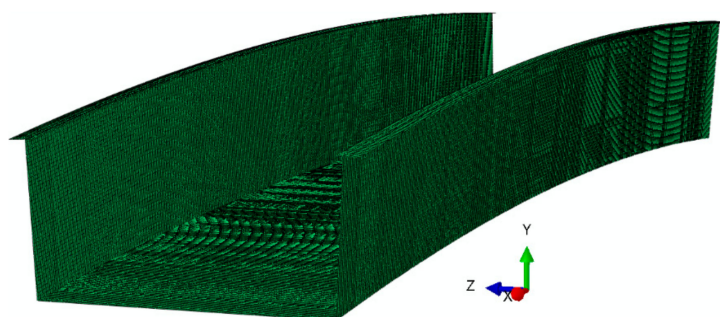
**Figure 3.** Visualization of the footbridge numerical model.

Many finite element method (FEM) computational models with different levels of complexity were created in order to estimate the bridge response under different conditions. They were used to carry on various studies intending to design the footbridge and establish a load tests program, including using a ballast selection or location of network of sensors. All the aforementioned studies were however preceded by complex validation analyses of laminate coupons, sandwich beams and 3 m long full-scale footbridge segment (see references [29,30]). In this paper some FEM estimations of strains and displacements under loads applied during short-term static load test are compared with the in-situ values in order to evaluate accuracy of measurements and modeling. A pure shell equivalent single layer (ESL) (refer to reference [31]) FEM model was used for this purpose (refer to Figure 3), which was motivated by the fact that in this case, only a global response of the bridge needed to be determined and consideration of local effects and influences could be avoided. The precision of numerical results was sufficient and relatively low computational effort was required. It is worth mentioning that the ESL was also found to be used in more sophisticated approaches of shell structures analysis [32].

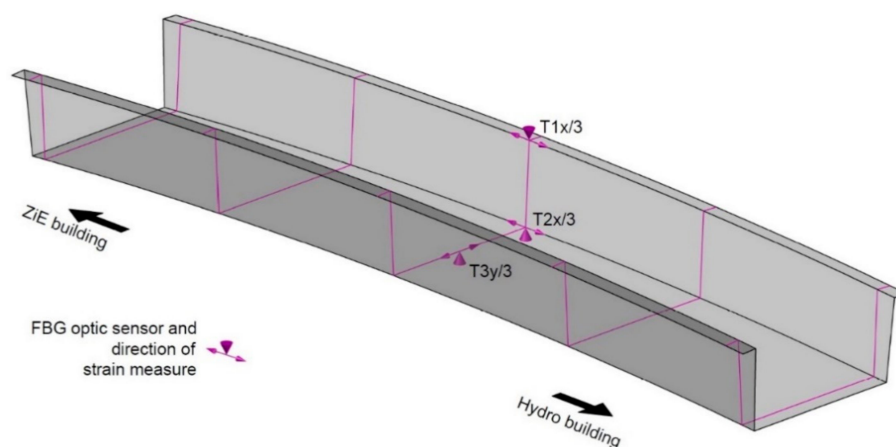
**Figure 5.** Location of FBG optic fiber sensors.

The fiber optic measurement system is based on two kinds of sensors. It includes three Bragg gratings to measure strain and one for temperature compensation. They form a one wire chain, ending in the SC/APC connector, see Figure 4. The following parameters characterize the Sylex (Bratislava, Slovakia) strain gauges used in measurements: 8 mm measuring length,  $0.85 \mu\epsilon$  resolution,  $1.7 \mu\epsilon$  accuracy, range of measure up to  $5000 \mu\epsilon$ . The temperature gauge parameters are:  $0.1 \text{ }^\circ\text{C}$  resolution,  $0.2 \text{ }^\circ\text{C}$  accuracy, in a measuring range from  $-20 \text{ }^\circ\text{C}$  to  $+150 \text{ }^\circ\text{C}$ . The single strain gauge length is 30 mm, it was fixed to the structure by the cyano-acrylate dedicated glue. The measurements were carried out using the Sylex SCN-80 S-line Scan 800 interrogator and a computer with dedicated ILLumiSense Strain software. The locations of the sensors are shown in Figure 5, they are all placed in one cross-section at the mid-span.

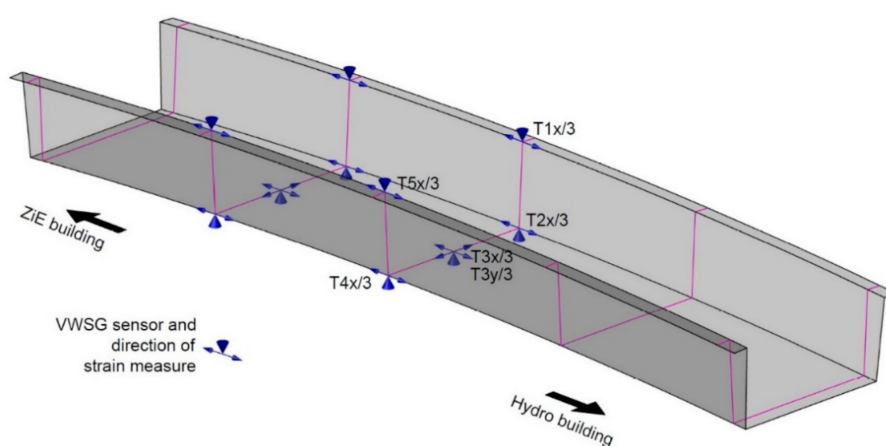
**Figure 6.** Location of VWSG sensors.

The VWSG measurement system is based on twelve GEOKON strain and temperature model 4000 gauges. The strain is measured on the basis of changes in the natural frequency of a string attached to anchor blocks inside a device. The system is characterized by a very good stability during long-term monitoring. The sensors are connected to the 16-channel recorder, which initiates the measurement within a given time interval. The parameters of the sensors are: measuring length of 150 mm, measuring range up to 3000  $\mu\epsilon$ , resolution of 1  $\mu\epsilon$ , accuracy <0.5% FS, temperature range  $-20\text{ }^{\circ}\text{C}$  to  $+80\text{ }^{\circ}\text{C}$ , simultaneous measurement of temperature and strain. The locations of the VWSG are shown in Figure 6. The sensors are placed in two cross-sections, at quarter and mid-span. One of the sensors, being fixed to the bridge deck is presented in Figure 7.

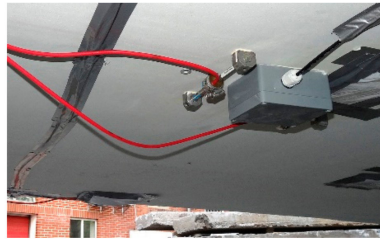
Figure 7. VWSG sensor fixed to the bridge.

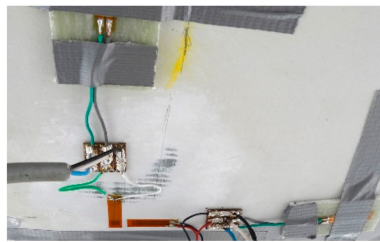
Figure 8. SG sensors mounted to the structure.

The measurement system is based on the electrical resistance strain gauges. The Hottinger Baldwin Messtechnik (HBM) (Darmstadt, Germany) foil gauges are used. They have the following properties: active grid length of 20 mm, 120  $\Omega$  nominal resistance and 50,000 microstrain range. Temperature is compensated in each measurement point using individual sensors, as is shown in Figure 8. The measurements were carried out using the HBM QuantumX MX1615B strain gauge bridge amplifier and a computer with dedicated the CatmanEasy/AP software. The locations of the sensors are shown in Figure 9, they are placed at the quarter spans and at the mid-span and over the supporting area (a rosette).

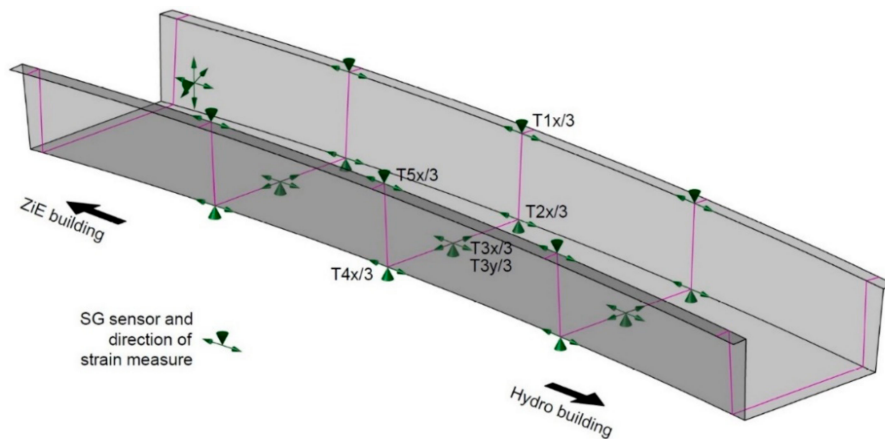
Figure 9. Location of SG sensors.

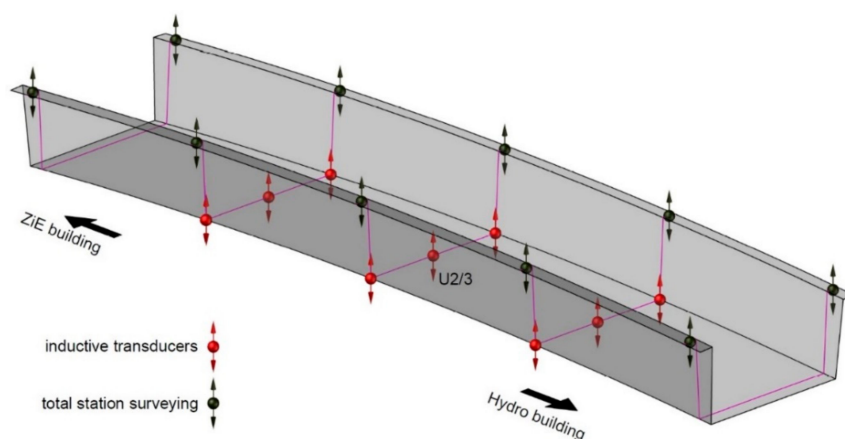
**Figure 11.** Location of displacement measurement points: inductive transducers and total station surveying.

The displacement measurement subsystem includes inductive transducers (see Figure 10) and precision leveling. The nine 100 mm range HBM inductive transducers connected to the HBM MX840B universal amplifiers are located as shown in Figure 11. The precision leveling measurement by Leica Geosystems (Heerbrugg, Switzerland) Nova TM50 Robotic Total Station was achieved with an accuracy of 0.1 mm in the locations presented in Figure 11 as well.

Also, displacements were measured during the short-term test. The example results from inductive sensors are shown in Figures 17 and 18 correspondingly for U1 and U3 tests in U2/3 points, for which extreme values were reported (refer to Figure 11).

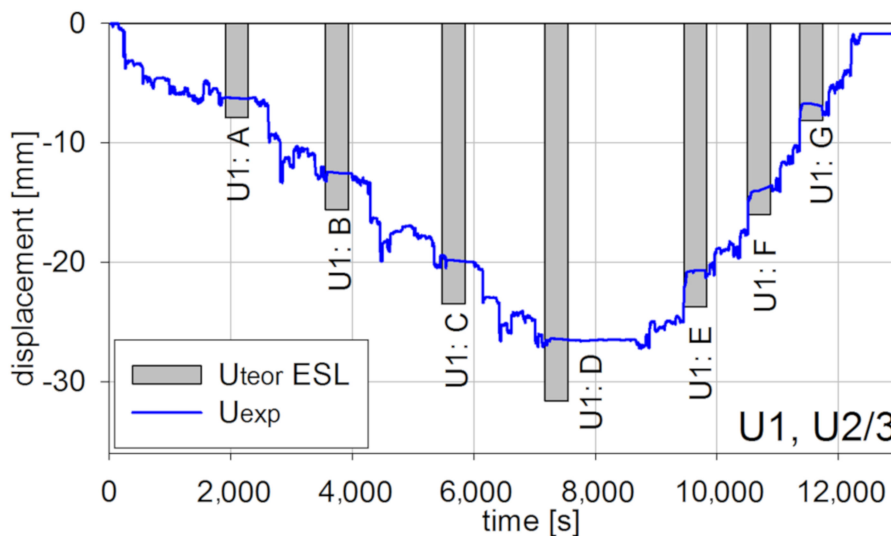
Figure 17. Vertical displacements in U2/3 for the U1 test.

The displacement inductive sensors measurements were checked using geodetic precision leveling and thus assessed as precise. Therefore, they can be used to assess the behavior of the innovative bridge. Similarly as in the case of a strain measure, the in situ measure revealed a stiffness margin for the safety of the bridge.

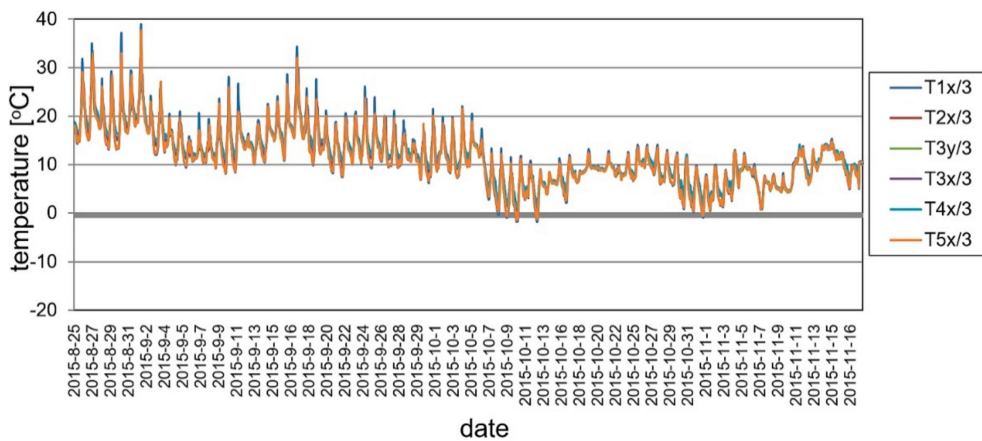
Figure 20. Temperature changes during the long-term load test.

During the long-term load tests (U2 ballast had been left on the deck) the measurement system included VWSG sensors and vibration monitoring, as well as periodic precision leveling. The changes of the mid-span strains in time are shown in Figure 19, while the change of temperature in the same domain of time as presented for strains is shown in Figure 20. The established time intervals measurements in characteristic points of the structure by precision leveling is presented in Figure 21. For more detailed verification, regardless of whether the weight of the ballast caused rheological changes in displacements, the obtained results were normalized with respect to the deflection at start of the test. The result is shown in Figure 22.

As was predicted, only a small strain and displacement deviations are observed because of the diurnal and seasonal changes of temperature. The performance of the bridge did not change because of rheological effects and inelastic strains or permanent displacements did not occur.

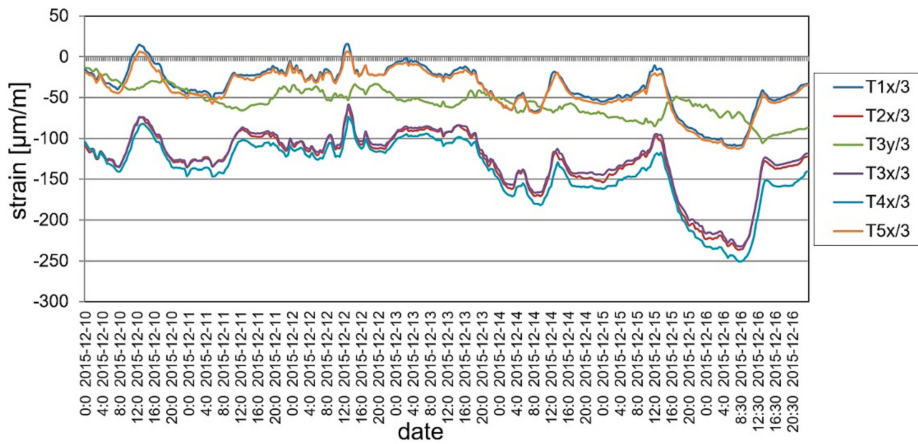
Figure 23. Strain monitoring using VWSG sensors during a one week period.

The structure was still continuously monitored by the SHM system when there were no static loads on the footbridge, between May 2015 and May 2016. In order to maintain readability of the recorded data, the presentation of results was limited to the periods of November 2015 and May 2016. The changes of the mid-span strains in time for ambient testing during a sample week period is shown in Figure 23. The temperature change in the same domain of time as presented for strains is shown in Figure 24. According to the surveillance observations and the gathered data the temperature changes and wind were the main influences affecting the footbridge. It can be observed in Figures 25 and 26, which are strains and temperature time histories throughout the six month monitoring period, that because of these effects, strains range from about  $-400$  to  $400$  microstrains. Nevertheless, higher values were calculated at the stage of bridge designing. Therefore, the SHM strain measurement confirms the safe design and behavior of the bridge for environmental influences. The graphs clearly show the impact of both daily temperature changes and the ones associated with the change of seasons. The research confirmed previous observations that composite sandwich material is sensitive to thermal influences, which should definitely be taken into account when designing this type of structure.

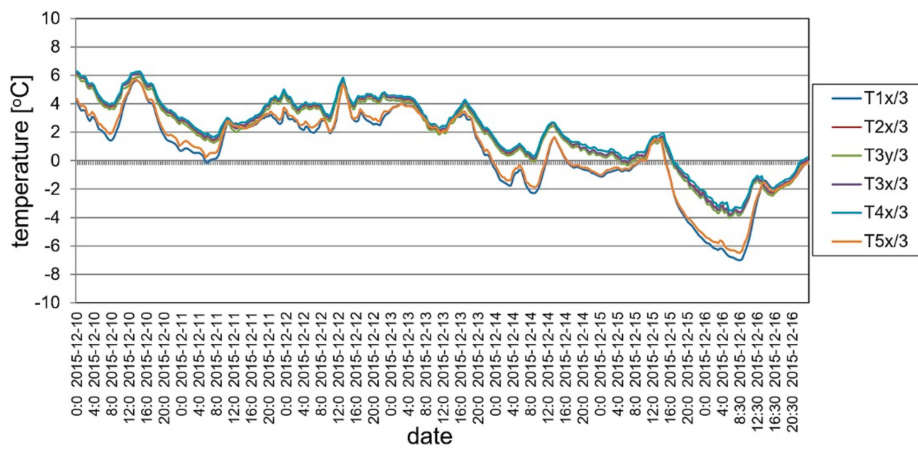
Figure 24. Temperature changes during a one week period.

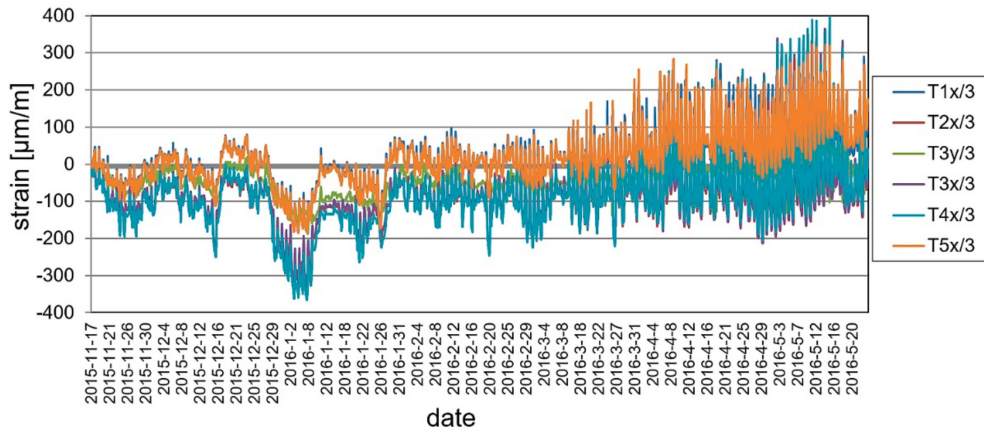
Figure 25. Strain monitoring using VWSG sensors during a six month monitoring period.
