Article

Short and Long Term Measurements in Assessment of FRP Composite Footbridge Behavior

Mikołaj Miśkiewicz

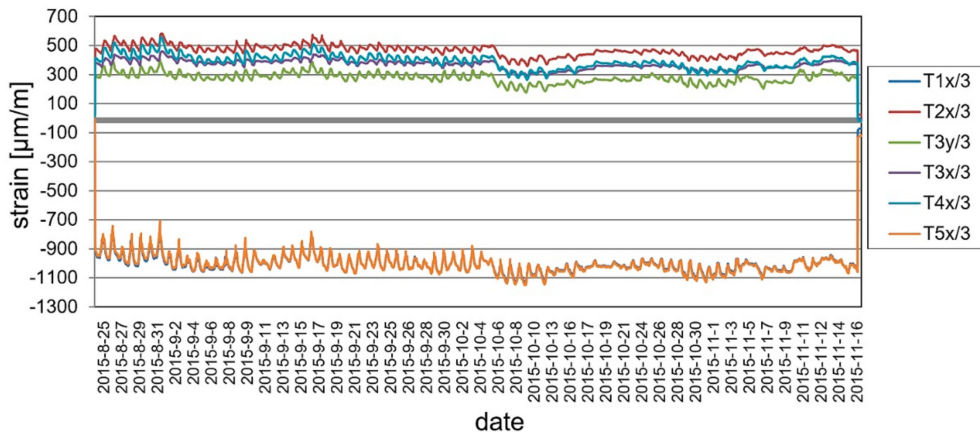
Figure 19. Strain monitoring using VWSG sensors during the long-term load test.

During the long-term load tests (U2 ballast had been left on the deck) the measurement system included VWSG sensors and vibration monitoring, as well as periodic precision leveling. The changes of the mid-span strains in time are shown in Figure 19, while the change of temperature in the same domain of time as presented for strains is shown in Figure 20. The established time intervals measurements in characteristic points of the structure by precision leveling is presented in Figure 21. For more detailed verification, regardless of whether the weight of the ballast caused rheological changes in displacements, the obtained results were normalized with respect to the deflection at start of the test. The result is shown in Figure 22.

As was predicted, only a small strain and displacement deviations are observed because of the diurnal and seasonal changes of temperature. The performance of the bridge did not change because of rheological effects and inelastic strains or permanent displacements did not occur.

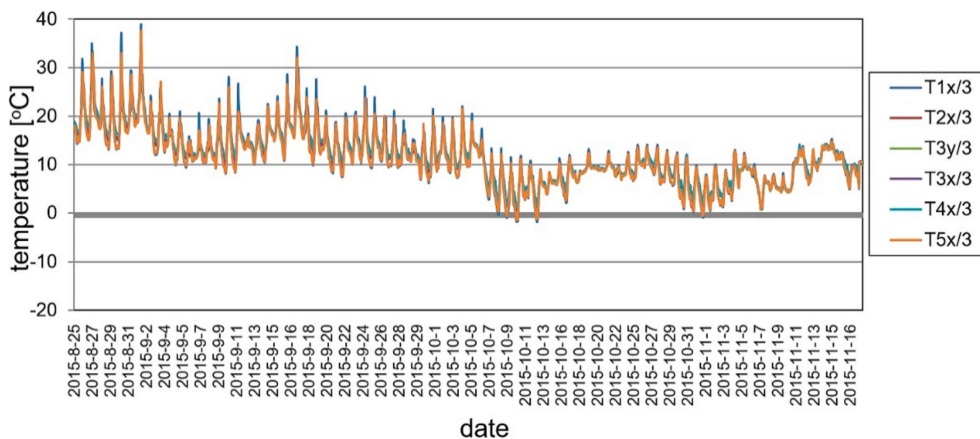
Figure 20. Temperature changes during the long-term load test.

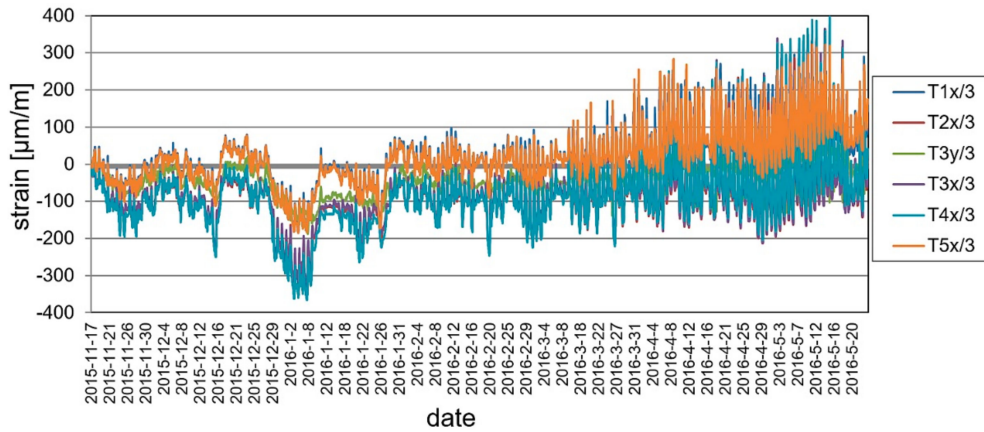
Figure 25. Strain monitoring using VWSG sensors during a six month monitoring period.

The structure was still continuously monitored by the SHM system when there were no static loads on the footbridge, between May 2015 and May 2016. In order to maintain readability of the recorded data, the presentation of results was limited to the periods of November 2015 and May 2016. The changes of the mid-span strains in time for ambient testing during a sample week period is shown in Figure 23. The temperature change in the same domain of time as presented for strains is shown in Figure 24. According to the surveillance observations and the gathered data the temperature changes and wind were the main influences affecting the footbridge. It can be observed in Figures 25 and 26, which are strains and temperature time histories throughout the six month monitoring period, that because of these effects, strains range from about -400 to 400 microstrains. Nevertheless, higher values were calculated at the stage of bridge designing. Therefore, the SHM strain measurement confirms the safe design and behavior of the bridge for environmental influences. The graphs clearly show the impact of both daily temperature changes and the ones associated with the change of seasons. The research confirmed previous observations that composite sandwich material is sensitive to thermal influences, which should definitely be taken into account when designing this type of structure.
