Article

Short and Long Term Measurements in Assessment of FRP Composite Footbridge Behavior

In 2015, the consortium associating Gdańsk University of Technology (GUT), Military University of Technology in Warsaw and ROMA Co. Ltd. (Grabowiec, Poland) constructed a single element, sandwich composite footbridge with a span of 14 m long using vacuum infusion technology (Figure 1). This is the final product of the FOBRIDGE project, which aims to design pedestrian and cyclist bridges made of composite materials for use over dual carriageways and motorways. The footbridges were designed from scratch. The whole process resulting in bridge production included development of a preliminary concept, material selections, identification of material properties, numerical simulations, strength calculations, and serviceability analyses. The structure is innovative aforementioned for these reasons. According to the author knowledge, it has been the first structure in the world to be classified as a consistent, single element structural girder, without any connectors or fasteners, made of sandwich shells, entirely produced in a single cycle vacuum infusion process. The application of non-classical m

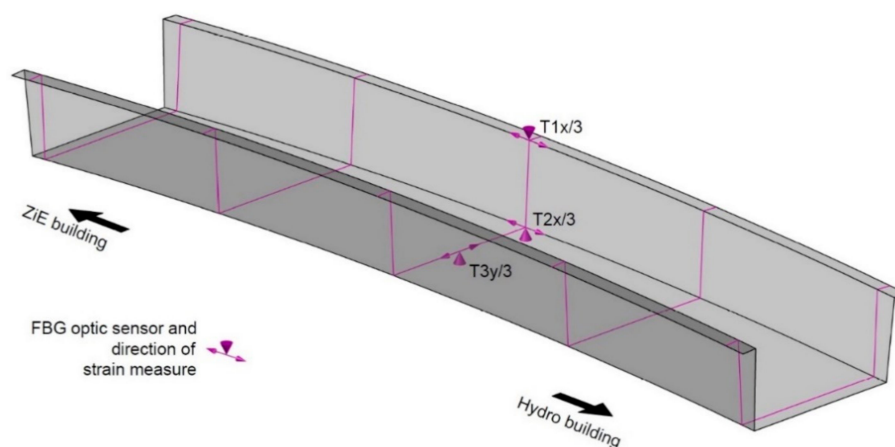
Figure 5. Location of FBG optic fiber sensors.

The fiber optic measurement system is based on two kinds of sensors. It includes three Bragg gratings to measure strain and one for temperature compensation. They form a one wire chain, ending in the SC/APC connector, see Figure 4. The following parameters characterize the Sylex (Bratislava, Slovakia) strain gauges used in measurements: 8 mm measuring length, $0.85 \mu\epsilon$ resolution, $1.7 \mu\epsilon$ accuracy, range of measure up to $5000 \mu\epsilon$. The temperature gauge parameters are: $0.1 \text{ }^\circ\text{C}$ resolution, $0.2 \text{ }^\circ\text{C}$ accuracy, in a measuring range from $-20 \text{ }^\circ\text{C}$ to $+150 \text{ }^\circ\text{C}$. The single strain gauge length is 30 mm, it was fixed to the structure by the cyano-acrylate dedicated glue. The measurements were carried out using the Sylex SCN-80 S-line Scan 800 interrogator and a computer with dedicated ILLumiSense Strain software. The locations of the sensors are shown in Figure 5, they are all placed in one cross-section at the mid-span.
