Article

Nondestructive Testing of the Miter Gates Using Various Measurement Methods

Faculty of Civil and Environmental Engineering, Gdansk University of Technology, 80-233 Gdańsk, Poland; mikbincz@pg.edu.pl (M.B.); przkalit@pg.edu.pl (P.K.); szulwic@pg.edu.pl (J.S.)

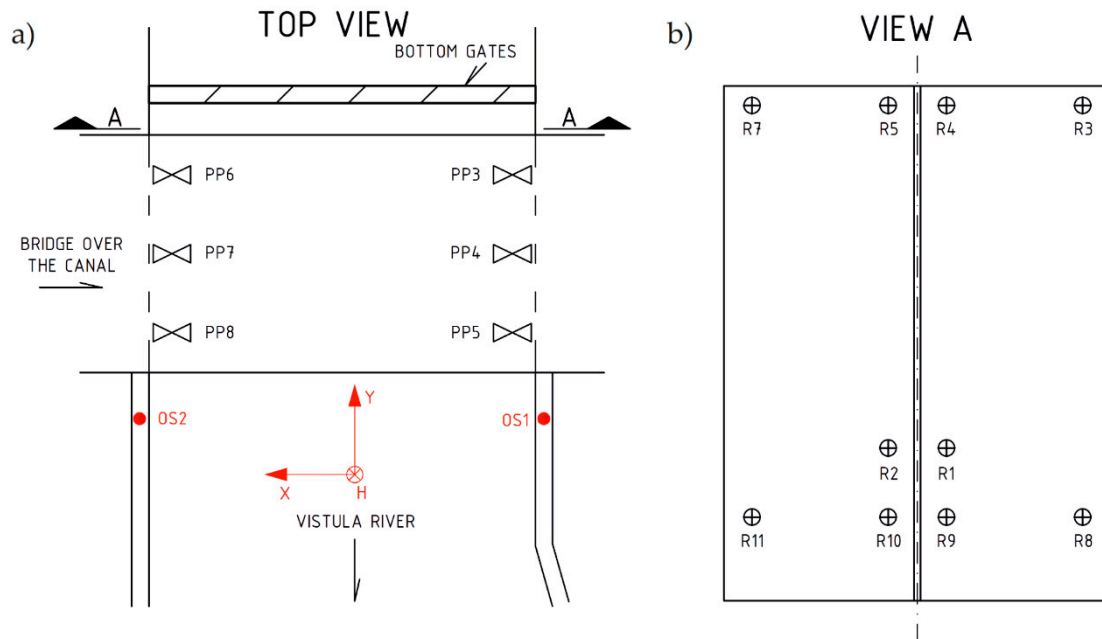
Figure 6. Sketch regarding a location of gates displacement measuring points. (a) Sketch regarding the location of control points and measurement positions, top view; (b) View from bottom water.

Surveying measurements were based on measurements performed with Leica TS30 (Leica Geosystems AG, Heerbrugg, Switzerland) (with a precise mode about 0.6 mm + 1 ppm / typ. 7 s) at data recording precision of 0.1 mm. Figure 6 specifies the locations of control points (from PP3 to PP8), measurement positions (OS1 and OS2), and measuring points (from R1 to R10).

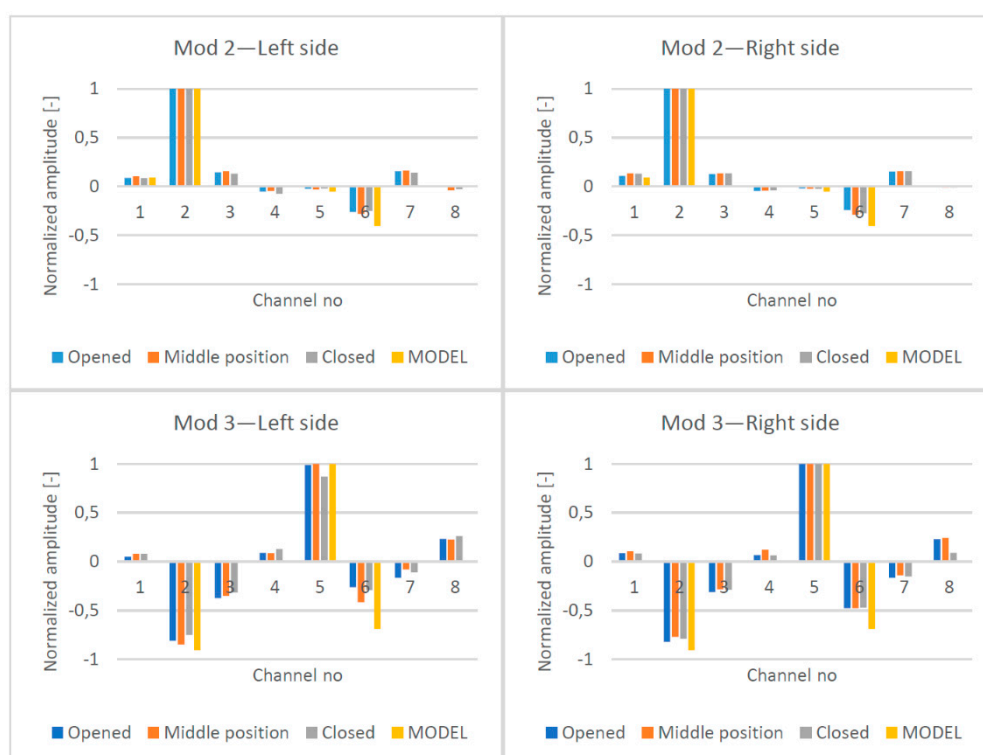
Figure 15. Comparison of the normalized eigenforms identified in three different positions of the gate's leaves for the two identified mods. Yellow bars represent corresponding results from the numerical model.

Dynamic measurements in different positions of the gates' leaves do not indicate any relevant displacements of the support bearings. A small difference between the identified, normalized modal displacements can be a consequence of adherence of the gasket to concrete elements. Differences occur, especially in the case of point K6, which is located near the bottom part of the gates, where the gasket is mounted. In addition to this, eigenfrequencies and eigenforms confirm matching between real structure and the numerical model.
