# Nondestructive Testing of the Miter Gates Using Various Measurement Methods

**Abstract:** When any problems related to civil engineering structures appear, identifying the issue through the usage of only one measuring method is difficult. Therefore, comprehensive tests are required to identify the main source. The strains and displacement measurements, as well as modal identification, are widely used in the nondestructive testing of structures. However, measurements are usually carried out at several points and confirm or exclude only one of many potential causes of the problem. The main aim of this paper is to identify the causes of miter gates' excessive vibration. The research includes displacement measurements using a tachometer and a laser scanner, acceleration measurements connected with modal analysis, and calculations with the finite element method (FEM) model. The numerical model underwent verification regarding test results. Particular attention was paid to evaluate the practical use of a laser scanner for diagnosing miter gates. Unlike classical methods, it measures many points. The analysis eliminated a number of potential causes of excessive vibration and highlighte

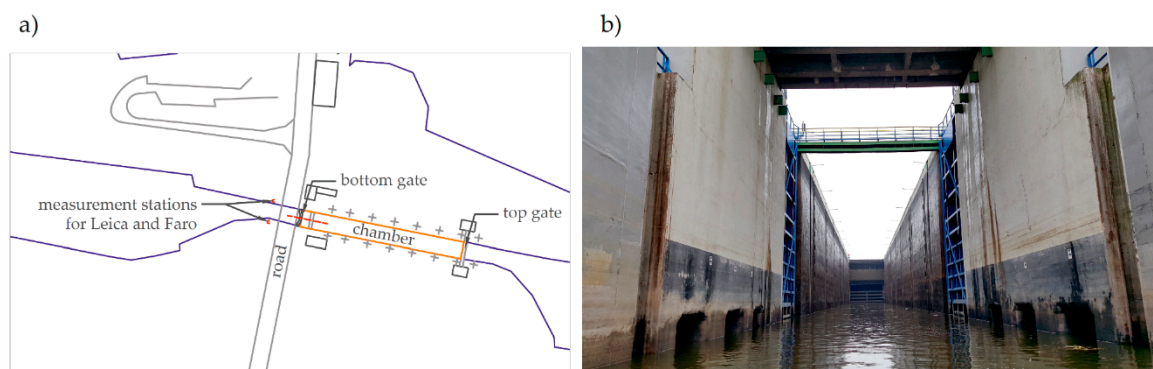
The lock was delivered mainly for navigation purposes, raising and lowering boats, ships, and other watercraft between different levels on the river. The maximum designed drop was 12.80 m, and the actual drop was 14.40 m. The lock, including roadstead, was located on the left bank. It was provided by a chamber with a size 115.00 × 12.00 m, at a downstream bar min. depth of 3.50 m (1.10 m at present). The lock featured a chamber, including the upper head and bottom head (Figure 1). The top closing of the lock was provided by a hydraulically driven segment that ensured water energy dissipation when filling the chamber with water. The bottom head was provided by a hydraulically-driven support gates. The upper and bottom head featured a monolithic reinforced-concrete structure. The chamber was provided with six dock sections, each 16.00 m long, provided with isolation joints. For repair purposes, steel flashboard beams were designed. If necessary, they were installed with a mobile crane. Chamber filling and emptying followed by-pass canals. Canal inlets and outlets were provided inside the heads at the two ends of the lock. By-pass canals carried the water towards the longitudinal chamber gallery, with openings located along the whole length, in the lower part of the chamber walls. By-pass canals were provided with flat gate valves.

**Figure 1.** (a) Diagram of the lock in the Wloclawek river barrage; (b) View of the lock from the bottom side.

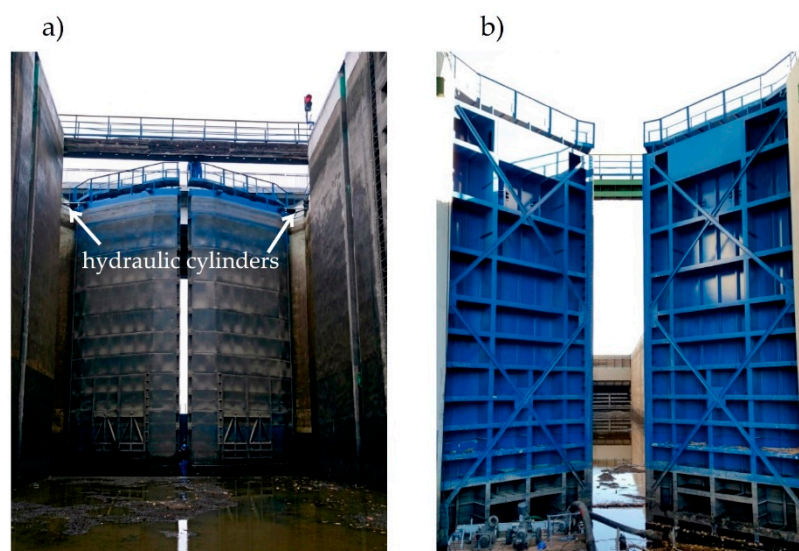
The support gates of the bottom head were related to the movable double-leaf (Figure 2) feature with a frame structure, including I-section girders. The frame was covered with sheet cladding from the side of the lock. The gates' elements were made from steel, with yield strength  $f_y = 235$  MPa. Additional elements included bracing, rubber sealing, arched bearings, and rotating bearings, and top deck. Gates closing and opening were provided by hydraulic cylinders.

**Figure 2.** General view of the Wloclawek lock bottom miter gates. (a) From the side of the lock; (b) From the side of downstream.

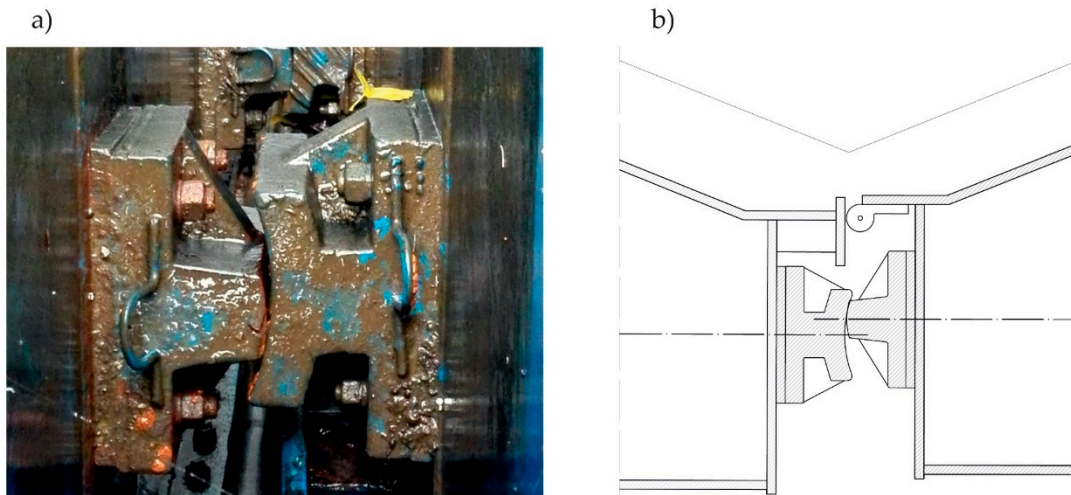
When totally emptied, the structure of the lock chamber underwent inspection based on visual examination, including photo records. The examination indicated misaligned miter bearings. Figure 3a shows a misaligned bearing that was observed. Figure 3b presents a scheme of this phenomenon.

**Figure 3.** Observed misalignment of miter bearings. (a) Real view; (b) Scheme of the top view.

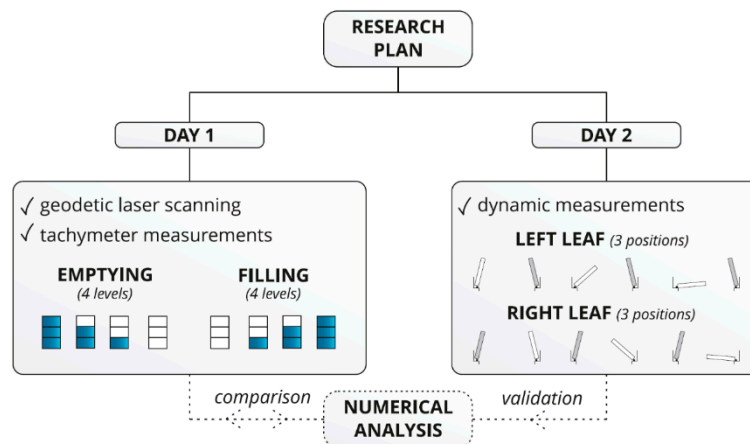
Additionally, consultations followed with operators regarding any noticed cases related to interruption of lock filling and emptying. Operators reported some factors contributing to the sudden movement such as high temperature, strong wind blowing from the east (top water), and the irregular position of miter bearings after gates closing. According to the received information, the following goals of this research were set: To assess the static work of the lock during filling and emptying and assess work and condition of rotational bearings on the top and bottom. To achieve the goals, surveying and dynamical field tests were planned (Figure 4). Before the field tests, a numerical model was created. Static and modal analyses were executed. Static calculations were conducted for a comparison with surveying measurements. Dynamic calculations were conducted to evaluate the quality of the numerical model as comparing with modal model parameters with parameters identified in dynamic measurements. During the first day of the tests, the lock underwent emptying and filling, and each procedure included 4 steps. Following each step, the water level was recorded, including surveying measurements and laser scanning. During the second day of the tests, dynamic measurements were conducted. Six setups were done, 3 per each lock's gates' leaf. In each setup, the leaf had various opening angles, i.e., closed position, midposition between closed and opened, and fully opened position.

**Figure 4.** Diagram of tests regarding the lock in the Wloclawek river barrage.

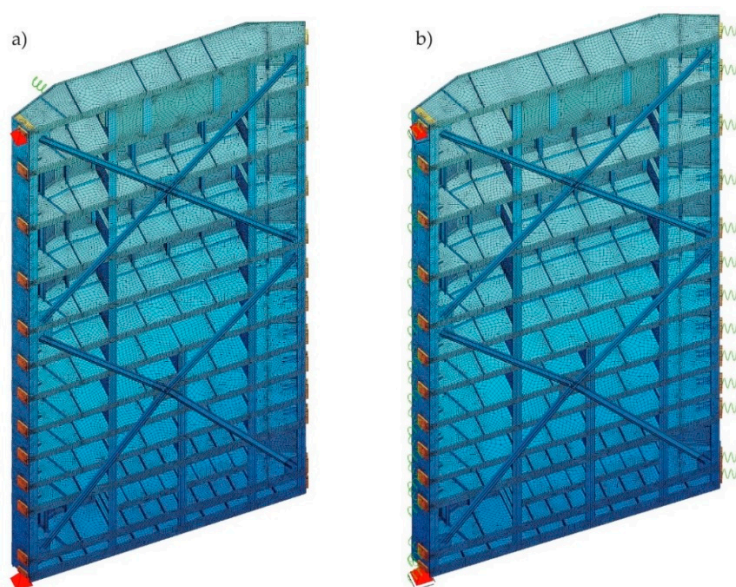
Firstly, static analysis was performed with the numerical model. For this purpose, the 3D model was created with FEM SOFiSTiK. Since the structural geometry of the gates' leaves and the hydrostatic loading are symmetric about the leaf center line, only one of the gates' leaves was modeled. Two-dimensional, four-nodal shell elements and one-dimensional beam elements were used for the construction [39]. The gates' structural elements were elaborated pursuant to design documentation. However, the following assumptions and simplifications were applied in the model. Supports were taken into account by point constraints or elastic supports (springs). The effect of contact of the side and the bottom gaskets was not considered. Due to the different boundary conditions of the gates during opening (separated gates' leaves) and after closing (connected gates' leaves), two different models were established. The first one, named "opened model" (Figure 5a), provided simulation for open gates and allowed the identification of modal parameters. In this model, the rotational bearings were articulated supports. Because other bearings were not involved in the load transfer, they were omitted and only non-structural masses of those bearings and the upper deck were added to the model. The additional spring was mounted in place of the hydraulic cylinder. Its stiffness was established in the calibration process so that the natural frequencies of the modal analysis were consistent with those obtained from field tests. The second model, named "closed model" (Figure 5b), provided simulation for the closed gates and was purposed for static analyses. In this model, the rotational bearings were vertical, articulated, sliding supports. In place of the miter and the support bearings, rigid springs were mounted. Loadings to the "closed model" were provided with dead weight and the following water static pressure:

**Figure 5.** Visualization of the numerical models with different boundary conditions. (a) "Opened model"; (b) "Closed model".

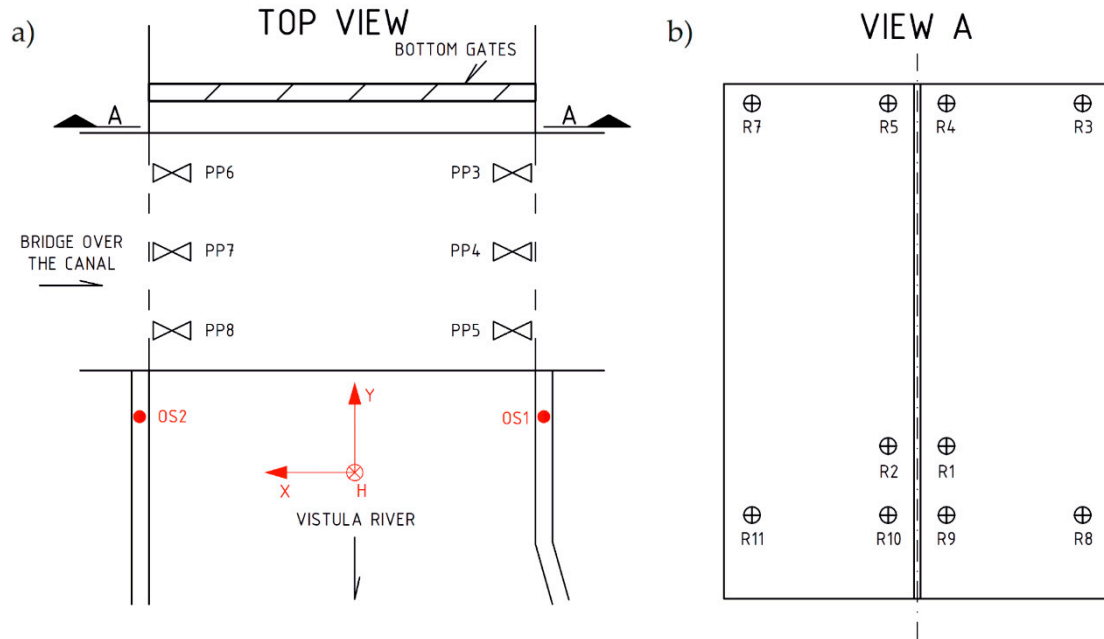
Surveying measurements were based on measurements performed with Leica TS30 (Leica Geosystems AG, Heerbrugg, Switzerland) (with a precise mode about 0.6 mm + 1 ppm / typ. 7 s) at data recording precision of 0.1 mm. Figure 6 specifies the locations of control points (from PP3 to PP8), measurement positions (OS1 and OS2), and measuring points (from R1 to R10).

**Figure 6.** Sketch regarding a location of gates displacement measuring points. (a) Sketch regarding the location of control points and measurement positions, top view; (b) View from bottom water.

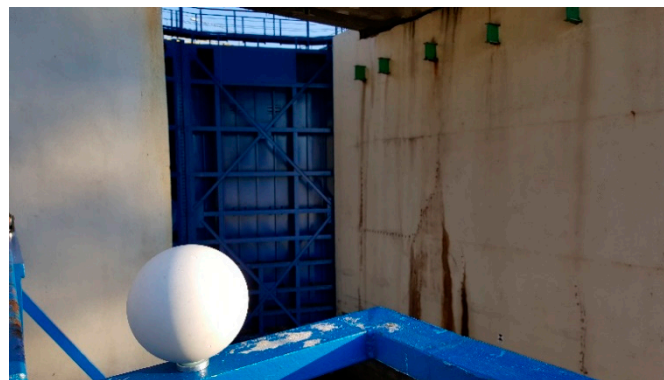
For comprehensive survey and assessment regarding the entire gate deformation, measurements were performed with laser scanning. All measurements were performed using the Faro branded device, Focus 3D X130 (FARO Swiss Holding GmbH, Beringen, Switzerland) (with an accuracy of about 2 mm and a measurement speed up to 1 million points per second). Survey results allowed assessment regarding gates' element deformation during lock filling. Before measurement, stabilization followed 6 flat marks (Figure 6a) to ensure proper coordination of the system, and 6 positioning balls (Figure 7) providing data records at the required accuracy. Due to the gates' dimensions ( $12.50 \times 16.00$  m) and difficulty in accessing the gates, there was a need to take measurements from two different positions (from the left side "OS1" and the right side "OS2", Figure 6) when performing the scanning.

**Figure 7.** Representation of the surveying point during the tests.

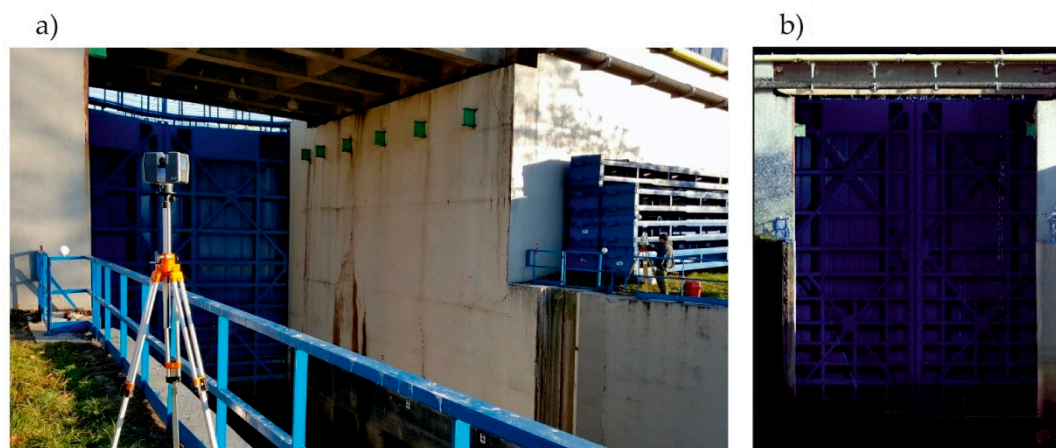
Measurements with a tachymeter and a laser scanner were performed at the following 4 different water levels (Figure 4): (1) level 0/3, (2) level 1/3, (3) level 2/3, and (4) level 3/3. These were static measurements correlated with a constant water level in the lock. Each measuring series was taken for each of the two measuring positions, OS1 and OS2. Figure 8 includes the laser scanner operation and a cloud of points, along with the RGB (red-green-blue) color code.

**Figure 8.** Laser scanner operation. (a) General view; (b) Scanning result, namely, a cloud of points, along with red-green-blue (RGB) color code.

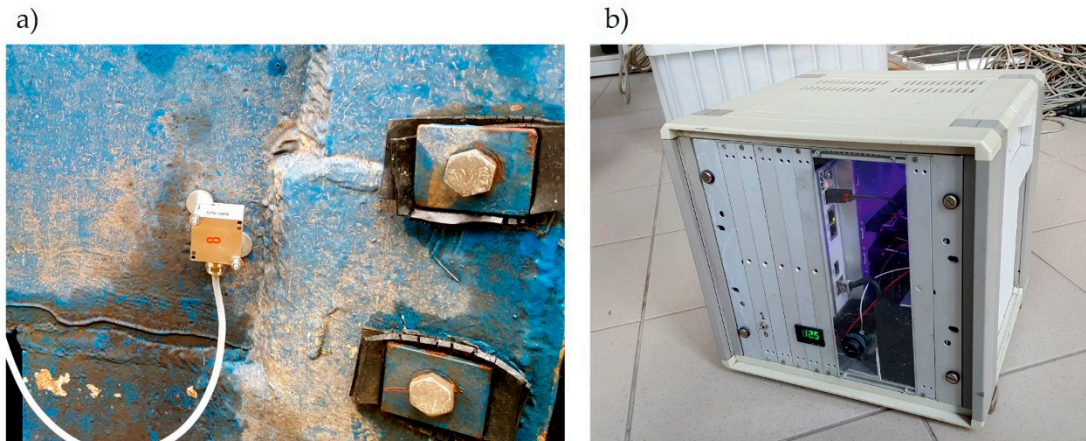
In addition, acceleration measurements were performed on the gates' steel structure. As mentioned, the dynamic measurements had two main purposes, i.e., validation of the numerical FEM model and detecting of the unexpected movements of bearings. The measuring system consisted of the HBM PMX Amplifier (Hottinger Baldwin Messtechnik GmbH, Darmstadt, Germany) system, 4 MEMS (Micro Electro Mechanical System) Direct Current (DC) response accelerometers, and wires. The amplifier was connected by an Ethernet wire to a PC computer. HBM CatmanEasy (Hottinger Baldwin Messtechnik GmbH, Darmstadt, Germany) software installed on the PC was used in the configuration of the system and data acquisition. The used amplifier was designed for, and typically utilized in, industry control systems. However, after some modifications, its parameters allowed researchers to use it in laboratory and field tests. Improvements were carried out by the crew of the Field Test Laboratory of the Technical University of Gdansk. The amplifier was covered with a stiff box to protect it from mechanical damage and adverse weather conditions. Additionally, a battery was inserted into the box. Therefore, after connection with the PC computer (notebook type), it created a stand-alone, portable, 16-channels measuring system, which could be used for up to 8 hours without access to electricity. Another advantage was the elimination of redundant, additional vibrations coming from the electric generator's work. It was especially significant to use low-noise sensors when low-magnitude vibrations are measured. Thus, the created acquisition system is very universal and convenient for field tests on bridges and other infrastructure constructions. In the system, following MEMS DC response, 4 to 20 mA signal output sensors were used as follows: 2 tri-axial accelerometers TE 4332M3-002 (TE Connectivity Ltd., Schaffhausen, Switzerland) and 2 one-axial accelerometers TE 4312M3-002. The following characteristic parameters of these accelerometers were: range  $\pm 2$  g, sensitivity 4.0 mA/g, frequency response 0 to 200 Hz, and natural frequency 700 Hz. The noise measured on the gates' leaf, if no intentional load was applied, was in the range of  $\pm 0.005$  m/s<sup>2</sup>. The acquisition sampling rate was established to be 300 Hz. If predicted, interesting natural frequencies of the gates were below 30 Hz, it was evaluated as high enough to ensure the obtainment of all information about vibrations. Figure 9 shows the instrumentation for the acceleration measurements.

**Figure 9.** (a) Used tri-axis accelerometer TE 4332M3-002; (b) The individually improved HBM PMX Amplifier.

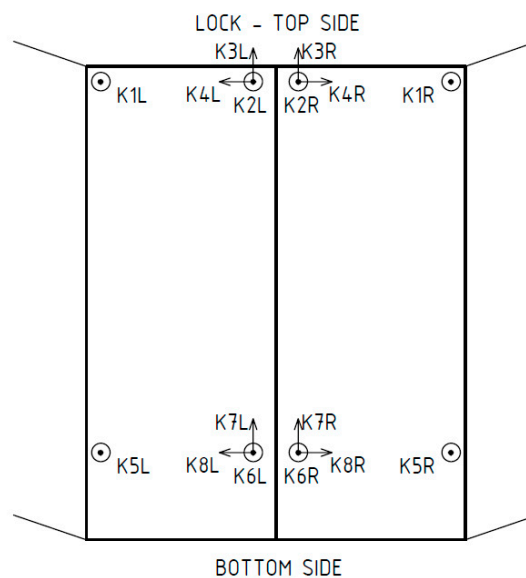
In each of the 6 positions, the gates' leaf was excited three times to natural vibrations, and then was left until vibrations damped. The measurements were carried out separately for the left leaf and separately for the right, as shown in Figure 4. Figure 10 specifies the location of the accelerometers placed on the gates' steel structure. The same sensors were used for both leaves. Therefore, the letter "L" (left leaf) or "R" (right leaf) was added, as shown in Figure 10, for channel markings. The gates were excited to vibrations by shaking the bridge railing, by one of the researchers standing on the top of the gates' leaf. The direction of the shakes was perpendicular to the gates' surface. The starting frequency of shaking was approximately 4 Hz, and during excitation, it was adopted to the natural frequency. After obtaining acceleration amplitudes close to  $1 \text{ m/s}^2$ , the shaking stopped. For analysis, when the shaking stopped and vibrations were damped to about  $0.5 \text{ m/s}^2$  was used as a signal.

**Figure 10.** Location of the control points on the gates and the direction of the acceleration measurements.

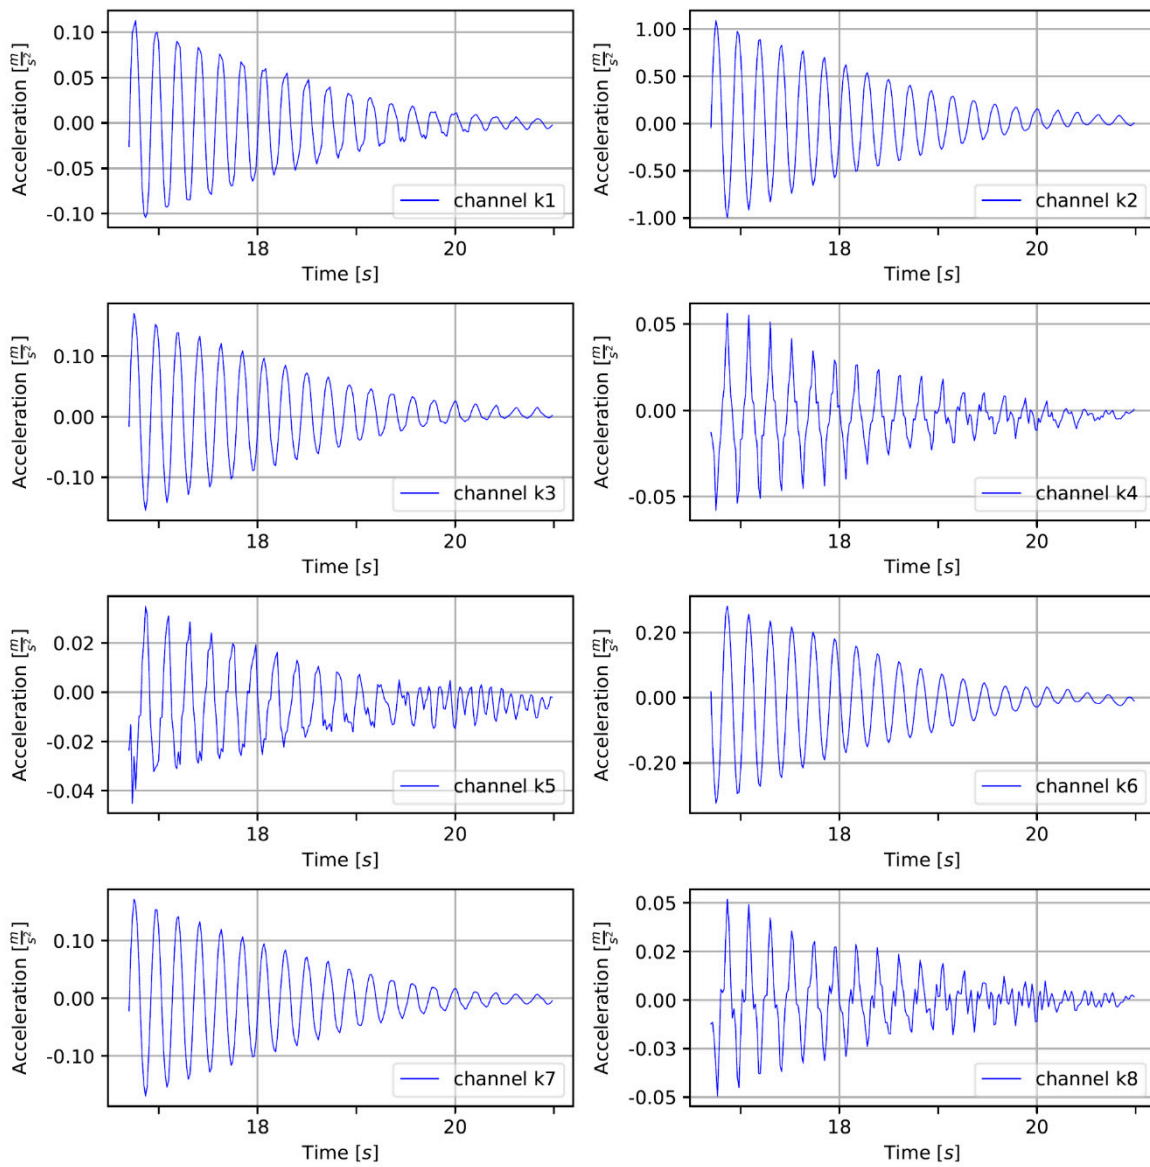
Before static analysis, the model underwent verification provided by comparing model eigenforms and eigenfrequencies with those identified in the field tests. Figure 11 shows an example of the measured accelerations in the gates' left leaf in the middle position after shaking stopped. Each signal underwent basic, preparing processing, the constant component was removed, and the appropriate natural vibrations were cut from the whole series. To ensure better results in the ERA, in the range of lower frequency (0–15 Hz), the signal was downsampled to 60 Hz. To build the Hankel matrix, the following parameters of shape were used:  $\alpha = 12$  and  $\beta = 200$ . To identify stable modes, stabilization diagrams were used. Figure 12a presents an example of the classic version of the diagram, where all calculated poles are presented. On the chart, marked with red crosses, on the one hand, are poles which were evaluated as real as compared with results from previous iterations. On the other hand, the poles evaluated as numerical and artificial are marked with blue dots. Figure 12b shows a filtered version of the diagram. Here, only stable modes are shown. Additionally, on the background of the diagrams, a spectral density of signals is presented to demonstrate compatibility identified in the ERA modes and FFT results.

**Figure 11.** Acceleration measurements at points K1L to K8L during natural vibrations of the left gates' leaf.

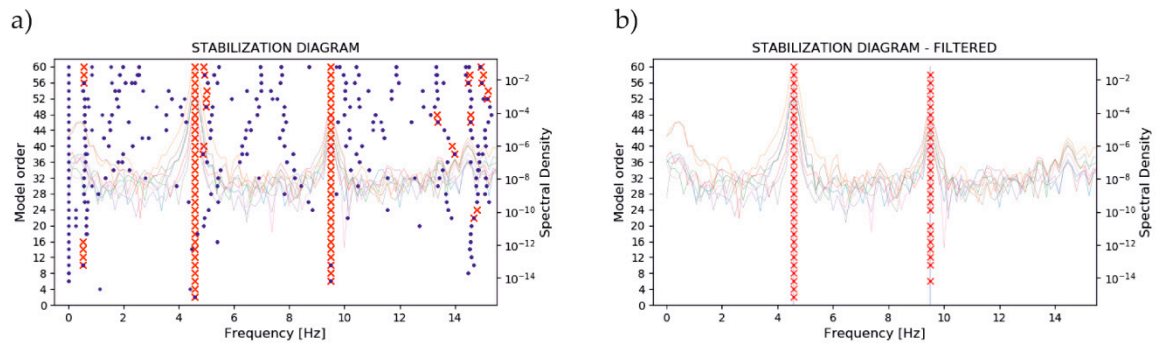
Among all measuring series, for both gates' leaves, in the range to 10 Hz, two eigenmodes always occurred. Sometimes, in the results, one more stable mod appeared and its frequency was below 1 Hz. Subsequent analysis confirmed that it was the first mod of opened gates. However, it did not show up in all measurements, and cannot be taken into account for comparisons and diagnostics. Table 1 summarizes the identified natural frequencies for the second and the third mod for each leaf separately.

**Figure 12.** Stabilization diagram created for the gates' left leaf. (a) Classic version; (b) Filtered version.

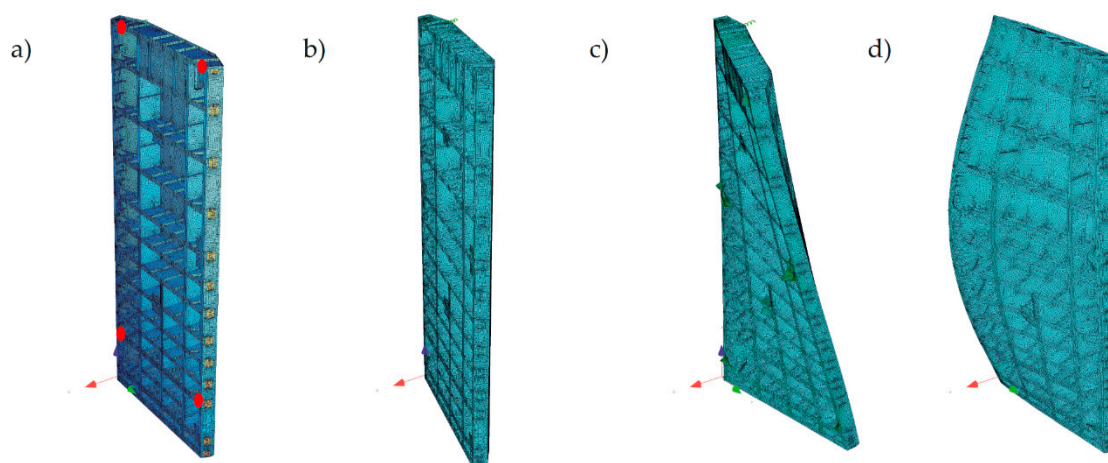
The “opened model” was used for the purpose of modal analysis. The model was validated by adding non-structural masses to the top deck and the miter bearings. First, three eigenfrequencies and eigenforms were determined (Figure 13) and both, identified in the tests and determined in the FEM analysis, were similar. The ratio between that identified in the test frequency and that from the FEM model was in the range of 99–102% for the second mode and in range of 98–101% for the third mode. Those which were identified in the field test eigenforms for the direction perpendicular to the gates’ surface are presented in Figure 14. All eigenform coordinates were normalized. The linear connection between points was applied only for the visualization of mutual distances. For each leaf position and for each mod, the eigenforms were compared (Figure 15). All measuring points (K1 to K8) were included in the chart. Additionally, the normalized displacements of nodes were read from the numerical model for the second and the third mod. Appropriate nodes were chosen according to the location of measuring channels K1, K2, K5, and K6. The obtained frequencies and eigenforms for each mod were similar. Differences in frequencies and eigenforms, dependent on position, indicate that there were factors that slightly influence modal parameters. We discuss this phenomenon later. Although, from the aggregation of forms, it can be concluded that in all of the selected positions, the structure works in the same manner. Also, the displacements identified in channels related directly to potential bearings’ movement (K4 and K8) did not reveal any disturbing values. The above results indicate that the assumed stiffness and elements’ mass were established properly. The numerical model represents the real structure with a sufficient degree of precision. Therefore, there is the possibility of a comparison of calculated and measured at real structure displacements.

**Figure 13.** Frequency and eigenforms of the gates’ leaf according to the “opened model”. (a) Original geometry; (b) First eigenform,  $f = 0.51$  Hz; (c) Second eigenform,  $f = 4.62$  Hz; (d) Third eigenform,  $f = 9.46$  Hz.

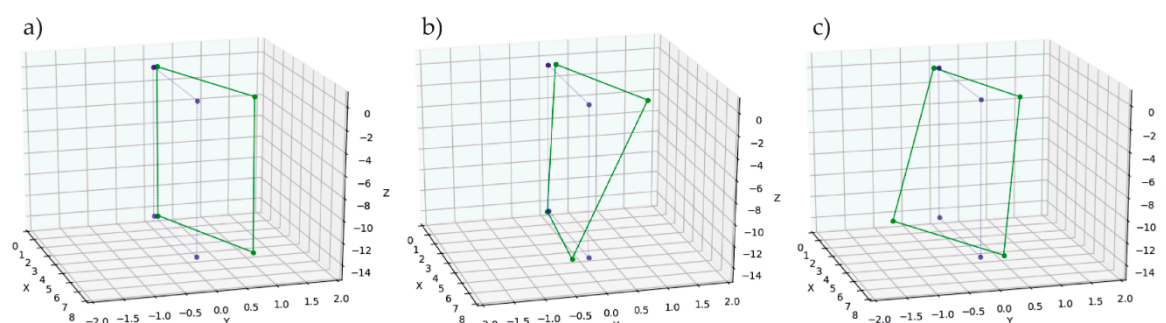
**Figure 14.** Identified in the eigensystem realization algorithm (ERA) eigenforms. (a) 1st; (b) 2nd; (c) 3rd. Blue points indicate the original positions of sensors. Green marked points displaced according to identified eigenform shape.

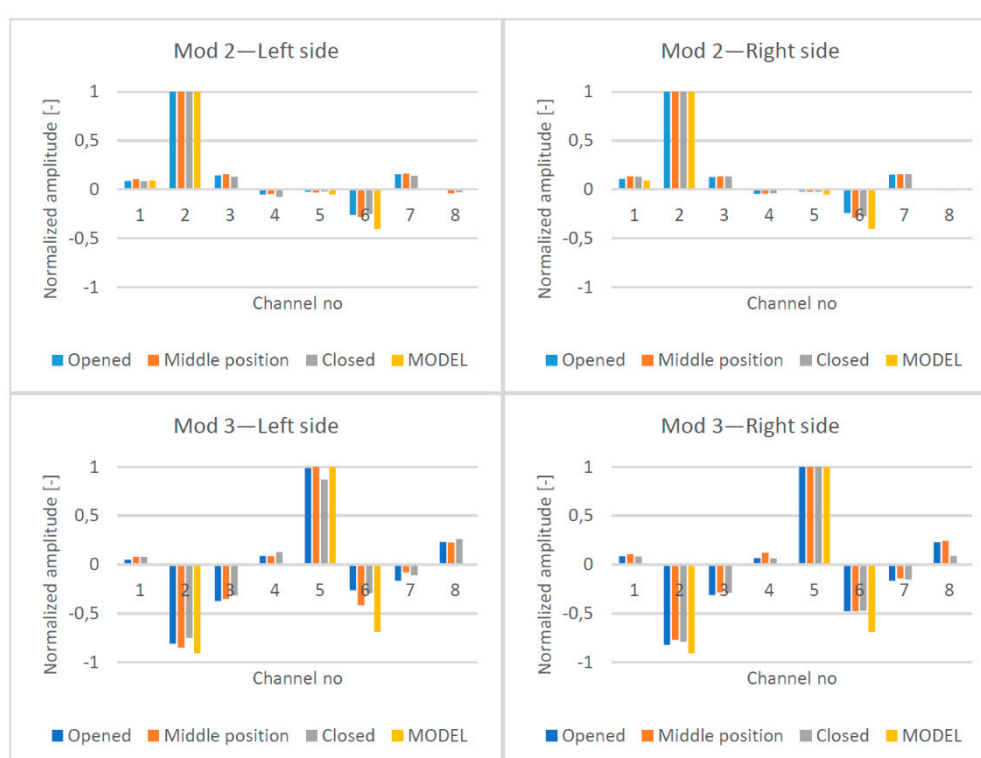
**Figure 15.** Comparison of the normalized eigenforms identified in three different positions of the gate's leaves for the two identified mods. Yellow bars represent corresponding results from the numerical model.

Dynamic measurements in different positions of the gates' leaves do not indicate any relevant displacements of the support bearings. A small difference between the identified, normalized modal displacements can be a consequence of adherence of the gasket to concrete elements. Differences occur, especially in the case of point K6, which is located near the bottom part of the gates, where the gasket is mounted. In addition to this, eigenfrequencies and eigenforms confirm matching between real structure and the numerical model.

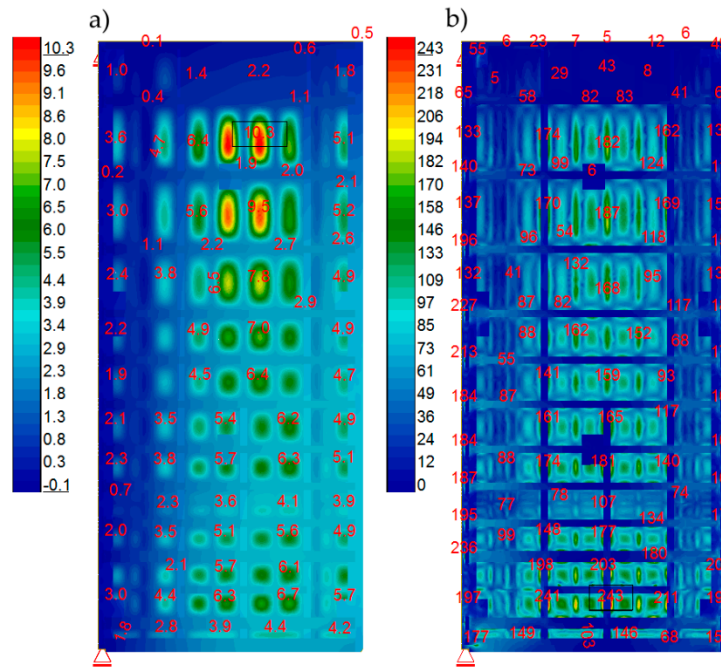
Afterward, the verified FEM model was loaded with static water pressure at different water levels in the lock. A “closed model” was used for this analysis. The calculated load cases were as specified previously: A, B1, B2, and B3. Figure 16 specifies the results for Case A. This case represented a simulation regarding the lock gates under maximum load. It was employed to determine the maximum stress of structural elements. Calculated von Mises stresses for frame girders were not exceeded (Figure 16b). Values over 235 MPa were recorded for sheet cladding at joints with girders. They were local and resulted from the connection of the frame and the sheet in the numerical model. To obtain accurate results for these areas, a detailed numerical model was required. The load cases B1, B2, and B3 represented in-between situations that occurred during emptying and filling the lock. Actually, they corresponded to phases assumed for measurements with the tachymeter and laser scanning. Figure 17 shows the calculated displacements of the structure obtained during particular lock filling phases.

**Figure 16.** Calculation results regarding load A. (a) Displacements [mm] at water thrust direction; (b) Maximum von Mises stresses [MPa].

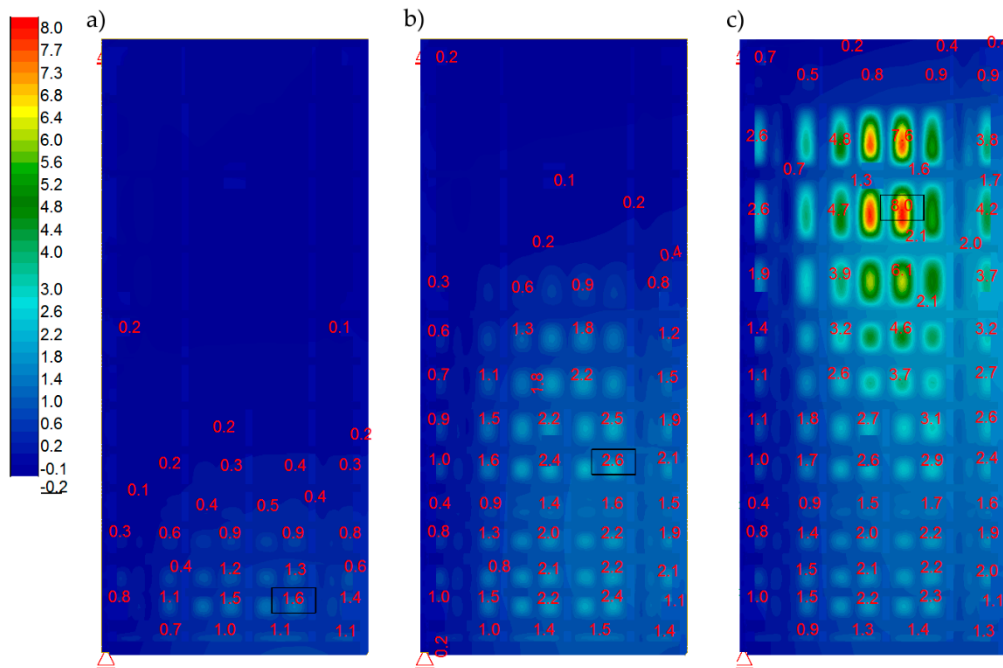
**Figure 17.** Calculated displacements [mm] at water thrust direction for respective loads. (a) B1; (b) B2; (c) B3.

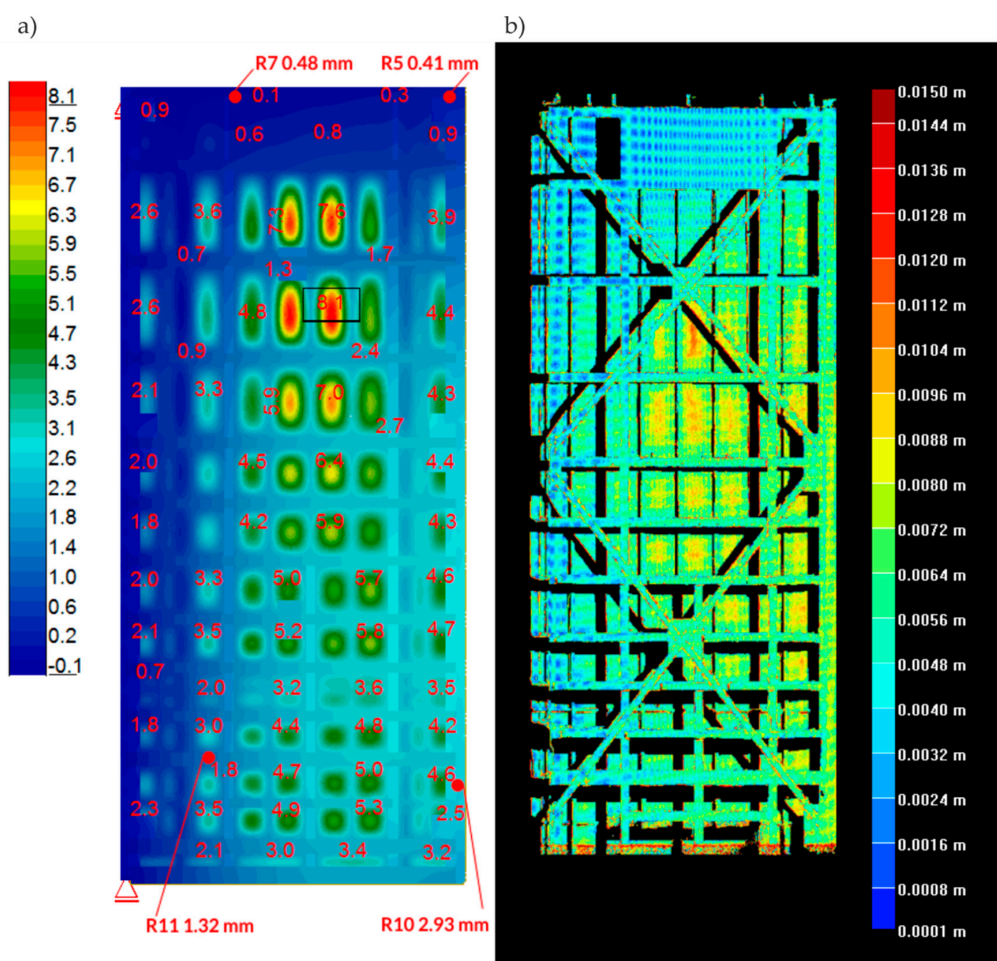
Note, at minimal water level, the minimal opening of the lock gates followed as a result of wind. During the initial filling phase, the displacement was also affected by the deformation of the gaskets. This fact explained the difference between dY displacements during filling and emptying. In addition, because of this, the diagram regarding top water increases from the 1/3 to the 3/3 level was used, as the most representative for the comparative analysis of displacements. The comparative analysis was performed regarding displacements at Y direction (horizontally at longitudinal direction) obtained during surveying measurements and laser scanning against numerical calculations. Figure 18 includes graphics of the results. On the map of displacements calculated with the numerical model (Figure 18a), four points are marked. The exact values of the calculated displacements are given. At these points, the measurement was performed with the use of a tachymeter. Table 4 shows a comparison of the calculated and measured displacements. Attention should be paid to two points (R4 and R5), for which the differences are in the order of several hundred percent. For the remaining points, the differences are much smaller. In Figure 18b, laser scanning results are presented. They were calculated by subtracting the coordinates of the two point clouds from two different measurements.

**Figure 18.** Comparative analysis regarding displacements at Y direction from. (a) Numerical model (mm); and (b) Laser scanning (m), top water increases from the 1/3 to the 3/3 level.

The comparative analysis was performed regarding measurements and calculations of structure displacement resulted from water level change from 1/3 to 3/3. Horizontal displacements, at a direction parallel to the gates' surface obtained based on the numerical model and the measurements with the tachymeter, were similar. Insignificant variance resulting from gates additional displacements resulted from pressure and gasket deformation at the initial phase during lock filling, which is a natural effect. Thanks to the miter gasket's deformation the sealing of gates was provided. The numerical model did not include this phenomenon; only points close to the miter axis indicate an anomaly. Displacements measured with tachymeter in points R5 and R4 (miter top corner) are significantly different than those obtained with the numerical model. However, the remaining results indicate that structure operation was consistent with the numerical model (design input). Therefore, we could exclude any significant damage to the main structural elements.

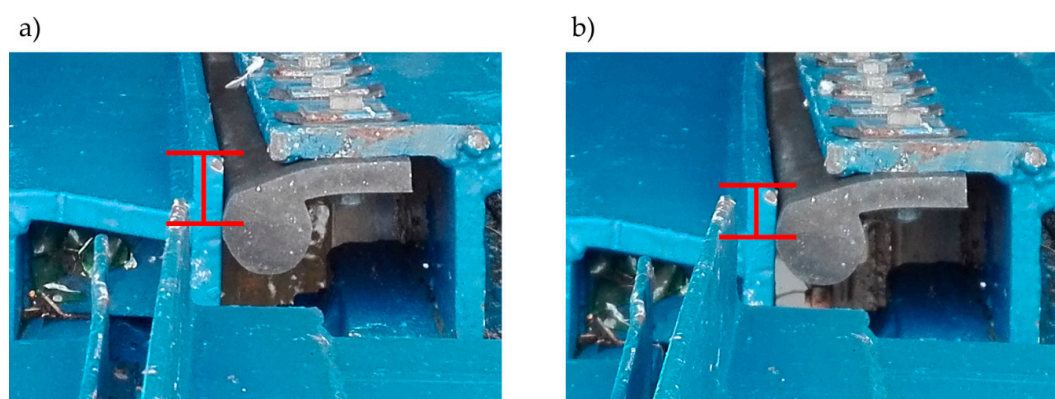
In summary, the visual examination and analysis regarding surveying measurements, vibration measurements, and laser scanning indicate that miter gates work properly, although all of the field tests were conducted without the occurrence of sudden movement. Thus, we concluded that only in the case of normal conditions does the operation of the gates work properly. All of the comprehensive measurements allow researchers to conclude that the rotating bearings work without redundant lose, and if sudden movement does not occur, the miter gates are characterized by elastic behavior. The differences between the measured and calculated displacements in the R5 and R4 points could indicate that boundary conditions close to these points can vary in structure and in the numerical model. During the visual examination, misaligned positions of the miter bearings were noticed. Unfortunately, no sudden movement was observed during the measurements. However, photographic documentation was taken before and after the example of sudden movement. Figure 19 shows the mutual position of the left and the right leaves after and before a sudden movement. The difference in the position of the leaves is marked with a red line. During a sudden movement of the miter gates, the miter bearings shifted. In [59] a similar problem was presented, which occurred in the case of the Red River Lock and Dam no 1. In [1], the authors also paid attention to the importance of adherence of the bearings for the appropriate distribution of loads. In our case, there is a possibility that the miter gates before filling are closed with misaligned miter bearings. It is hypothesized that, subsequently, the water level increases against the gates, and at some point, the pressure causes the leaves' self-adjustment. The gates final closing follows suddenly and results in a significant horizontal force transfer onto other adjacent structural elements, consequently, increasing vibrations.

**Figure 19.** The shift between the gate's leaves. (a) Position after sudden movement; (b) Position before sudden movement.

The research of the analyzed structure was performed using multiple methods that allowed assessment regarding different performances of the structure. The comprehensive analysis of all results enabled us to exclude some potential causes of excessive vibrations. Dynamic measurements were used to assess the condition of rotational bearings and confirmed their lack of redundant lose during operation. The correct operation of the rotational bearings was checked by comparing the eigenforms of the gates' leaves in different opening positions. Additionally, thanks to the dynamic results, the numerical FEM model could be validated. The tachymeter measurements provided information about the generally elastic behavior of the gates during operation. Although, as compared with the FEM results, they also indicated points at which behavior is inappropriate. Deformations of these parts of the structure (near points R4 and R5) probably are caused by misalignment of miter bearings. The results from laser scanning are consistent with the FEM results in terms of direction and shape of deformation, also in both cases, an order of magnitude of displacements are similar. The laser scanning has been proven to be a method that can only generally present the deformation of the structure. Due to the subtraction of coordinates from two different point clouds, the accuracy of this measurement is insufficient to assess displacements in detail. In the authors' opinion, laser scanning can be used to measure displacements if they are significantly bigger than error arising from point clouds subtraction. However, it should be pointed out that all of the conducted measurements are significantly faster and cheaper in execution than is typical for cases utilizing strain gauges. Additionally, all of the employed methods provided mutual verification. The new combination of comprehensive measurement methods in nondestructive testing of the miter gates excluded some potential reasons of excessive vibrations. Nevertheless, further investigation should focus on researching how misalignment of miter bearings influences sudden movement existence. A possible option is to utilize inductive sensors between miter bearings to acquire mutual displacements. Another one is to use strain gauges and to detect indirectly the bearings without adherence.
