Article

The influence of welding heat input on the quality and properties of high strength low-alloy dissimilar steel butt joints

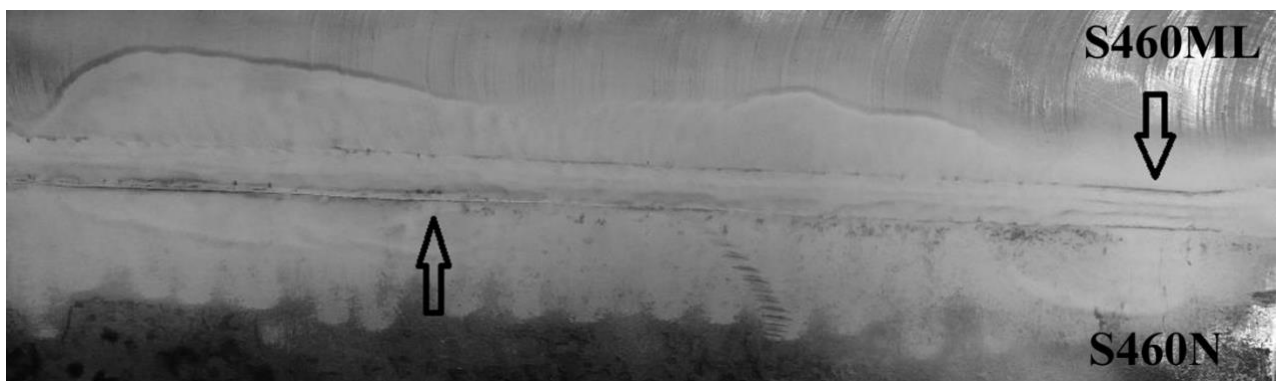
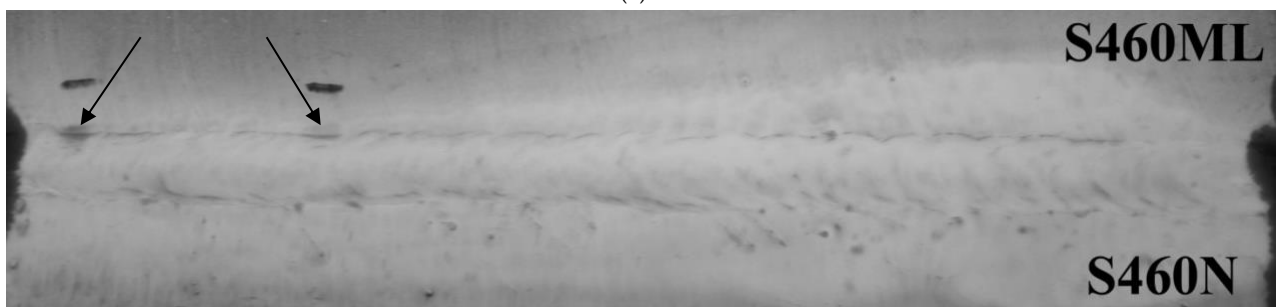
Fig. 4. Results of PT: a) Specimen 1, porosity in the middle, indication at right; b) Specimen 2, lack of fusion marked by lines

Before applying the penetrant, the surfaces were cleaned and the spatters were removed from them. A penetrant was then applied, the excess of which was removed with a cleaner after ten minutes, to then apply a developer layer. During the examination of the first sample, two indications appeared on both sides of the weld at the fusion line and a cluster of blisters at the place indicated during VT tests from the S460N steel side. Examination of a sample welded with lower heat input showed no other indications than in VT tests. The results of PT testing are presented in figure 4.

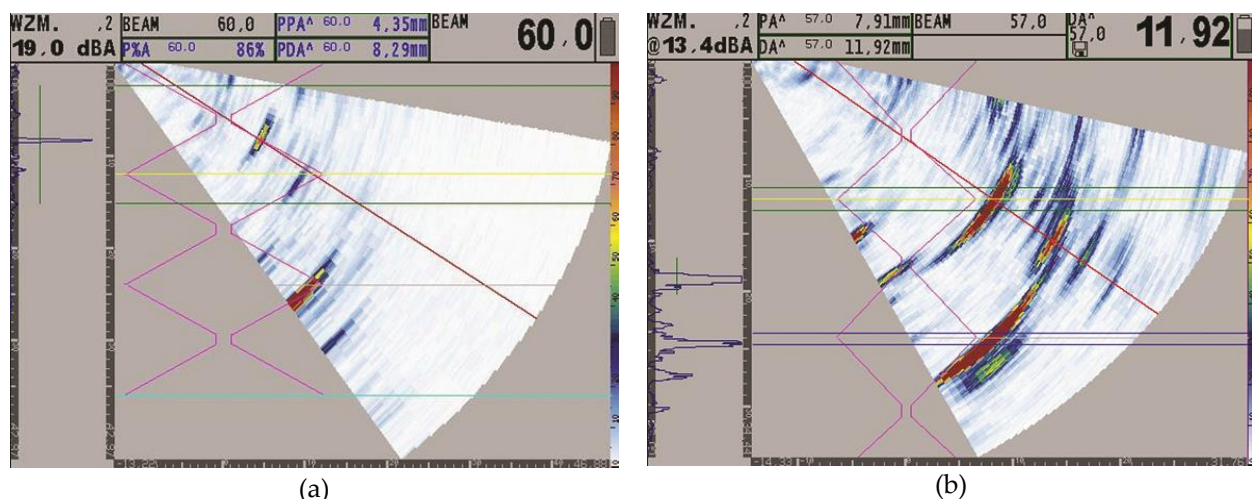
Fig. 6. Example results of UT, Phased Array: a) Specimen 1; b) Specimen 2

The Phasor XS defector was used to perform the ultrasonic tests, allowing the use of the Phased Array head. A 16-element head was used, the wedge of which has a 36° angle of inclination. The head sends 4 MHz waves. During the tests, type A and S imaging were obtained. For both joints, the tests were carried out in places where indications on radiographs appeared so as to determine their depth of occurrence. Similarly to other non-destructive tests, it was proved that a greater number of discrepancies occurred in joint 2, which was performed using a smaller amount of introduced heat. It was also confirmed that discrepancies occur at the fusion line and in the HAZ of S460N steel. In the case of the first joint, discrepancies occurred at a depth of 8 to 11.5 mm from the upper surface of the sample, while in joint 2 their depth was more diverse, from 5 to 12 mm. Examples of type A and S flaw detectors imaging are presented in figure 6.
